Site Code: <b>MNO12</b>	Location: AREA B	Grid Sq: 15/210	Context Type: DEPOSIT	Context Number: 2104
Deposit	1. FRIABLE			Cut
1. Compaction	2. LIGHT YELLOW GREY			
2. Colour	3. COARSE SAND WITH SILT			
3. Composition	4. FREQUENT SMALL STONES $\leq 3\text{M}$			
4. Inclusions	OCCASIONAL CHARCOAL $\leq 5\text{M}$ . FREQUENT LIMST			
5. Interface	$\leq 3\text{mm}$			
6. Dimensions	5. CLEAR.			
7. Other Comments	7. SMALL PATCH IN CORNER OF ROOM			
8. Method/Conditions	Text			
8. TROWEL, SHOVEL.				
6. DIMENSIONS: 0.32M x 0.30M 0.05M				
				Max Level: 11.09 m OD
				Min Level: 11.06 m OD

Context Number:  
2104

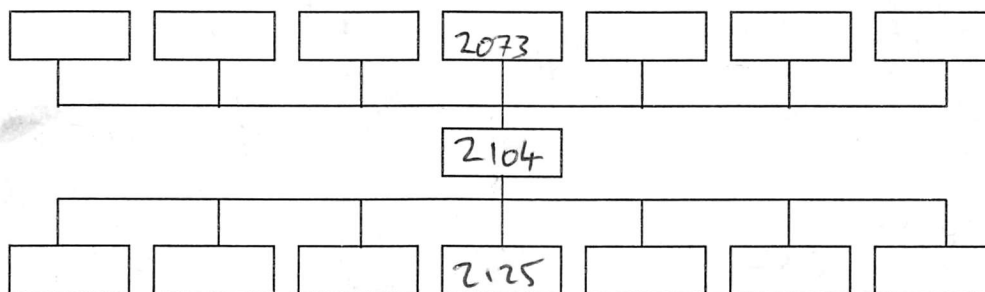
Interpretation:	<u>Internal</u>	External	Structural
SMALL PATCH OF MORTAR BEDDING IN SE CORNER OF BACK ROOM OF NO 2 THE CRESCENT, DIRECTLY BENEATH FLOOR [2073]. MAY HAVE ORIGINALLY SPREAD UNDER MORE OF THE FLOOR.			
Context same as:
