| Site Code:<br><b>MNO12</b> | Location:<br>AREA<br>C | Grid Sq: 130/210<br>130/205 135/210<br>135/205 | Context Type:<br>CUT | Context Number:<br>3094 |

| ROBBED CUT (3094), CUTS THROUGH TOP OF BARREL VAULT<br>+ WALLS [3003]. CUT IS UNUSUAL AS IT CUTS THROUGH THE<br>TOP OF THE STRUCTURE BUT HAS NO CLEAR BASE. CUT<br>EXTENDS OUT OF SOUTHERN ENTRANCE OF VAULT AND OVER<br>BRICK FLOOR [3119]. STEPS IN ENTRANCE AREA WERE<br>LIKELY ROBBED OUT (LEAVING ONLY STEPS [3128] AND SMALL<br>WALLS [3131], [3129] & [3130] | | | |

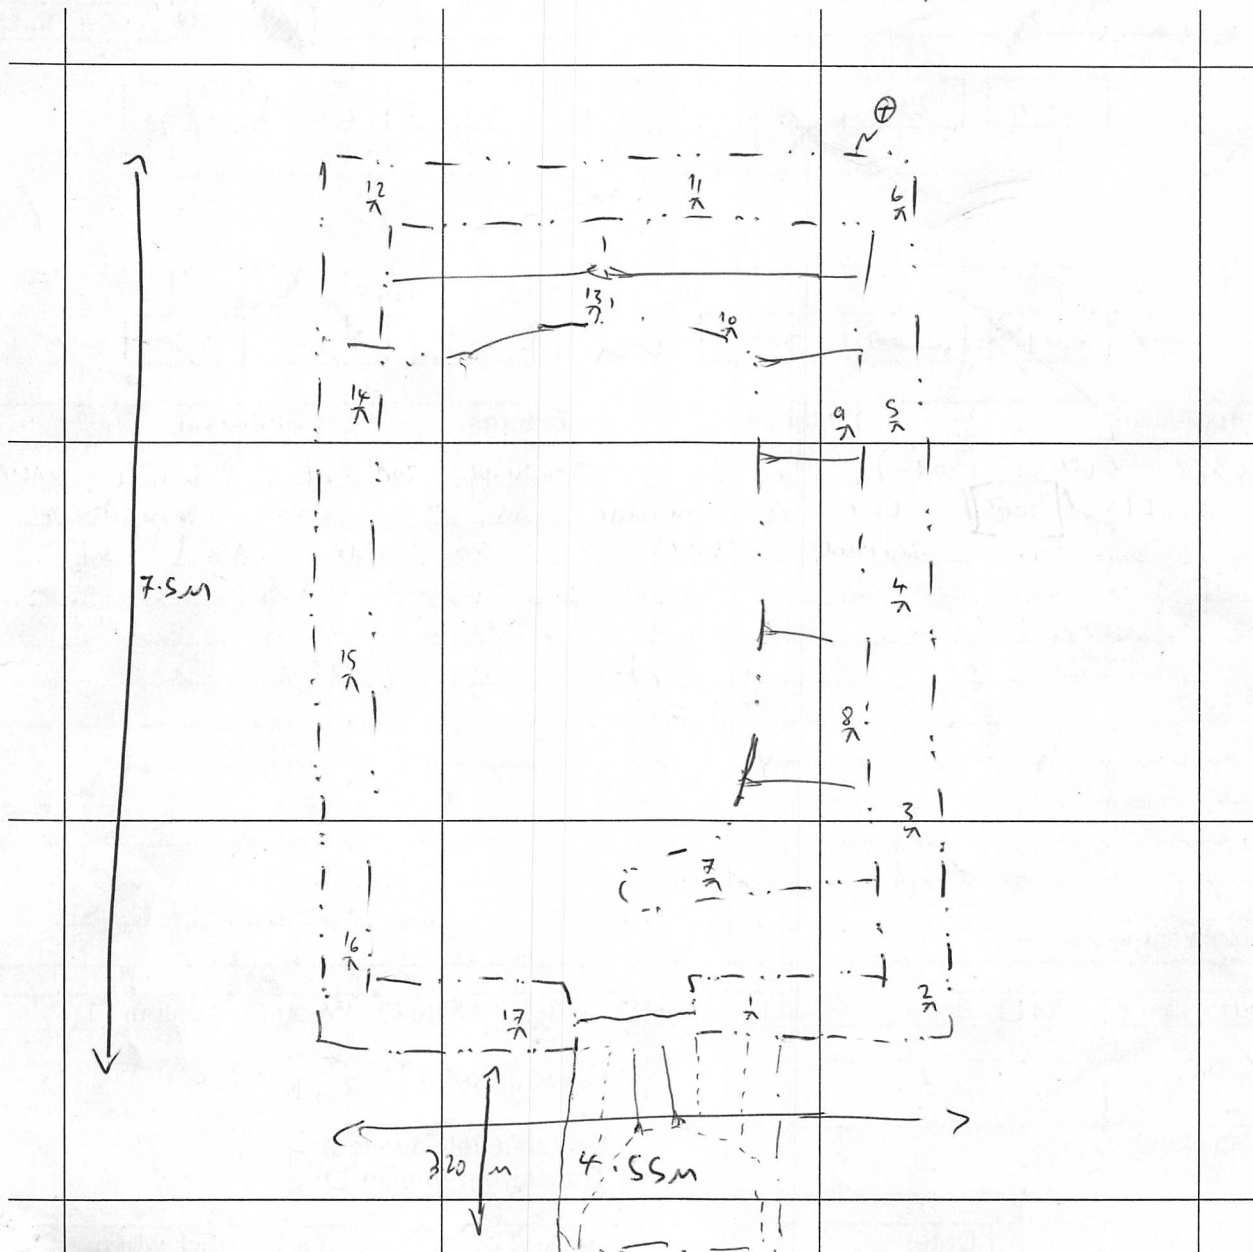
3094

Level No.s 1-3 <sup>15</sup> S, 11-~~17~~ Level No.s 4, 7, 8, 9, 13, 16, 17 Level No.s  
 TBM 11.40 TBM 11.40 TBM  
 B/S -0.26 B/S 0.46 B/S  
 IH 11.14 IH 11.86 IH

| No. | F/S | R/L (m OD) | No. | F/S | R/L (m OD) | No. | F/S | R/L (m OD) | No. | F/S | R/L (m OD) |
| 1 | 1.70 | 9.44 | 6 | 1.04 | 10.10 | 11 | 2.01.99 | 9.15 | 16 | 2.53 | 8.65 |
| 2 | 1.34 | 9.80 | 7 | 1.63 | 9.23 | 12 | 2.20 | 8.94 | 17 | 2.29 | 8.92 |
| 3 | 1.89 | 9.25 | 8 | 2.16 | 9.70 | 13 | 1.97 | 9.89 | | | |
| 4 | 2.62 | 9.24 | 9 | 2.34 | 9.52 | 14 | 2.49 | 8.65 | | | |
| 5 | 1.85 | 9.29 | 10 | 1.16 | 10.70 | 15 | 3.03 | 9.11 | | | |
