Site Code: <b>MNO12</b>	Location: <b>C</b>	Grid Sq: <b>145/215</b>	Context Type: <b>MASONRY</b>	Context Number: <b>3356</b>
1. Materials	① BRICKS (ORANGEY RED, SLIGHT FROG, MARK)			
2. Size of materials (brick: BTL in mm)	② 105mm x 60mm x 230mm			
3. Finish of stones	③ MOUNDEN BRICK			
4. Coursing / bond	④ STRETCHERS ON BED, ONE COURSE THICK			
5. Form	⑤ BRICK FLOOR			
6. Direction of face(s)	⑥ UP			
7. Surface treatment	⑦ -			
8. Bonding material (if brick: record height of 4 courses & 4 bed joints in m)	⑧ SOME TRACES OF SAND IN BETWEEN AND BENEATH THE BRICKS			
9. Dimensions of masonry as found	⑨ 0.56m N-S, 0.65m E-W			
10. Other comments	⑩ HEAVILY TRUNCATED			Max Level: 10.83 m OD
	⑪ HALF/BROKEN BRICKS			Min Level: 10.75 m OD

Interpretation:	<input checked="" type="checkbox"/> internal	<input type="checkbox"/> external
PART OF A TRUNCATION BRICK FLOOR IN THE REAR ROOM OF A BUILDING ON THE MINORIES STREET		
Context same as: 3355

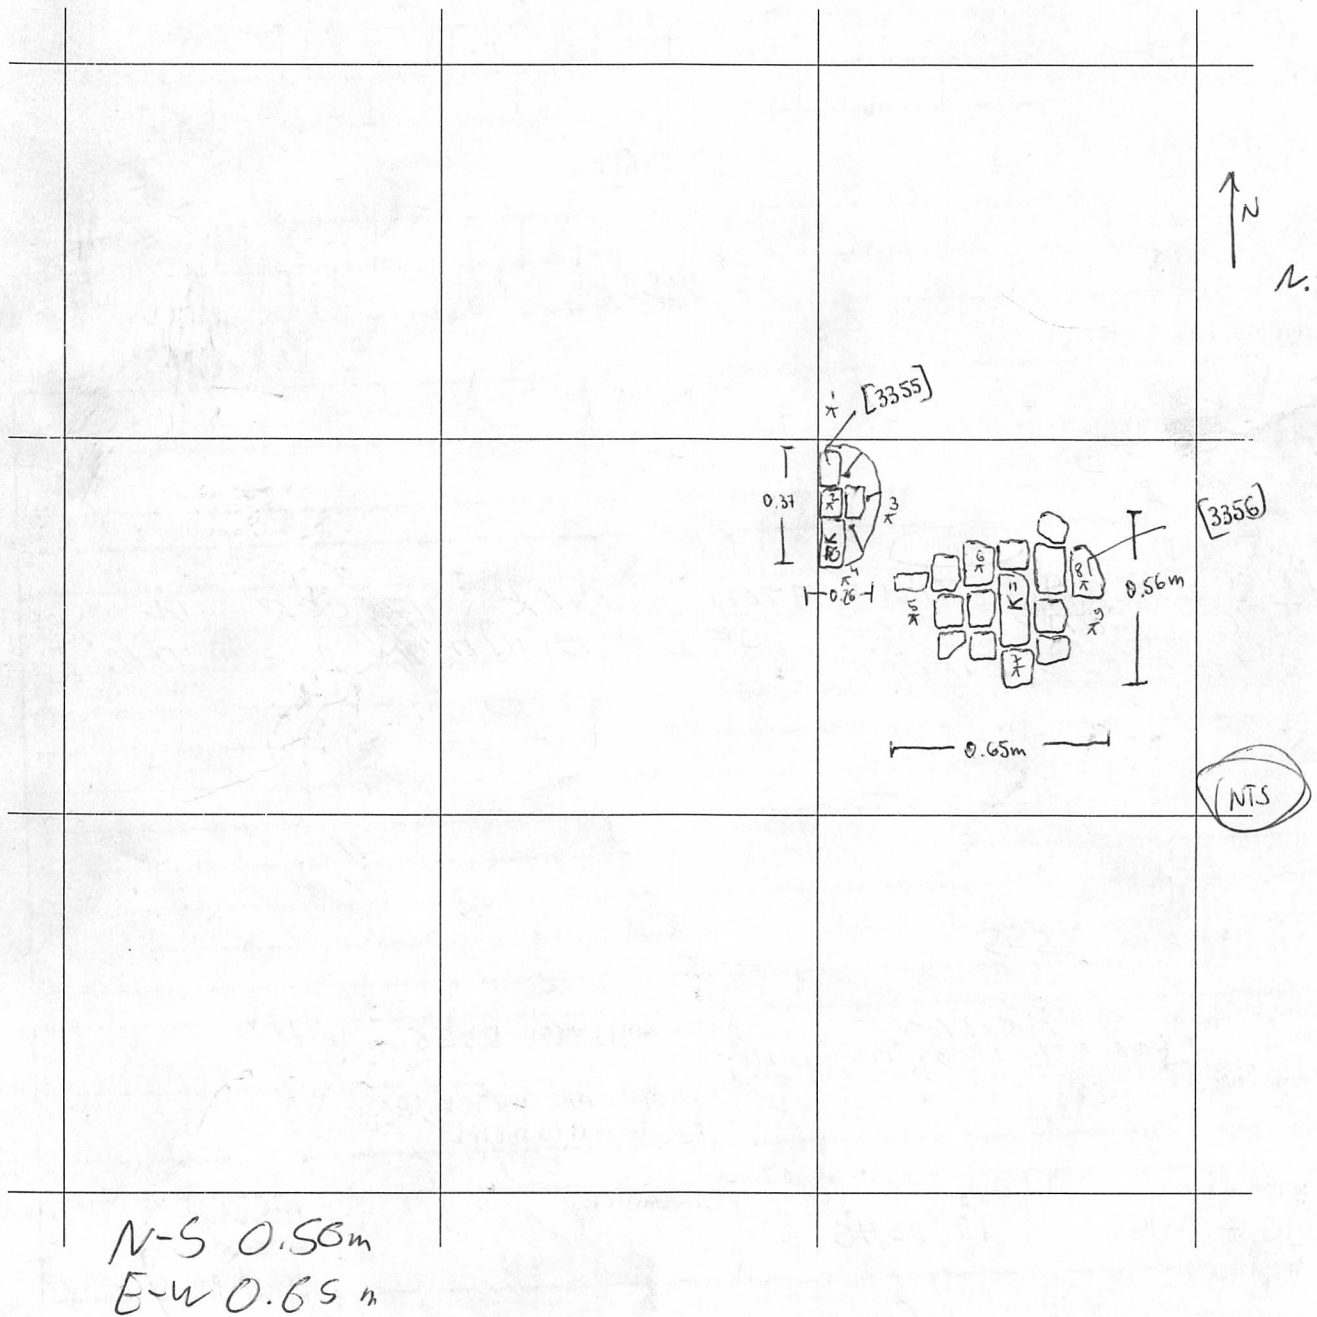
Sketch Plan & Notes

No.	F/S	R/L (m OD)	No.	F/S	R/L (m OD)	No.	F/S	R/L (m OD)	No.	F/S	R/L (m OD)
1	1.41	10.84	6	1.42	10.83	11	1.50	10.75			
2	1.35	10.90	7	1.43	10.82						
3	1.43	10.82	8	1.44	10.81						
4	1.41	10.84	9	1.46	10.79						
5	1.47	10.78	10	1.42	10.83
