Site Code: MNO12	Location: C	Grid Sq: 145/215	Context Type: CUT	Context Number: 3438
Deposit	① RECTANGLE			Cut 1. Shape in Plan 2. Corners 3. Dimensions 4. Break of slope – Top 5. Sides 6. Break of slope – Base 7. Base 8. Orientation 9. Inclination 10. Truncation 11. Other comments
1. Compaction	② —			
2. Colour	③ 1.4m x 0.9m x 0.15m MAX			
3. Composition	④ SHARP			
4. Inclusions	⑤ NEAR VERTICAL			
5. Interface	⑥ SHARP			
6. Dimensions	⑦ FLAT			
7. Other Comments	Text			
8. Method/Conditions	⑧ N-S POSSIBLY			
	⑨ —			
	⑩ YES TO N, E AND S			
⑪ NOT PRESENT TO S OF TRUNCATION ALTHOUGH EQUIVALENT OF PATH [3432] IS POSSIBLY JUST A HIGHER PIECE OF GROUND THAT WAS CUT INTO TO MAKE PATH FLAT				
				Max Level: 10.41 m OD
				Min Level: 10.24 m OD

Context Number:
3438

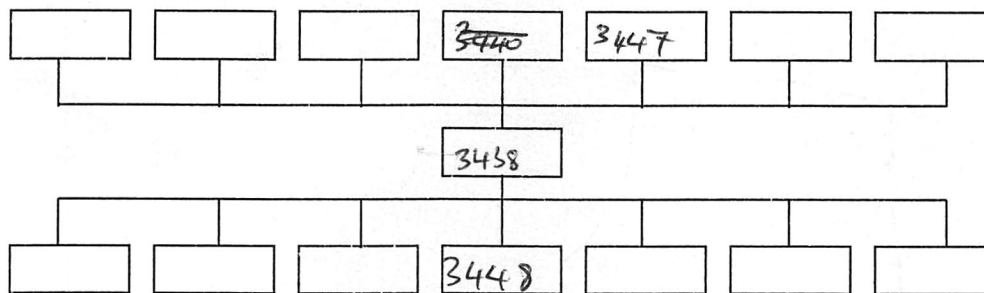
Interpretation:	Internal	External	Structural
CUT FOR BRICK PATH IS RUNNING N-S IN BACK YARDS OF PRE-1960S PRE HOUSES. EXTENDS TO S BEYOND TRUNCATION AS [3418] AND [3419]			
Context same as: [3418] [3419]

Level No.s 1-7
TBM 11.40
B/S 1.11
IH 12.51

No.	F/S	R/L (m OD)	No.	F/S	R/L (m OD)	No.	F/S	R/L (m OD)	No.	F/S	R/L (m OD)
1	2.10	10.41	6	2.24	10.24						
2	2.20	10.31	7	2.23							
3	2.23	10.28									
4	2.21	10.30	6	2.27	10.24						
5	2.12	10.39	7	2.23	10.28
