Site Code: MNO12	Location: AREA C	Grid Sq: 145/210-215 150/210-215	Context Type: Cut	Context Number: 3368
Deposit				Cut
1. Compaction	1. sub-rectangular			1. Shape in Plan
2. Colour	2. sub-oval			2. Corners
3. Composition	3. 2m 2.00m (E-W), 0.95m (N-S); 0.36m deep			3. Dimensions
4. Inclusions	4. sharp			4. Break of slope - Top
5. Interface	5. vertical - gradual			5. Sides
6. Dimensions	6. gradual			6. Break of slope - Base
7. Other Comments	7. flat			7. Base
8. Method/Conditions	Text	8. E-W		8. Orientation
		9. /		9. Inclination
		10. 3378 - drain		10. Truncation
		11. ✓		11. Other comments
				Max Level: 10.76 m OD
				Min Level: 10.40 m OD

Context Number:
3368

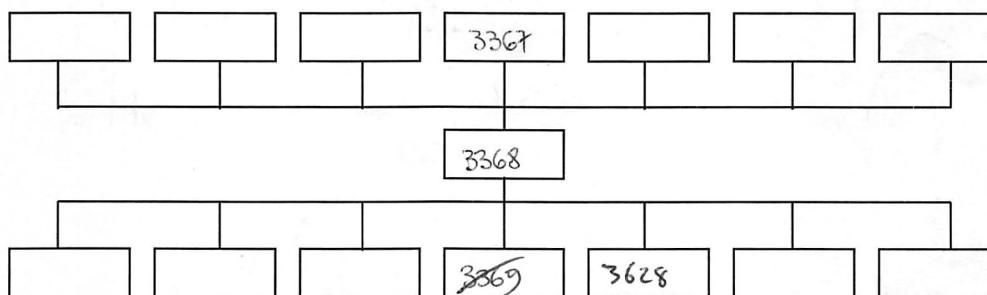
Interpretation:	Internal	External	Structural
linear cut (E-W) in Georgian building			
The function of the cut remains unclear.			
Possibly a robber / repair cut in the rear room of Georgian building.			
Context same as:

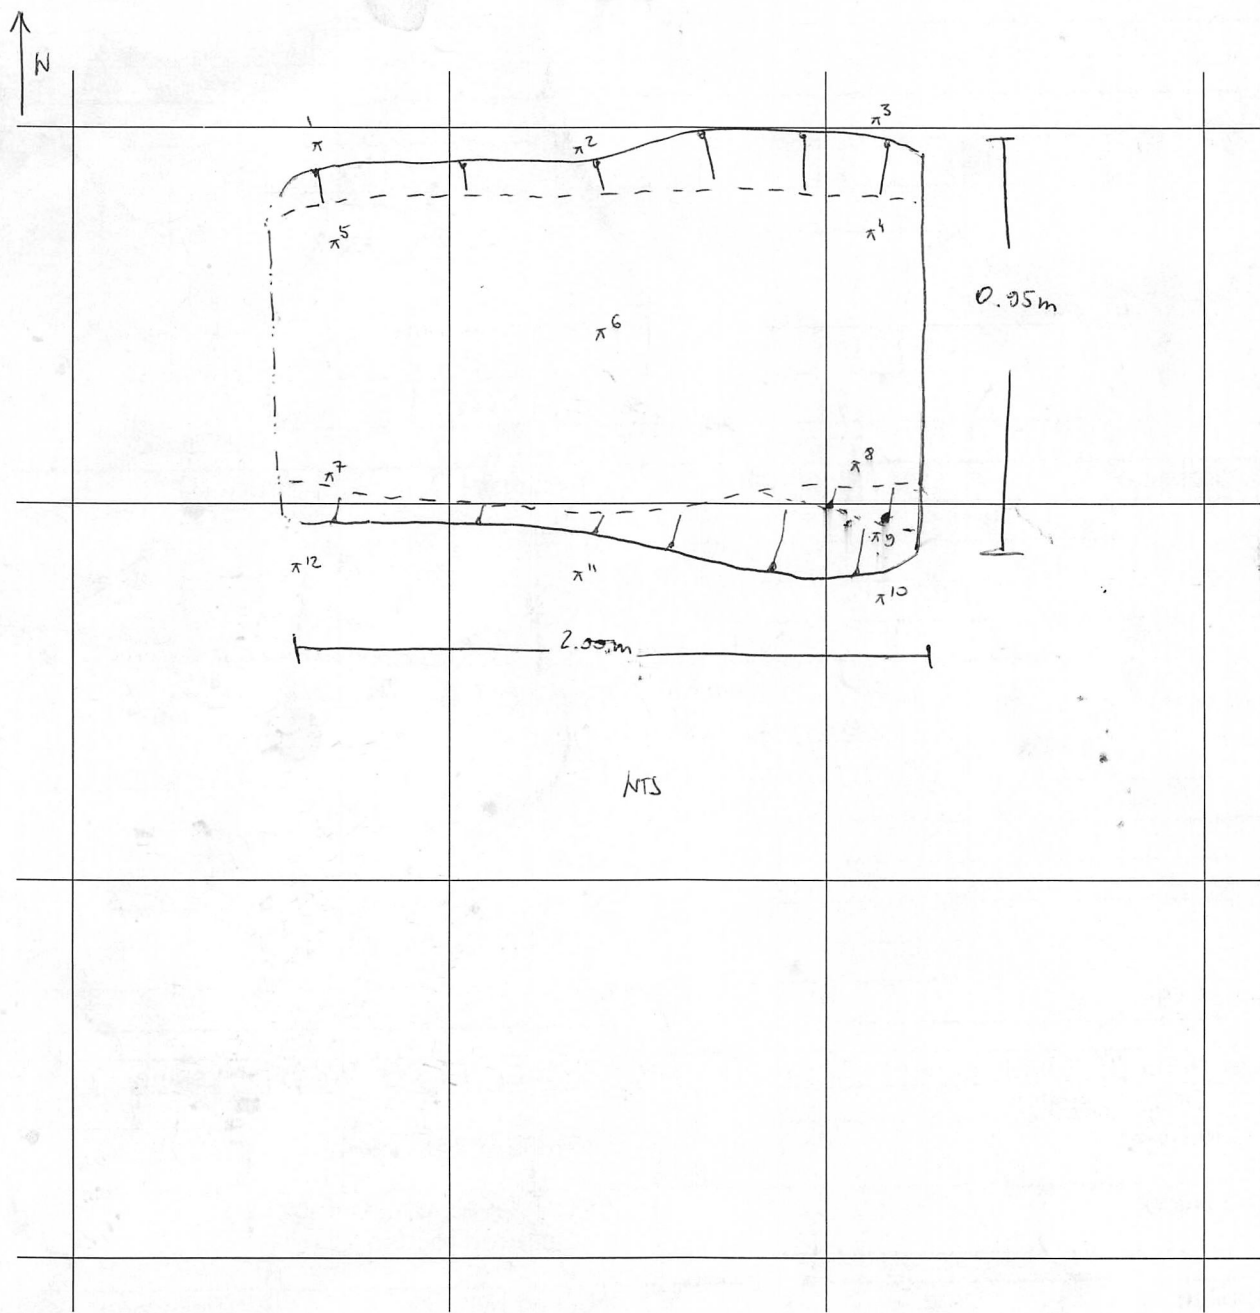
Level No.s 1-12
TBM 11.40
B/S 0.85
IH 12.25

No.	F/S	R/L (m OD)	No.	F/S	R/L (m OD)	No.	F/S	R/L (m OD)	No.	F/S	R/L (m OD)
1	1.49	10.76	6	1.81	10.44	11	1.53	10.72			
2	1.49	10.76	7	1.84	10.41	12	1.52	10.73			
3	1.55	10.70	8	1.81	10.44						
4	1.82	10.43	9	1.80	10.56						
5	1.85	10.40	10	1.52	10.73
