Site Code: MNO12	Location: <i>AREA</i>	Grid Sq: <i>145/215</i>	Context Type: MASONRY	Context Number: 3417
1. Materials	1. BRICK (DARK PINKISH RED, SLIGHTLY SOFT)			
2. Size of materials (brick: BTL in mm)	2. 93mm x 67mm x 230mm			
3. Finish of stones	3. Moulded BRICKS			
4. Coursing / bond	4. BRICKS ALL ON BED, OTHERWISE IRREGULAR			
5. Form	5. PART OF A BRICK DRAW			
6. Direction of face(s)	6. —			
7. Surface treatment	7. —			
8. Bonding material (if brick: record height of 4 courses & 4 bed joints in m)	8. THICK MORTAR (DARK YELLOWISH BROWN, HARD, SANDY)			
9. Dimensions of masonry as found	9. 0.50m E-W, 0.35m N-S, 0.17m HIGH			
10. Other comments	10. /			
			Max Level: 10.57 m OD	
			Min Level: 10.40 m OD

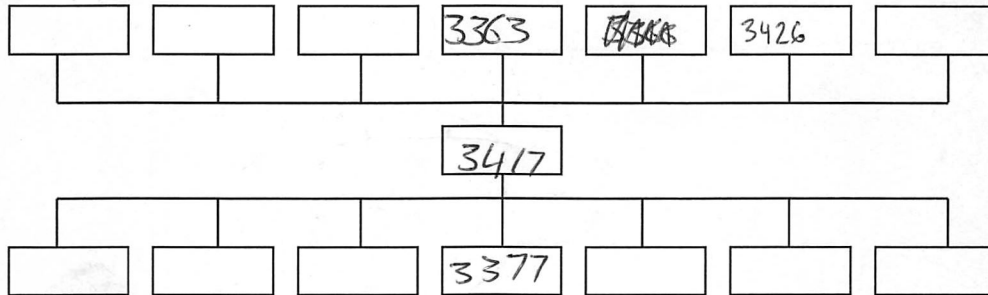
Stratigraphic Relationships:

Abuts: <i>3377</i>	Abutted by:
Cut by:

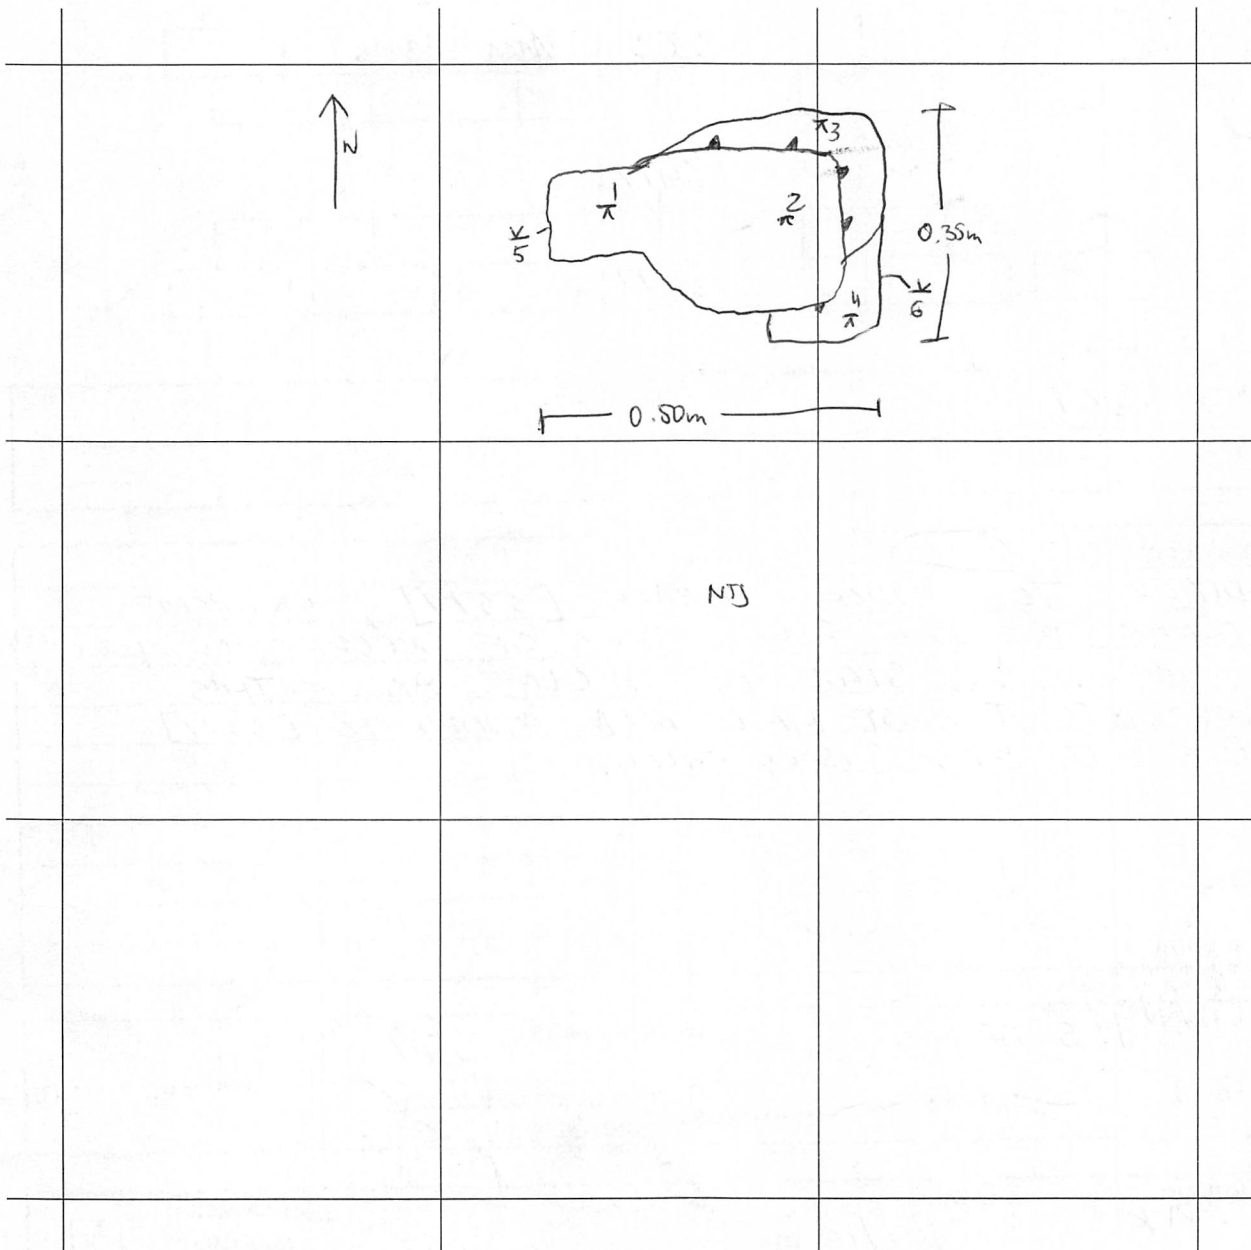
Interpretation: <u>internal</u> external
ADDITION TO BRICK DRAW [3377], PURPOSE UNKNOWN POSSIBLY SOME SORT OF REINFORCEMENT OR REPAIR. NO SIGN OF A CUT ABOVE THIS MASONRY SO IT MUST HAVE BEEN ADDED TO [3377] BEFORE IT WAS BACK FILLED.
Context same as:

No.	F/S	R/L (m OD)	No.	F/S	R/L (m OD)	No.	F/S	R/L (m OD)	No.	F/S	R/L (m OD)
1	1.89	10.57	6	2.06	10.40						
2	1.89	10.57									
3	1.95	10.51									
4	1.95	10.51									
5	1.98	10.48
