Site Code: MNO12	Location: AR267A L	Grid Sq: 150/215	Context Type: DEP.	Context Number: 3458
Deposit	1. V. HARD		Cut	
1. Compaction	2. DARK PURPLEY ORANGE		1. Shape in Plan	
2. Colour	3. Fe		2. Corners	
3. Composition	4. —		3. Dimensions	
4. Inclusions	5. DISTINCT		4. Break of slope —	
5. Interface	6. 8.00m x 4" DIAMETER		5. Sides	
6. Dimensions	7. IT IS AN IRON PIPE		6. Break of slope —	
7. Other Comments	Text		7. Base	
8. Method/Conditions	8. SUNNY, LEFT IN SITU (27/05/15)		8. Orientation	
	MAY BE REMOVED LATER		9. Inclination	
			10. Truncation	
			11. Other comment	
			Max Level: 4.23	
			Min Level: 2.70

Context Number:
3458

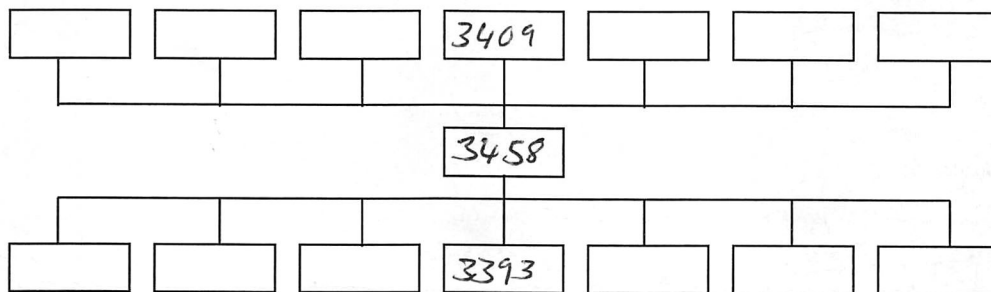
Interpretation:	<u>Internal</u>	External	Structural
AN IRON PIPE CONNECTING TO A BRICK INSPECTION CHAMBER TO THE WEST [3409], WHOLE STRUCTURE IS WITHIN CON. CUT [3393]			
Context same as:
