Site Code: MNO12	Location: C	Grid Sq: 145/210	Context Type: CU7	Context Number: 3496
Deposit 1. Compaction 2. Colour 3. Composition 4. Inclusions 5. Interface 6. Dimensions 7. Other Comments 8. Method/Conditions	1. LINEAR / RECTANGULAR			Cut 1. Shape in Plan 2. Corners 3. Dimensions 4. Break of slope - Top 5. Sides 6. Break of slope - Base 7. Base 8. Orientation 9. Inclination 10. Truncation 11. Other comments
	2. /			
	3. 1.04 m (N-S) 0.35 (E-W) x			
	0.27 (DEPTH)			
	* SLIGHTLY ROUNDED			
	S: STEEP ON W. SIDE, VERTICAL ON			
	EAST.			
	6. ROUNDED.			
	Text			
	7. FLAT.			
	8. N-S			
9. /				
10. (P) e ROBBED [3459].				
11.				
				Max Level: 10.78 m OD
				Min Level: 10.51 m OD

Context Number:
3496

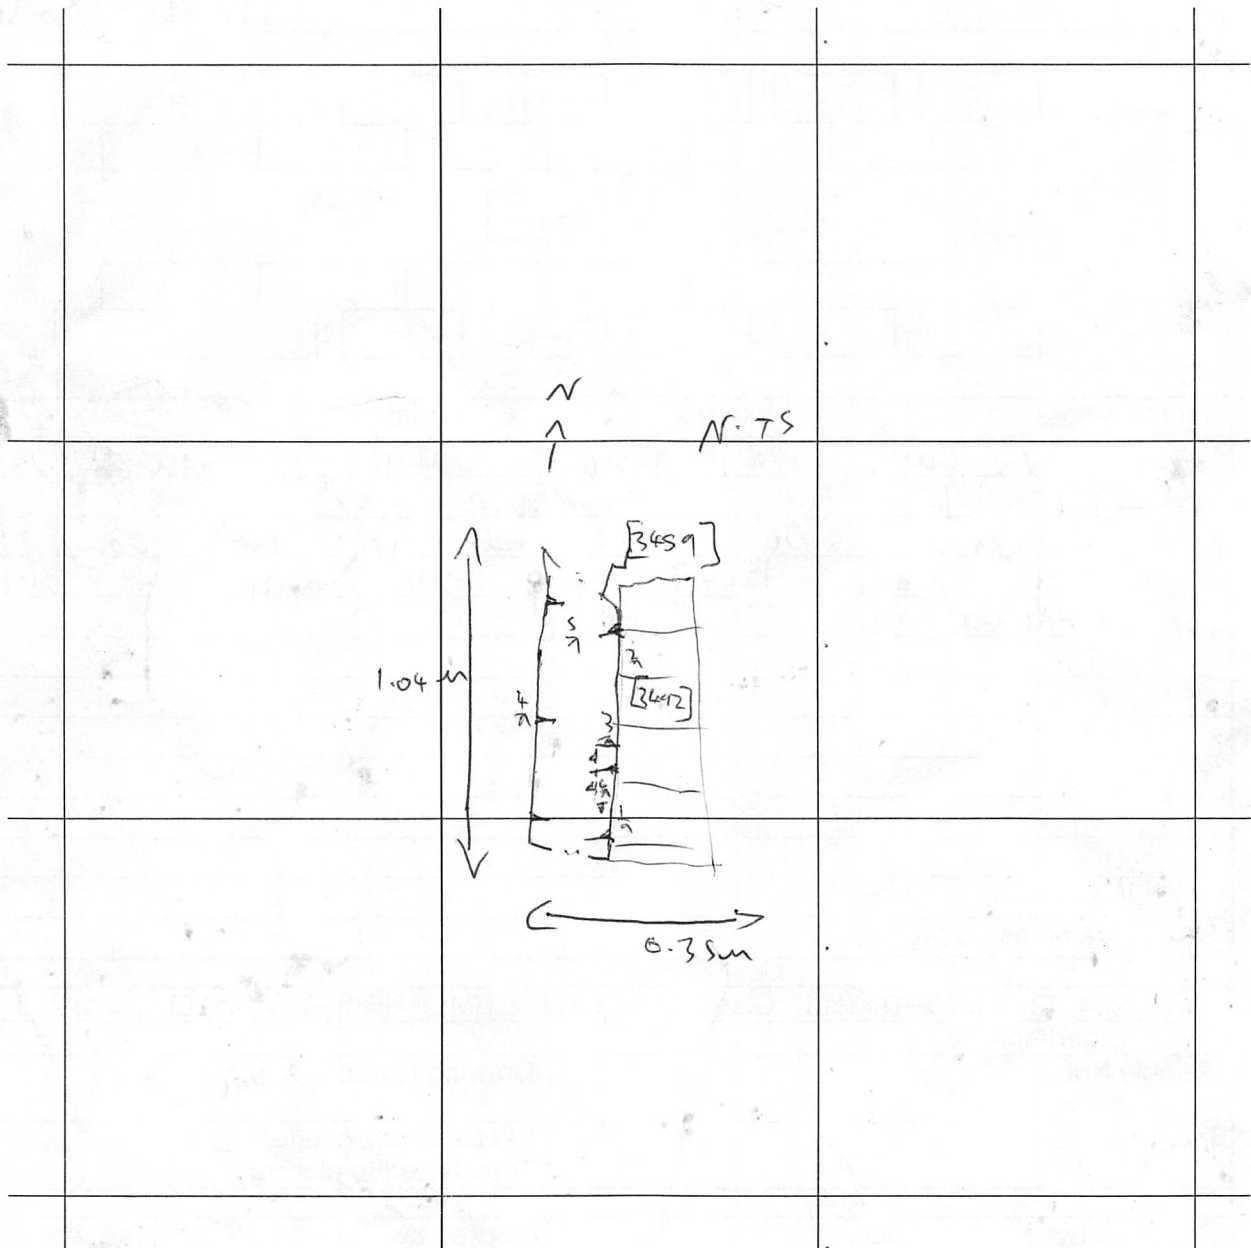
Interpretation:	Internal	External	Structural
CONSTRUCTION CU7	FOR	WALL [3491]	SAME AS
[3454] [3454]	BUILT	TRUNCATED 137'	[3459]
ON EASTERN	SIDE	THE ON IT	CUTS DOWN THE
SIDE OF WALL	[3492]	AND THE WALL IS BUILT	UP AGAINST IT.
Context same as: 3454

No.	F/S	R/L (m OD)	No.	F/S	R/L (m OD)	No.	F/S	R/L (m OD)	No.	F/S	R/L (m OD)
1	1.79	10.78	6.	1.94	10.63						
2	1.86	10.71									
3	2.06	10.51									
7	1.86	10.6									
5	2.02	10.55
