Site Code: MNO12	Location: C	Grid Sq: 145/210 145/215	Context Type: CUT	Context Number: 3454
Deposit	1. LINEAR/RECTANGULAR.			Cut 1. Shape in Plan 2. Corners 3. Dimensions 4. Break of slope – Top 5. Sides 6. Break of slope – Base 7. Base 8. Orientation 9. Inclination 10. Truncation 11. Other comments
1. Compaction	2. /			
2. Colour	3.			
3. Composition				
4. Inclusions	4. SHARP			
5. Interface	5. VERTICAL			
6. Dimensions	6. SHARP.			
7. Other Comments	7. FLAT.			
8. Method/Conditions	Text			
8. N-S				
9. /				
10. TRUNCATED BY OLD ROSSER CUT [3459], R+				
11. MATCH. SLOVE.				
				Max Level: 10.53 m OD
				Min Level: 10.38 m OD

Context Number:
3454

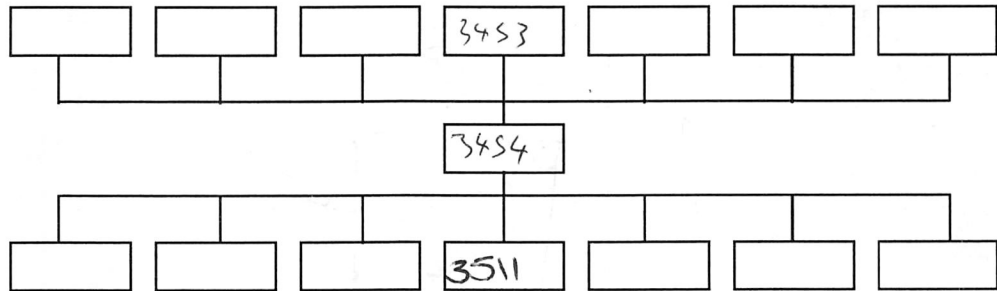
Interpretation:	Internal	External	Structural
CONSTRUCTION CUT FOR WALL [3453]. CUT IS			
SLIGHTLY WIDER THAN WALL & CONTAINS BACKFILL			
[3452]. AT THE BASE OF THE CUT WAS A			
THIN MORTAR BEDDING WHICH WAS \leq 10.0cm THICK.			
THE BEDDING WAS A YELLOW SAND AND WAS DIFFERENT			
TO THE MORTAR IN THE WALL.			
Context same as: \$ 3496

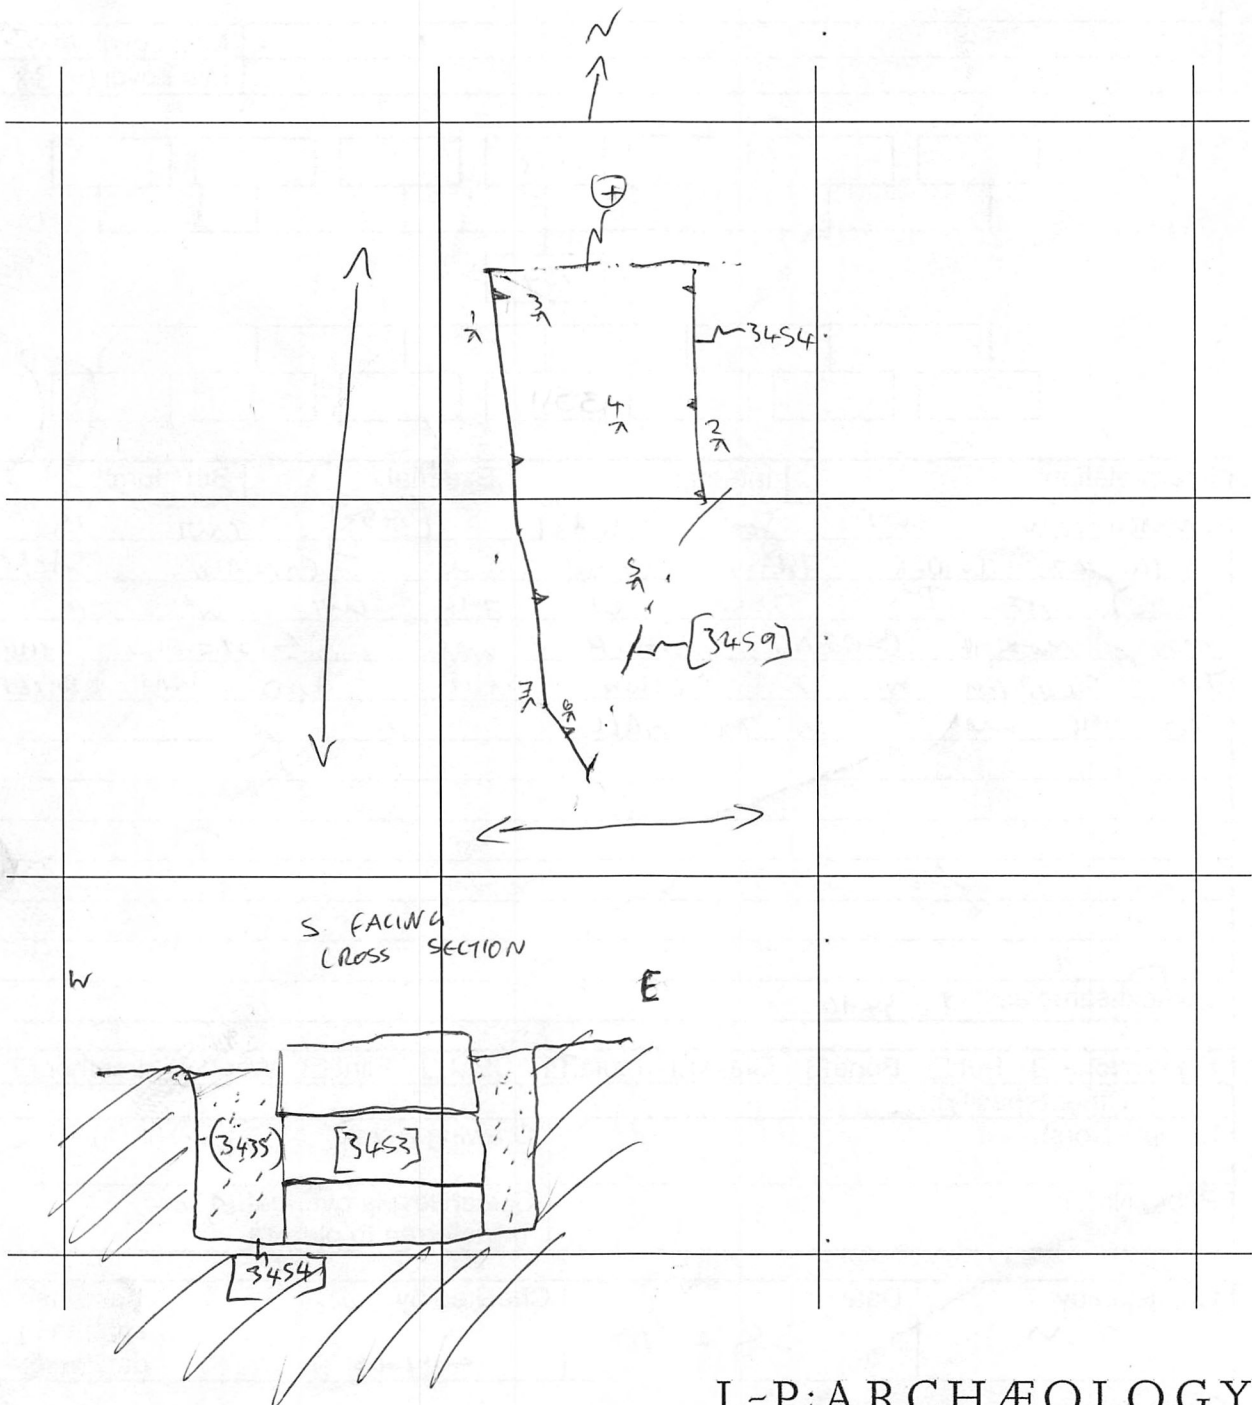
Sketch Plan & Notes

No.	F/S	R/L (m OD)	No.	F/S	R/L (m OD)	No.	F/S	R/L (m OD)	No.	F/S	R/L (m OD)
1	2.06	10.51	6	2.13	10.44						
2	2.04	10.53	7	2.06	10.51						
3	2.19	10.38									
4	2.13	10.44									
5	2.12	10.45
