Site Code: MNO12	Location: C	Grid Sq: 19/210	Context Type: MASONRY	Context Number: 3569
1. Materials	1. Mixed purple, red orange red bricks. some deep frog			
2. Size of materials (brick: BTL in mm)	2. 100mm x 65mm x 230mm			
3. Finish of stones	3. moulded bricks			
4. Coursing / bond	4. Random or uncoursed. mostly stretchers on bed. Two 1/2 bats on edge			
5. Form	5. Brick floor.			
6. Direction of face(s)	6. up			
7. Surface treatment	7. concrete seal over southern end.			
8. Bonding material (if brick: record height of 4 courses & 4 bed joints in m)	8. no mortar. concrete over southern part.			
9. Dimensions of masonry as found	9. 1.40m (N-S) x 1m (E-W) x			
10. Other comments				Max Level: 10.75 m OD
				Min Level: 10.54 m OD

Context Number:
3569

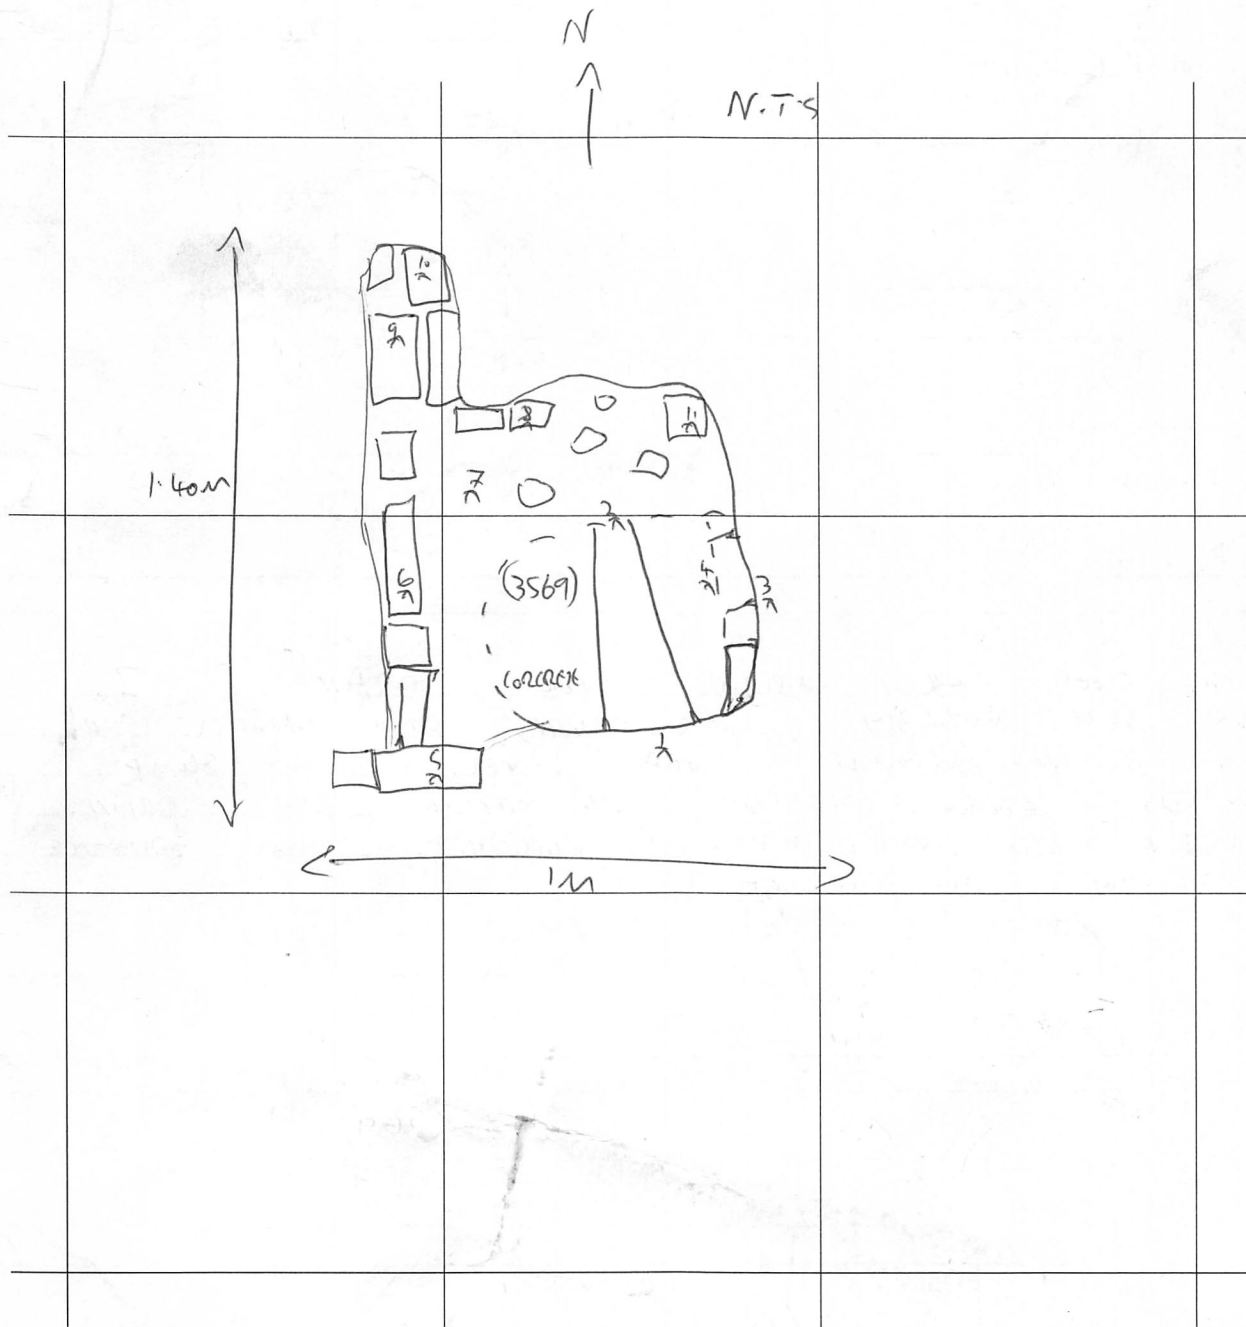
Interpretation:	internal	external
Brick floor or capping over drain [?]. Bricks were probably laid down over backfill of drain to make/rebuild floor level. Bricks slump towards centre, probably EA sinking into drain. The mixture of deep froged, shallow & unfroged bricks indicates that the bricks were re-used.		
Context same as:
