Site Code: MNO12	Location: Area C	Grid Sq: E 135/W220 E 140/W220	Context Type: MASONRY	Context Number: 3746 3582
1. Materials	1) IRREGULAR yellow brick, poorly fired			
2. Size of materials (brick: BTL in mm)	2) up to 210mm x 100mm x 70mm, ALTHOUGH MOST BRICKS RE-USED			
3. Finish of stones	3) SQUARED, BUT poor quality			
4. Coursing / bond	4) IRREGULAR COURSING			
5. Form	5) WESTERN LATE WALL AND BOTTING CORNER			
6. Direction of face(s)	SOUTH WALL IN GEORGIAN HOUSE			
7. Surface treatment	6) N/A			
8. Bonding material (if brick: record height of 4 courses & 4 bed joints in m)	7) NONE			
9. Dimensions of masonry as found	8) FRAGILE SAND MORTAR, LIGHT BLW CAGY.			
	9) 2.21m N-S, 0.96m E-W, 0.12m			
10. Other comments	10) -			
				Max Level: 10.71 m OD
			Min Level: 10.66 m OD

Context Number:
~~3582~~ 3746

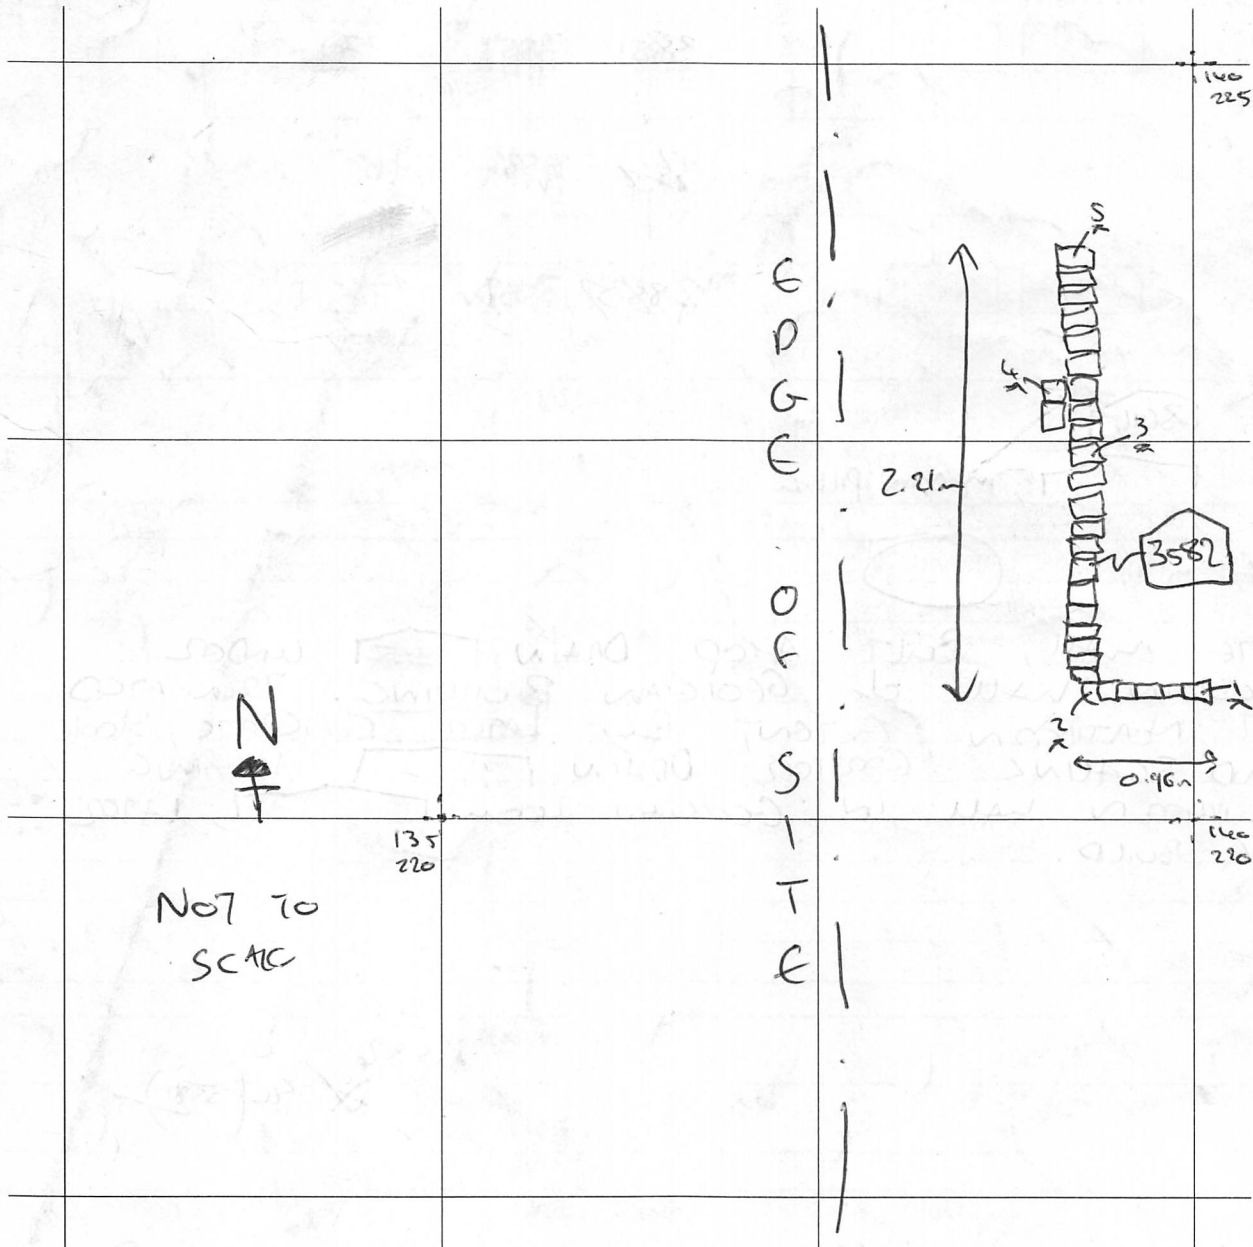
Interpretation:	<input checked="" type="radio"/> internal	<input type="radio"/> external
LATE WALL, BUILT ATOP DRAIN UNDER WESTERN WALL OF GEORGIAN BUILDING. TRUNCATED AT NORTHERN FRONT BY LATER CONCRETE BLOCK AND SCAFFOLD BRICK DRAIN ADJOINING SOUTHERN WALL IN GEORGIAN ROOM , LATER RE-BUILD.		
Context same as:
