Site Code: MNO12	Location: AREA D	Grid Sq: T40/ 225	Context Type: MASONRY	Context Number: 3816
1. Materials	1. York stone slabs 150x30x210mm			
2. Size of materials (brick: BTL in mm)	2. Largest = 400x40x580mm Small ^{est} - 350x40x470mm			
3. Finish of stones	3. Parallel tool marks on larger slab; no work on smaller			
4. Coursing / bond	4. N/A			
5. Form	5. Roof of drain			
6. Direction of face(s)	6. Vertical			
7. Surface treatment	7. Parallel tool marks on larger slab			
8. Bonding material (if brick: record height of 4 courses & 4 bed joints in m)	8. Bright yellowish grey with limestone flecks (<10mm) occasional small sub-angular stone (<10mm); 1 course, 4 slabs			
9. Dimensions of masonry as found	9. NS - 0.45m EW - 1.82m			
10. Other comments	Thickness - 0.04m			
	10. Truncated due to the wide by [+] concrete pile			
				Max Level: 10.82 m OD
				Min Level: 10.77 m OD

Context Number:
3816

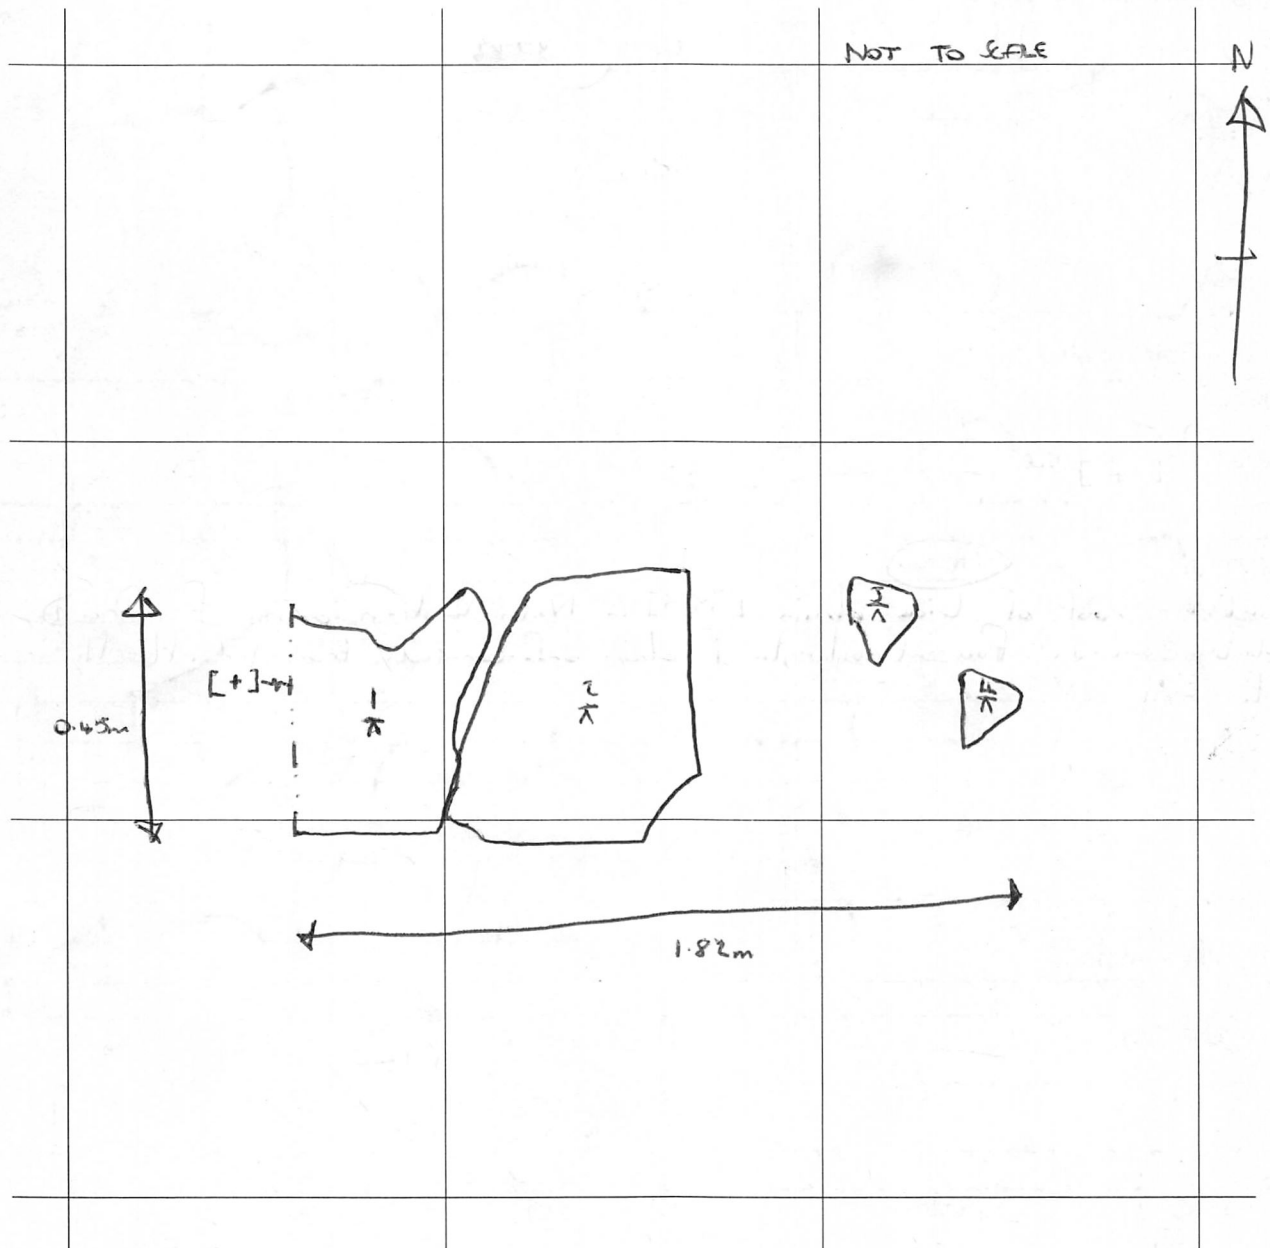
Interpretation:	<u>internal</u>	external
York stone roof of brick drain [3815] in North Western corner of Area D; probably continued for entire length of drain unfortunately truncated vertically by the East		
Context same as:

Level No.s 1-4
TBM 11.40
B/S 0.83
IH 12.23

No.	F/S	R/L (m OD)	No.	F/S	R/L (m OD)	No.	F/S	R/L (m OD)	No.	F/S	R/L (m OD)
1	1.46	10.77									
2	1.43	10.80									
3	1.41	10.82									
4	1.41	10.82
