Site Code: MNO12	Location: D	Grid Sq: 140/225	Context Type: CUT	Context Number: 4008
Deposit 1. Compaction 2. Colour 3. Composition 4. Inclusions 5. Interface 6. Dimensions 7. Other Comments 8. Method/Conditions 9. —	1. LINEAR			Cut 1. Shape in Plan 2. Corners 3. Dimensions 4. Break of slope – Top 5. Sides 6. Break of slope – Base 7. Base 8. Orientation 9. Inclination 10. Truncation 11. Other comments
	2. —			
	3. 0.90m E-W, 0.25m N-S			
	4. TRUNCATED			
	5. TRUNCATED			
	6. TRUNCATED			
	7. FLAT. GENTLY SLOPING DOWN TO WEST			
	8. E-W			
	Text			
	9. —			
10. TO EAST BY DRAIN CUT [4007], TO WEST BY DRAIN CUT [384], HORIZONTALLY TRUNCATED BY (7)				
			Max Level: 10.65 m OD	
			Min Level: 10.60 m OD

Interpretation:	Internal	External	<u>Structural</u>
CONSTRUCTION CUT FOR WALL [4007], HEAVILY TRUNCATED.			
Context same as: 3930

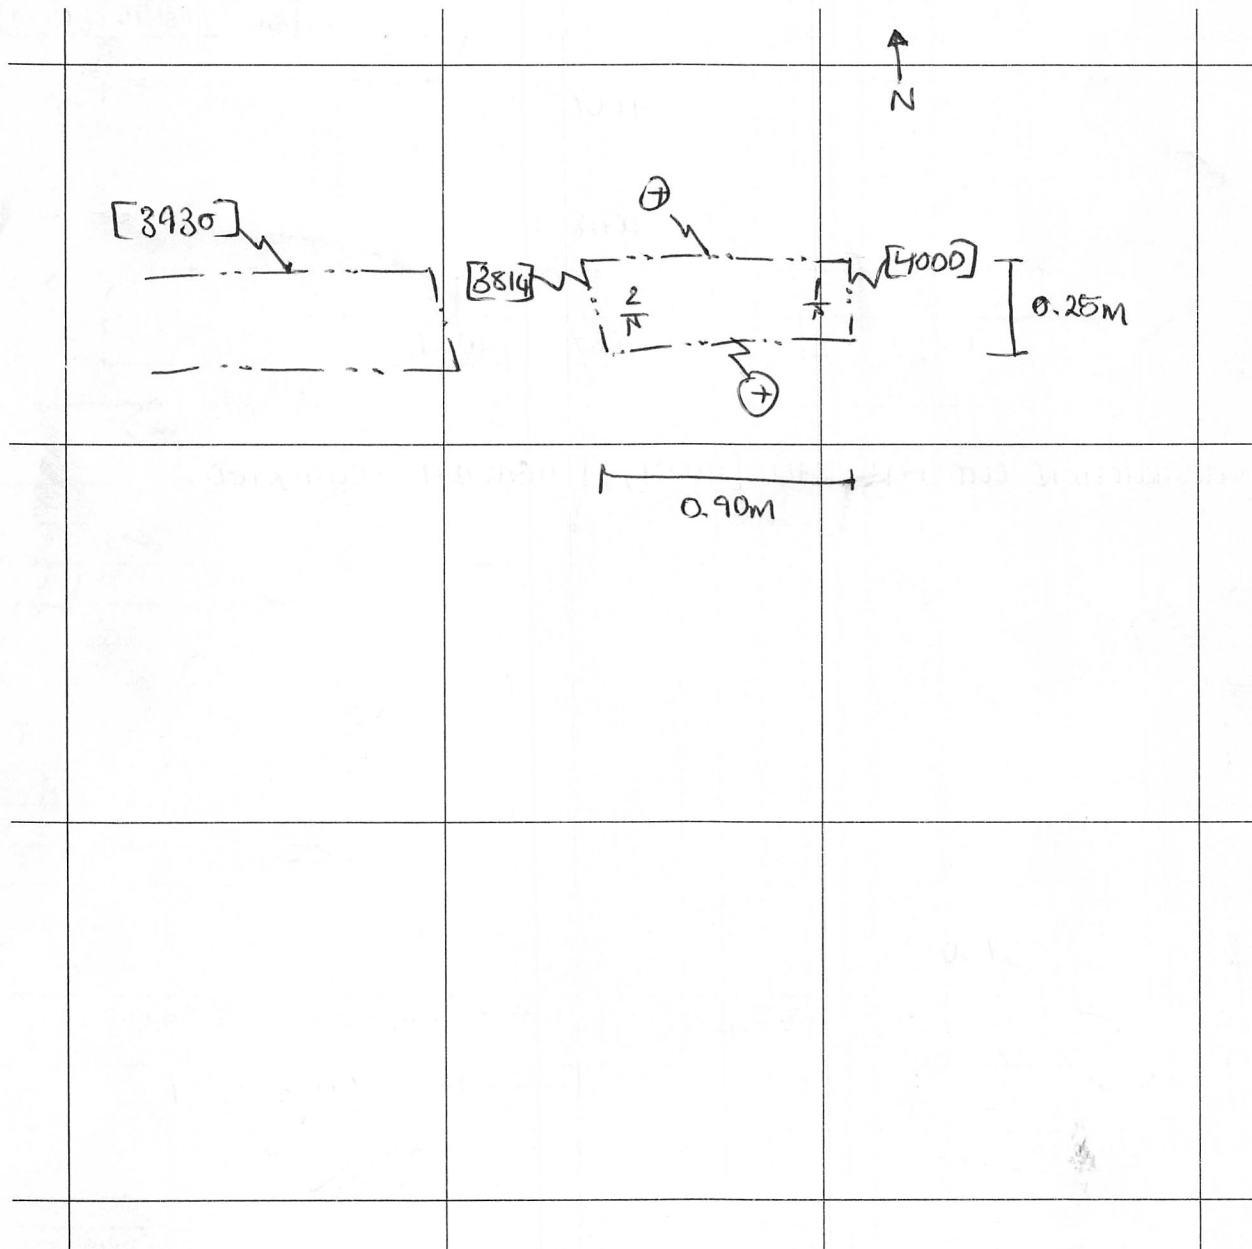
Context Number:
4008

No.	F/S	R/L (m OD)	No.	F/S	R/L (m OD)	No.	F/S	R/L (m OD)	No.	F/S	R/L (m OD)
1	121	10.65									
2	126	10.60
