Site Code: MNO12	Location: AREA D	Grid Sq: 135/225	Context Type: DEPOSIT	Context Number: 3955
Deposit 1. Compaction 2. Colour 3. Composition 4. Inclusions 5. Interface 6. Dimensions 7. Other Comments 8. Method/Conditions	1. MODERATELY LOOSE			Cut 1. Shape in Plan 2. Corners 3. Dimensions 4. Break of slope - Top 5. Sides 6. Break of slope - Base 7. Base 8. Orientation 9. Inclination 10. Truncation 11. Other comments
	2. LIGHT YELLOWISH WHITE			
	3. MORTAR SANDY MORTAR			
	4. OCCA. CBM (<100mm)			
	OCCA. OYSTER SHELL, OCCA.			
	LTP STEM, OCCA. GLASS,			
	OCCA. POT			
	Text 5. CLIPART ABOVE AND			
	BELOW			
	6. 1.11m E-W, 0.64m N-S, 0.11m THICK			
	7.			
8. MATTOCK AND TROWEL, SUNNY				
			Max Level: 10.56 m OD	
			Min Level: 10.46 m OD

Interpretation:	<input checked="" type="checkbox"/> Internal	<input type="checkbox"/> External	<input type="checkbox"/> Structural
MORTAR DEPOSIT, NW OF AREA D - NORTH OF PARTY WALL IN THE HEARTH AREA, LIKELY CONSTRUCTION WASTE			
Context same as:

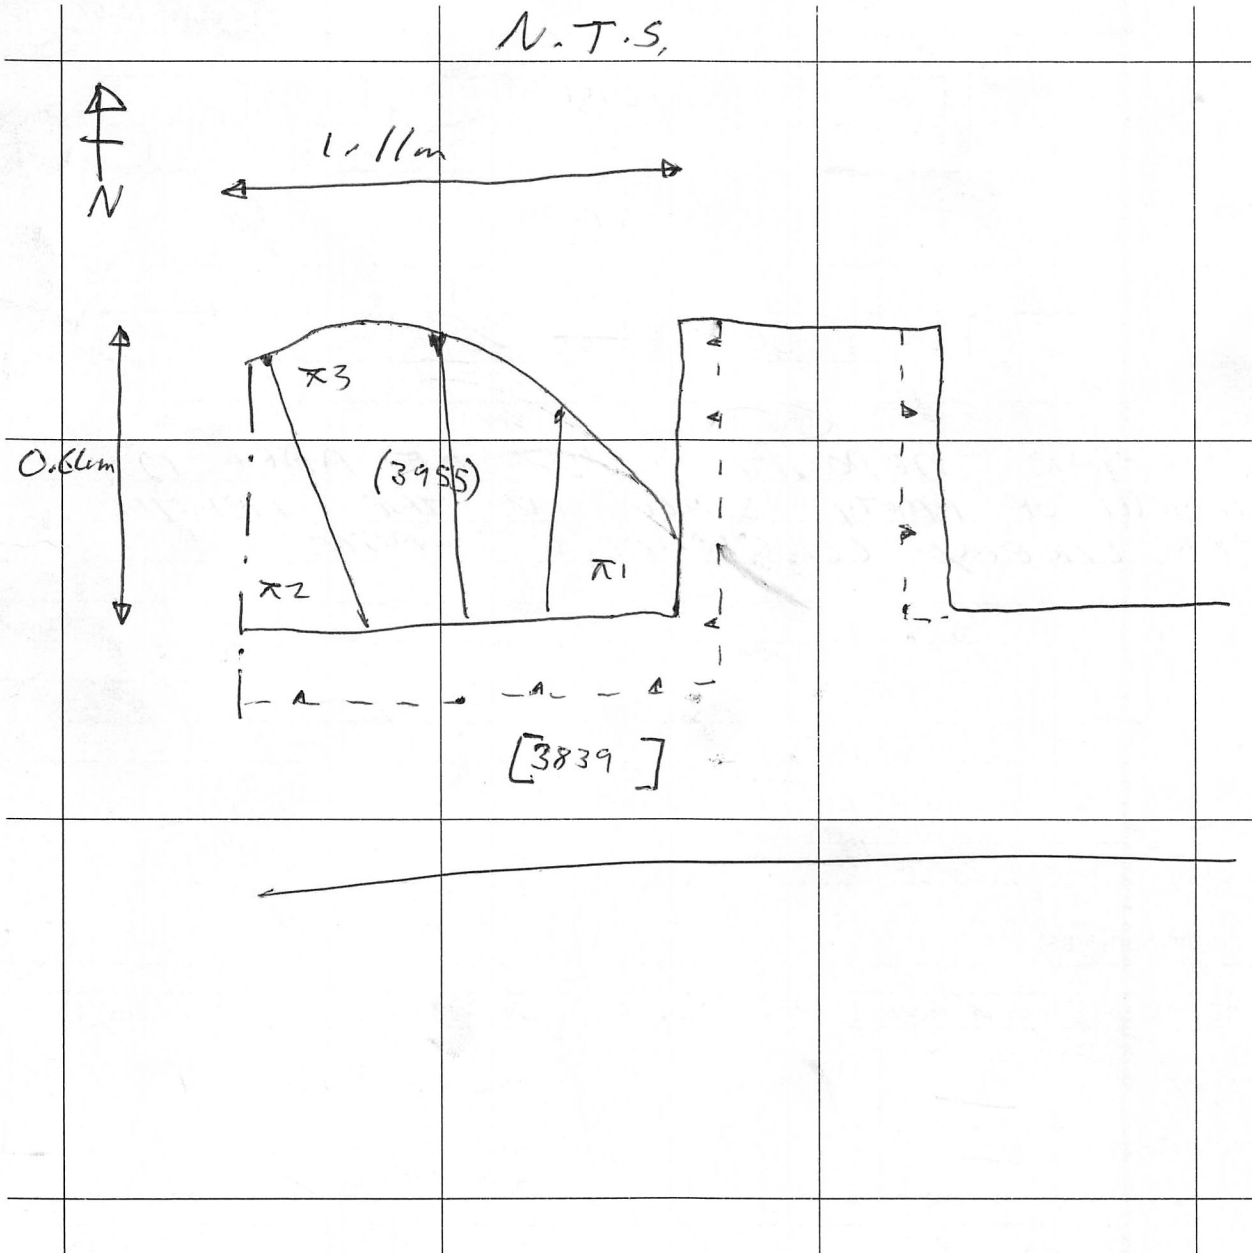
Context Number:
3955

No.	F/S	R/L (m OD)	No.	F/S	R/L (m OD)	No.	F/S	R/L (m OD)	No.	F/S	R/L (m OD)
1	1.72	10.52									
2	1.78	10.46									
3	1.68	10.56
