Site Code: MNO12	Location: AREA D	Grid Sq: 145 / 220	Context Type: MASONRY	Context Number: 3960
1. Materials	① MID ORANGE RED UNFROGGED BRICK.			
2. Size of materials (brick: BTL in mm)	② 100 x 50 x 220 mm			
3. Finish of stones	③ N/A.			
4. Coursing / bond	④ STRECHERS ON BED.			
5. Form	⑤ BRICK FLOOR.			
6. Direction of face(s)	⑥ VERTICAL, WP.			
7. Surface treatment	⑦ NONE.			
8. Bonding material (if brick: record height of 4 courses & 4 bed joints in m)	⑧ LIGHT CREAMY GREY MORTAR - SANDY LIMB. MAJORITY OF MORTAR ON BASE OF BRICK - LIKELY WAS ON SIDE DUE TO STAINING - WASHED AWAY, x1 COURSES 0.04m.			
9. Dimensions of masonry as found	⑨ N-S 0.10m E-W 0.36m D 0.04m			
10. Other comments	⑩ NONE.			
				Max Level: 10.61 m OD
				Min Level: 10.57 m OD

Context Number:
3960

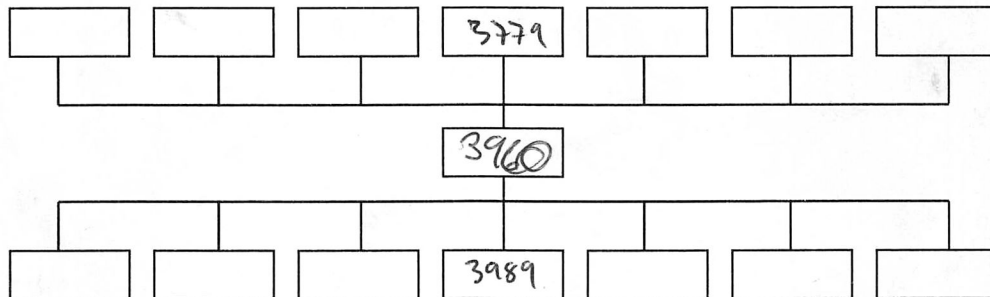
Stratigraphic Relationships:

Abuts:	Abutted by:
Cut by: [3695] & [2605].

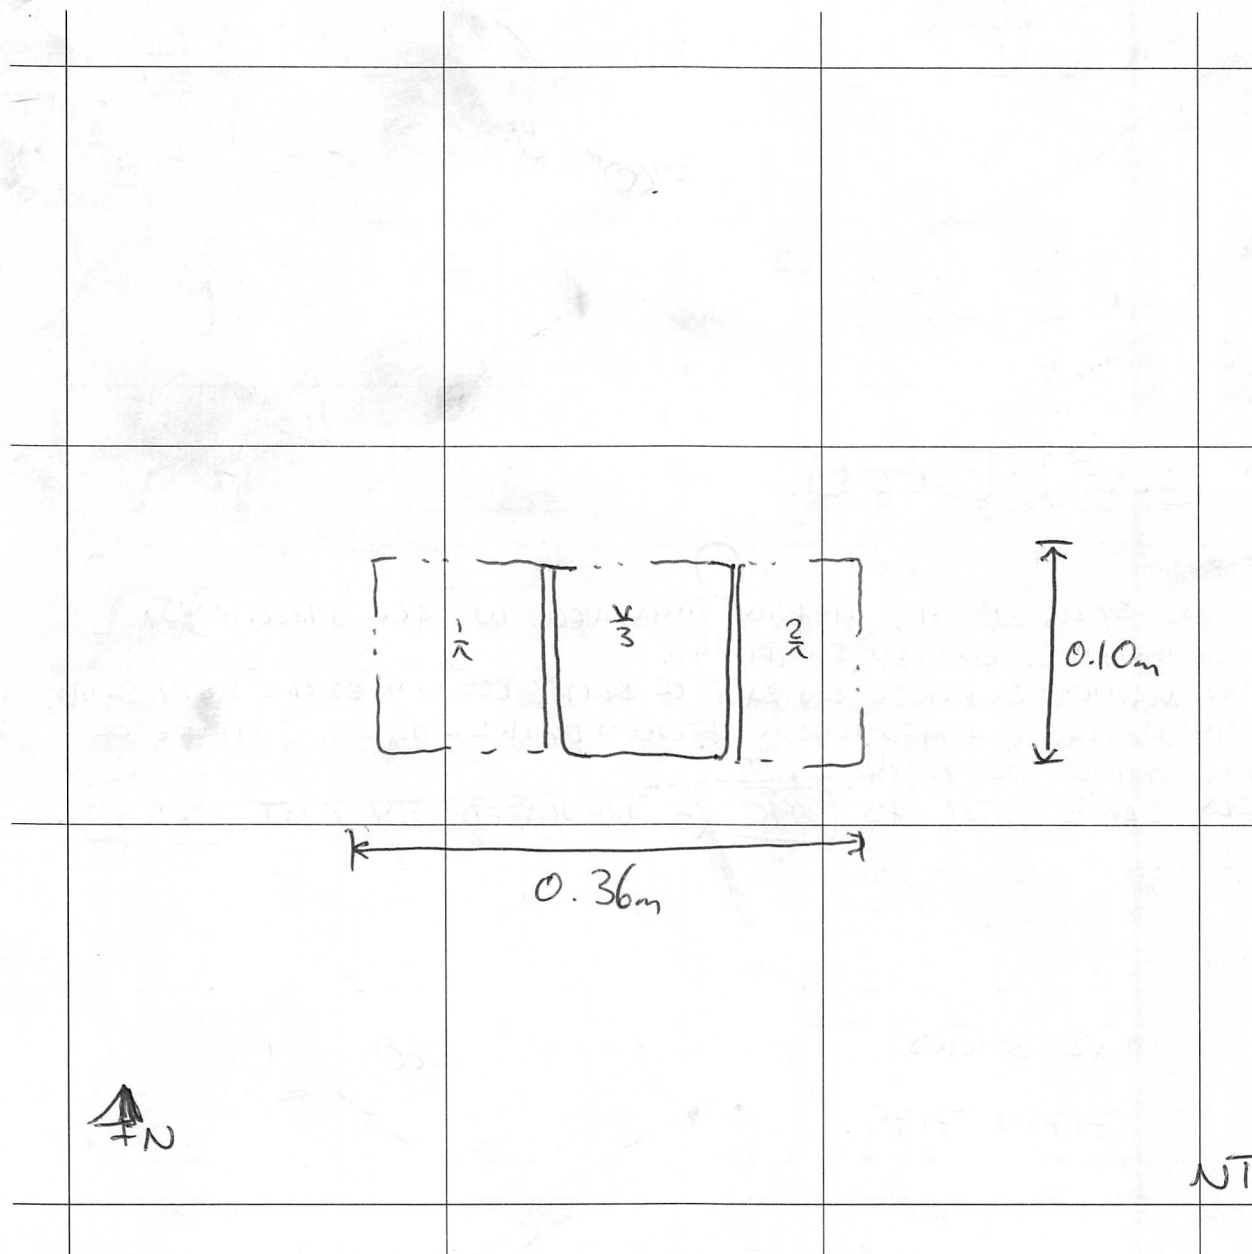
Interpretation:	internal	external
EXTERNAL BRICK PATH, HEAVILY TRUNCATED IN ALL DIRECTIONS. PATH BENEATH GEORGIAN BUILDING...		
MORTAR MAINLY SURVIVES ON BASE OF BRICK. BETWEEN BRICKS SILTY SAND, POSSIBLY MORTAR WASHED FROM BETWEEN BRICKS - DUE TO EVIDENCE OF MORTAR STAINS ON BRICK SIDES.		
LIKELY SAME PATH AS [3902] - TRUNCATED BY CUT [3695].		
Context same as:

No.	F/S	R/L (m OD)	No.	F/S	R/L (m OD)	No.	F/S	R/L (m OD)	No.	F/S	R/L (m OD)
1	1.27	10.61									
2	1.27	10.61									
3	1.31	10.57
