Site Code: MNO12	Location: D	Grid Sq: 1501230	Context Type: MASONRY	Context Number: 4091
1. Materials	1. Red Bricks + Yellow stocks			
2. Size of materials (brick: BTL in mm)	2. 105 mm x 63 mm x 225 mm			
3. Finish of stones	3. ROULDED			
4. Coursing / bond	4. STRETCHERS ON BED			
5. Form	5. linear running N-S			
6. Direction of face(s)	6. VP			
7. Surface treatment	7. none			
8. Bonding material (if brick: record height of 4 courses & 4 bed joints in m)	8. white / grey cement or mortar with (hard) with frog-lime and charcoal flecks (Portland?) + etc etc Small gravel (1-3 mm max)			
9. Dimensions of masonry as found	9. 0.56 m (N-S) x 0.24 (E-W)			
10. Other comments	10. NO BRICKS SAMPLE TAKEN AS THE		Max Level: 0.61 m OD	Min Level: 0.46 m OD
MASONRY WAS TOO HARD TO BREAK.

Interpretation:	internal	external
N-S Running Wall		
Remains part of an earlier building (before Georgian)		
→ PARTITION WALL WITHIN GEORGIAN BUILDING		
Context same as:

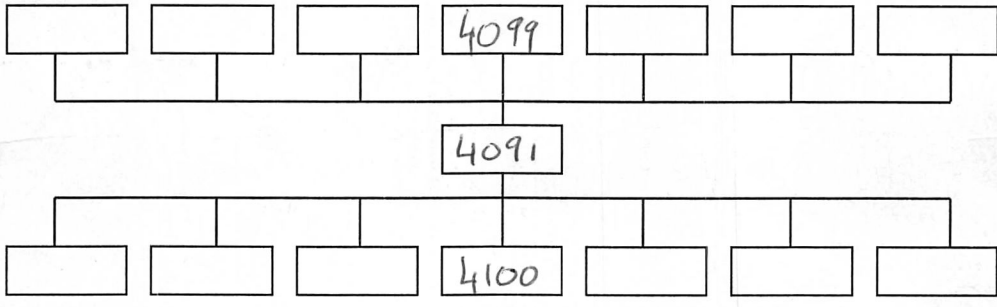
Stratigraphic Relationships:

Physical Relationships:

Abuts:	Abutted by:
Cut by: [] and ⊕	Same as [4090]

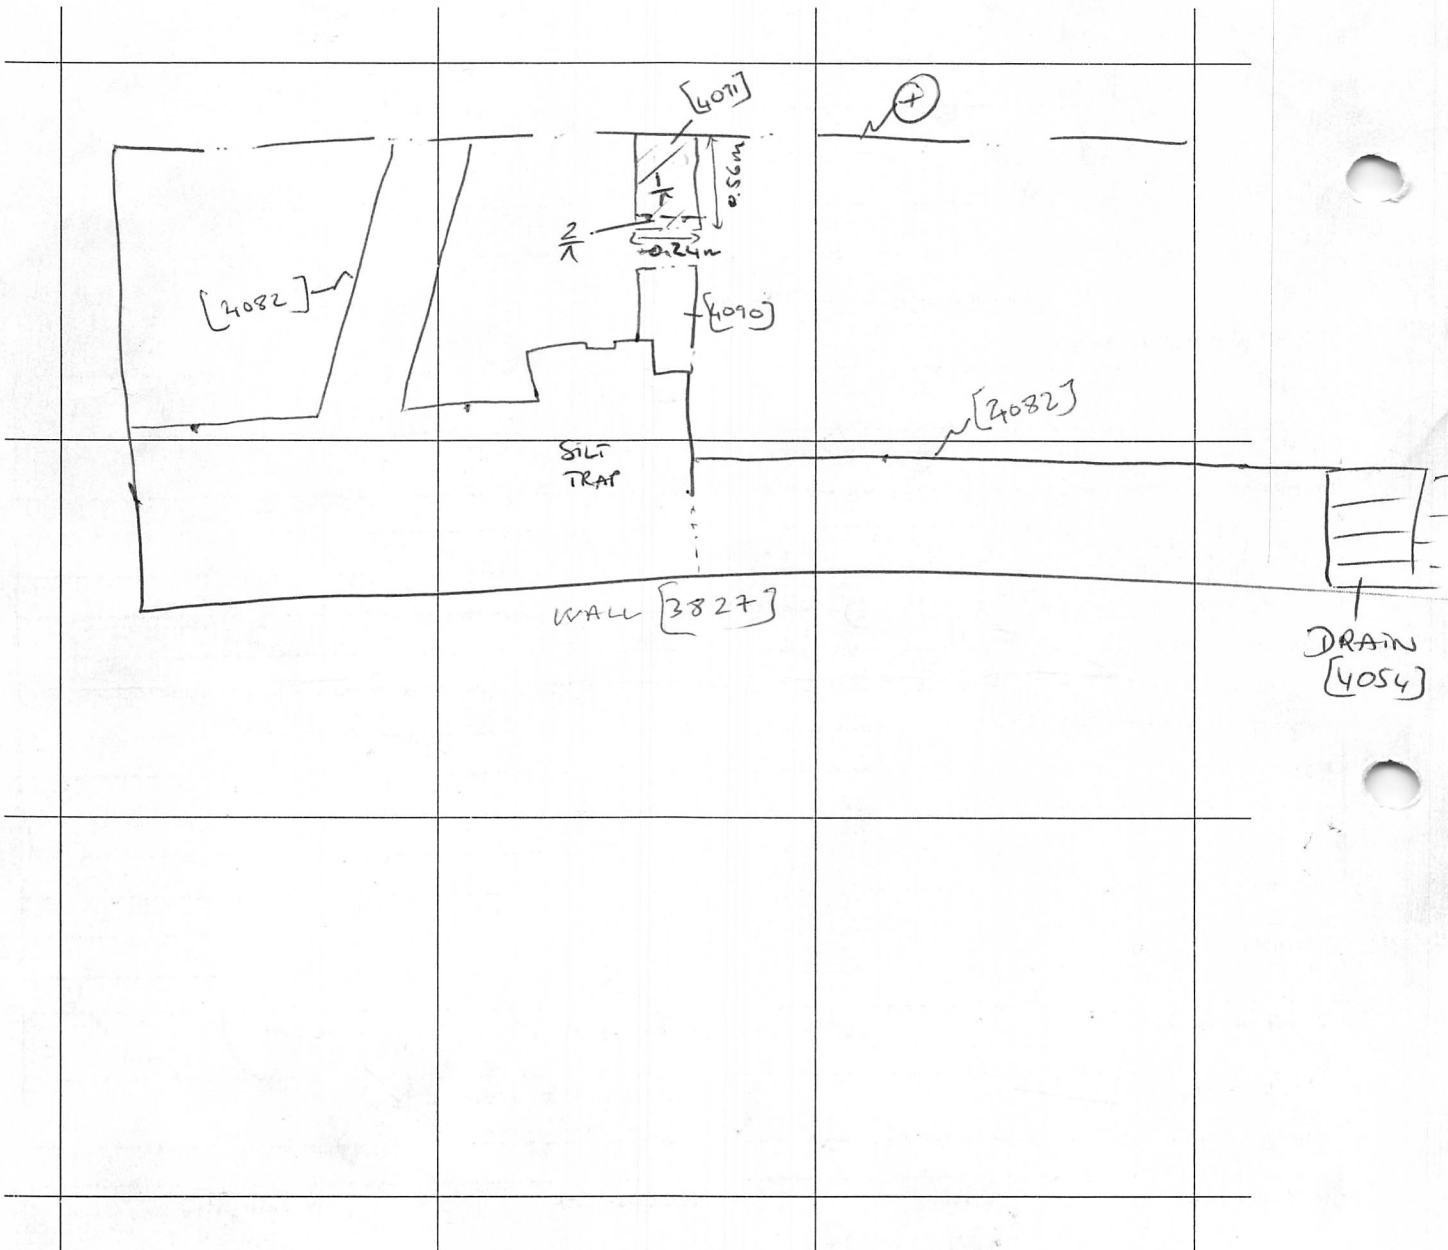
Context Number:
4091

Level No.s	Level No.s	Level No.s	Level No.s
TBM 11.40	TBM	TBM	TBM
B/S 0.66	B/S	B/S	B/S
IH 11.80 m a.d. 12.06	IH	IH	IH

No.	F/S	R/L (m OD)	No.	F/S	R/L (m OD)	No.	F/S	R/L (m OD)	No.	F/S	R/L (m OD)
1	1.19	10.87									
2	1.22	10.78									
		10.84
