| Site Code: MNO12 | Location: D | Grid Sq: 150/230 | Context Type: cut | Context Number: 4147 |

Context Number:
4147

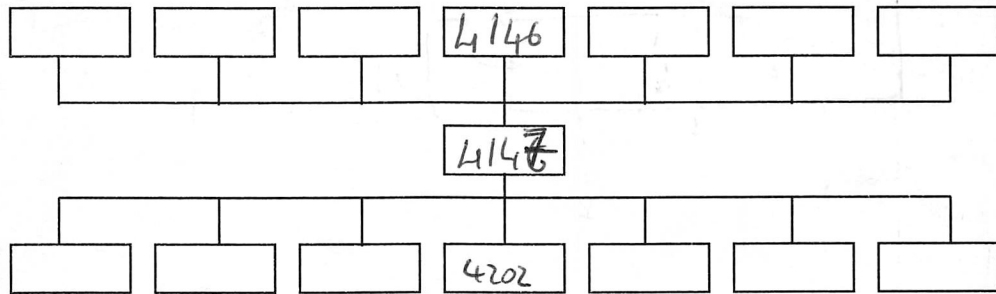
| 11. Cement filling impossible to take out with the walloch need to be taking down when [4114] is down in in order to observe the cut. | | | | Max Level: 10.81 m OD Min Level: 9.84 m OD (Base) |

| <p>Cut for [4146] within wall [4114]. → It shows a later phase in the use of the (possibly 2nd or 3rd) original cess pit [4114], perhaps to insert an new wall and dividing the SURFACE OF THE CESS PIT in 2 part? as the bricks of [4114] has been chiseled. It is possibly A Repair. in the northern wall of cess pit</p> | | | |
