| Site Code: MNO12 | Location: D | Grid Sq: 150 / 225 / 230 | Context Type: CUT | Context Number: 4145 |

Context Number:
4145

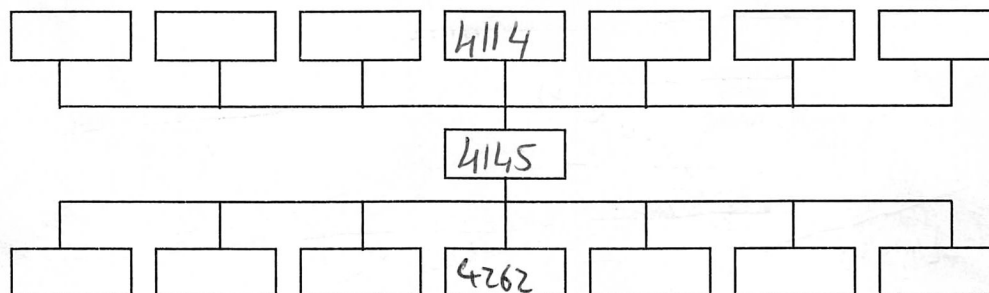
| Sample No(s): _____ | Drawing No(s): 4145 (x) |

| | 11. The ORIGINAL CUT SHAPE IS VERY DIFFICULT TO SEE AS IT HAS BEEN HEAVILY TRUNCATED EXCEPT AT THE W TOP WEST END + EASTERN EDGE. | | | 11. Other comments |

| <p>Cut for [4114] → CESS PIT IT IS HEAVILY TRUNCATED BY THE CONSTRUCTION OF A TUBULAR DRAIN TO THE NORTH [4202] AND THE INSERTION OF A SMALL N-S RUNNING TUBULAR DRAIN AND (PROBABLY LINKED TO [4202]) WHICH HAD INVOLVED THE INSERTION / RESULT OF NORTHERN WALL OF THE CESS PIT. FINALLY, THE SOUTHERN WALL HAS BEEN ALSO TRUNCATED BY THE REBUILT OF THE WALL AND (= [4148]) ^{ALSO} USED USED FOR THE CONSTRUCTION OF LATEST DRAIN + SILT TRAP [4054].</p> | | | |
