Site Code: <b>MNO12</b>	Location: AREA D	Grid Sq: 145/220	Context Type: <b>MASONRY</b>	Context Number: [4058]
1. Materials				
2. Size of materials (brick: BTL in mm)	1. hard orange bricks			
3. Finish of stones	2. 100mm x 60mm x 220mm			
4. Coursing / bond	3. moulded bricks			
5. Form	4. stretchers on bed			
6. Direction of face(s)	5. a blockage in the drain			
7. Surface treatment	6. N-S			
8. Bonding material (if brick: record height of 4 courses & 4 bed joints in m)	7. /			
9. Dimensions of masonry as found	8. hard mid - tork yellow red brown sandy mortar			
10. Other comments	9. 0.17 m (N-S); 0.21 m (E-W); 0.43 m (deep)			
	10. /			
				Max Level: 10.38 m OD
				Min Level: 10.00 m OD

Context Number:  
4058

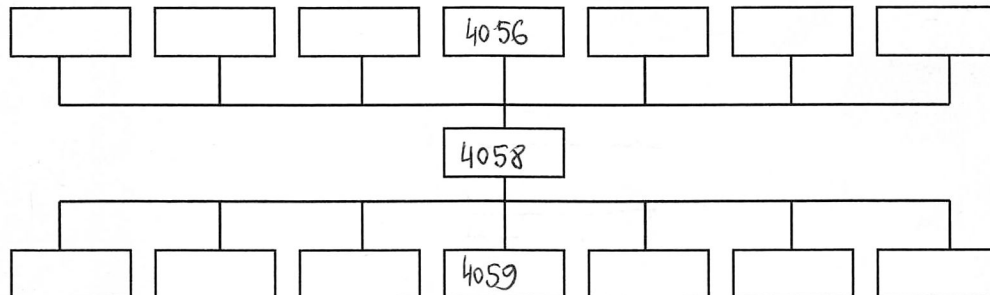
Stratigraphic Relationships:

Abuts: [4059]	Abutted by:
Cut by:

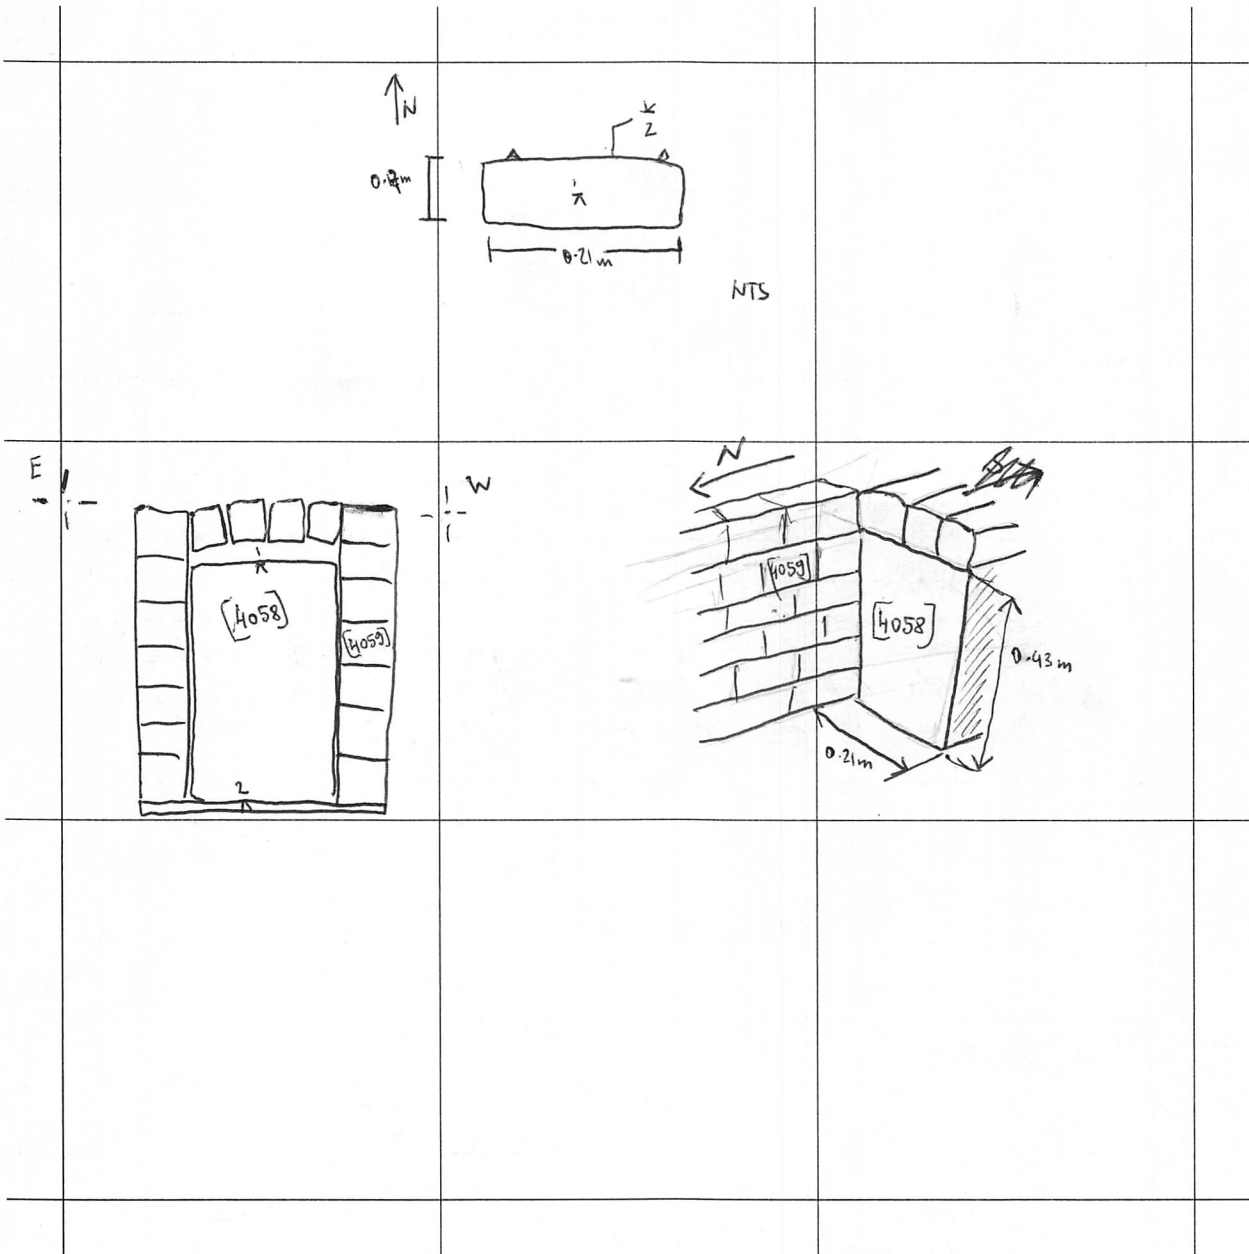
Interpretation:	internal	external <input checked="" type="checkbox"/>
A blocking in drain [4059]. At first glance it seemed this was a stone, but it turned out it was bricks covered in human waste.		
It appears to have been put in later than the drain.		
Context same as:

No.	F/S	R/L (m OD)	No.	F/S	R/L (m OD)	No.	F/S	R/L (m OD)	No.	F/S	R/L (m OD)
1	1.70	10.38									
2	2.08	10.00
