Site Code: MNO12	Grid Square: 115/210	Context Type: TIMBER	Context Number: T8 (2686)
1 Type	① JOIST		
2 Setting	② HORIZONTAL. IN SITU. ON BED. WITHIN LARGE PIT		
3 Orientation	③ N-S		
4 Cross-Section	④ ROUNDED RECTANGLE BUT VERY		
5 Condition	IRREGULAR		
6 Dimensions m/mm	⑤ DAMAGED. BROWN. INCOMPLETE. IN SITU		
7 Conversion	⑥ 1.65m x 0.14m MAX x 0.1m MAX		
8 Tool Marks	⑦ VERY ROUGH BOX HEADED		
9 Joints & Fittings			
10 Intentional Marks	⑧		
11 Surface Treatment			
12 Other Comments	⑨		
13 Method & Conditions	⑩		
⑪ ALIGNED WITH TIMBERS 7, 9 AND 18. BADLY DAMAGED ⑫ OAK			
Reuse	Yes:	No:	Unknown: Phases of Reuse:

PROBABLE FLOOR JOIST. SIMILAR TO AND PROBABLY PART OF SAME STRUCTURE AS TIMBERS 7, 9 AND 18.  
OAK

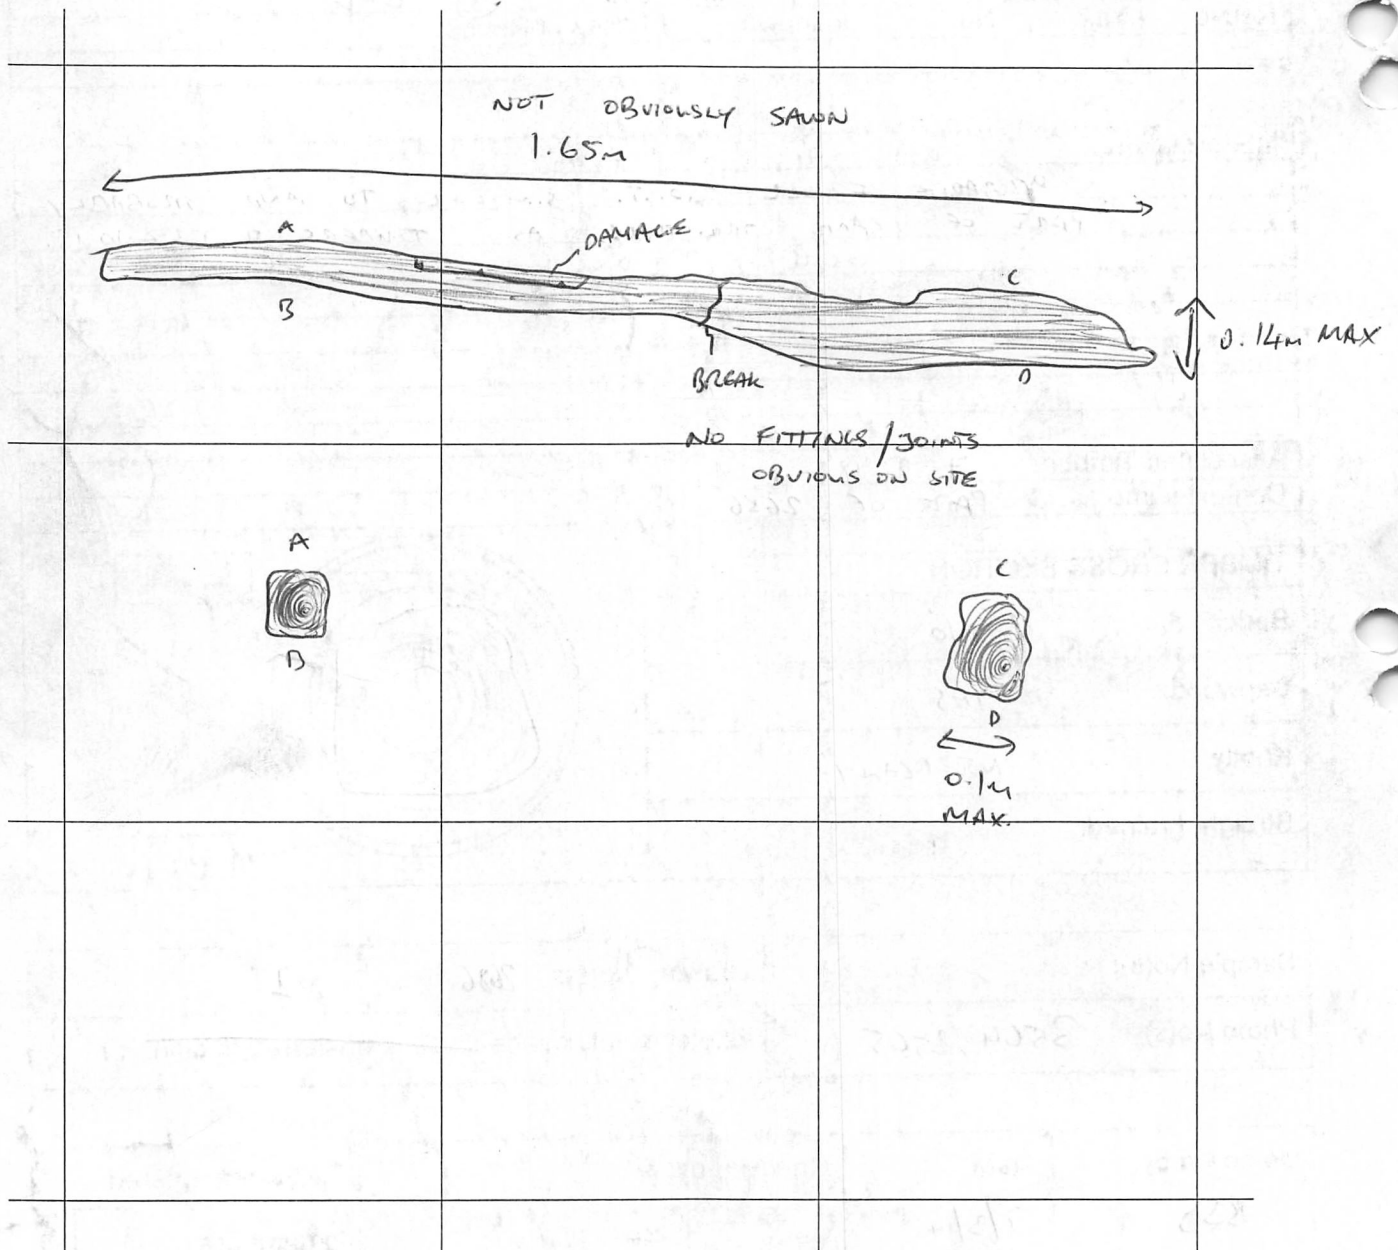
Context Number:  
T8

TIMBER CROSS SECTION		
Bark:		NO
Sapwood:		YES
Knotty:		NOT REALLY
Straight-grained:		YES

No.	F/S	R/L (m OD)	No.	F/S	R/L (m OD)	No.	F/S	R/L (m OD)	No.	F/S	R/L (m OD)
1	3.02	8.25									
2	3.04	8.23									
3	3.15	8.12									
4	3.16	8.11
