Site Code: MNO12	Grid Square: 115/210	Context Type: TIMBER	Context Number: T44 2697
1 Type	(1) CHOCK		
2 Setting	(2) ON BED IN SITE		
3 Orientation	(3) N-S		
4 Cross-Section	(4) RECTANGLE		
5 Condition	(5) VERY ROTTEN. ONLY LIFTED FOR SPECIES ID		
6 Dimensions m/mm	(6) <del>0.36 x 0.09 x 0.03</del> 0.6m x 0.2m x 0.09m		
7 Conversion	(7) BOX QUARTERED		
8 Tool Marks	(8) NONE VISIBLE - ROTTED		
9 Joints & Fittings	(9) -		
10 Intentional Marks	10 -		
11 Surface Treatment	11 -		
12 Other Comments	12 / OAK		
13 Method & Conditions			
(13) TRAWER			
Reuse	Yes:	No: <input checked="" type="checkbox"/>	Unknown: Phases of Reuse:
POSSIBLE BUT UNLIKELY. OFFCUT / WASTAGE.

Context Number:  
T44

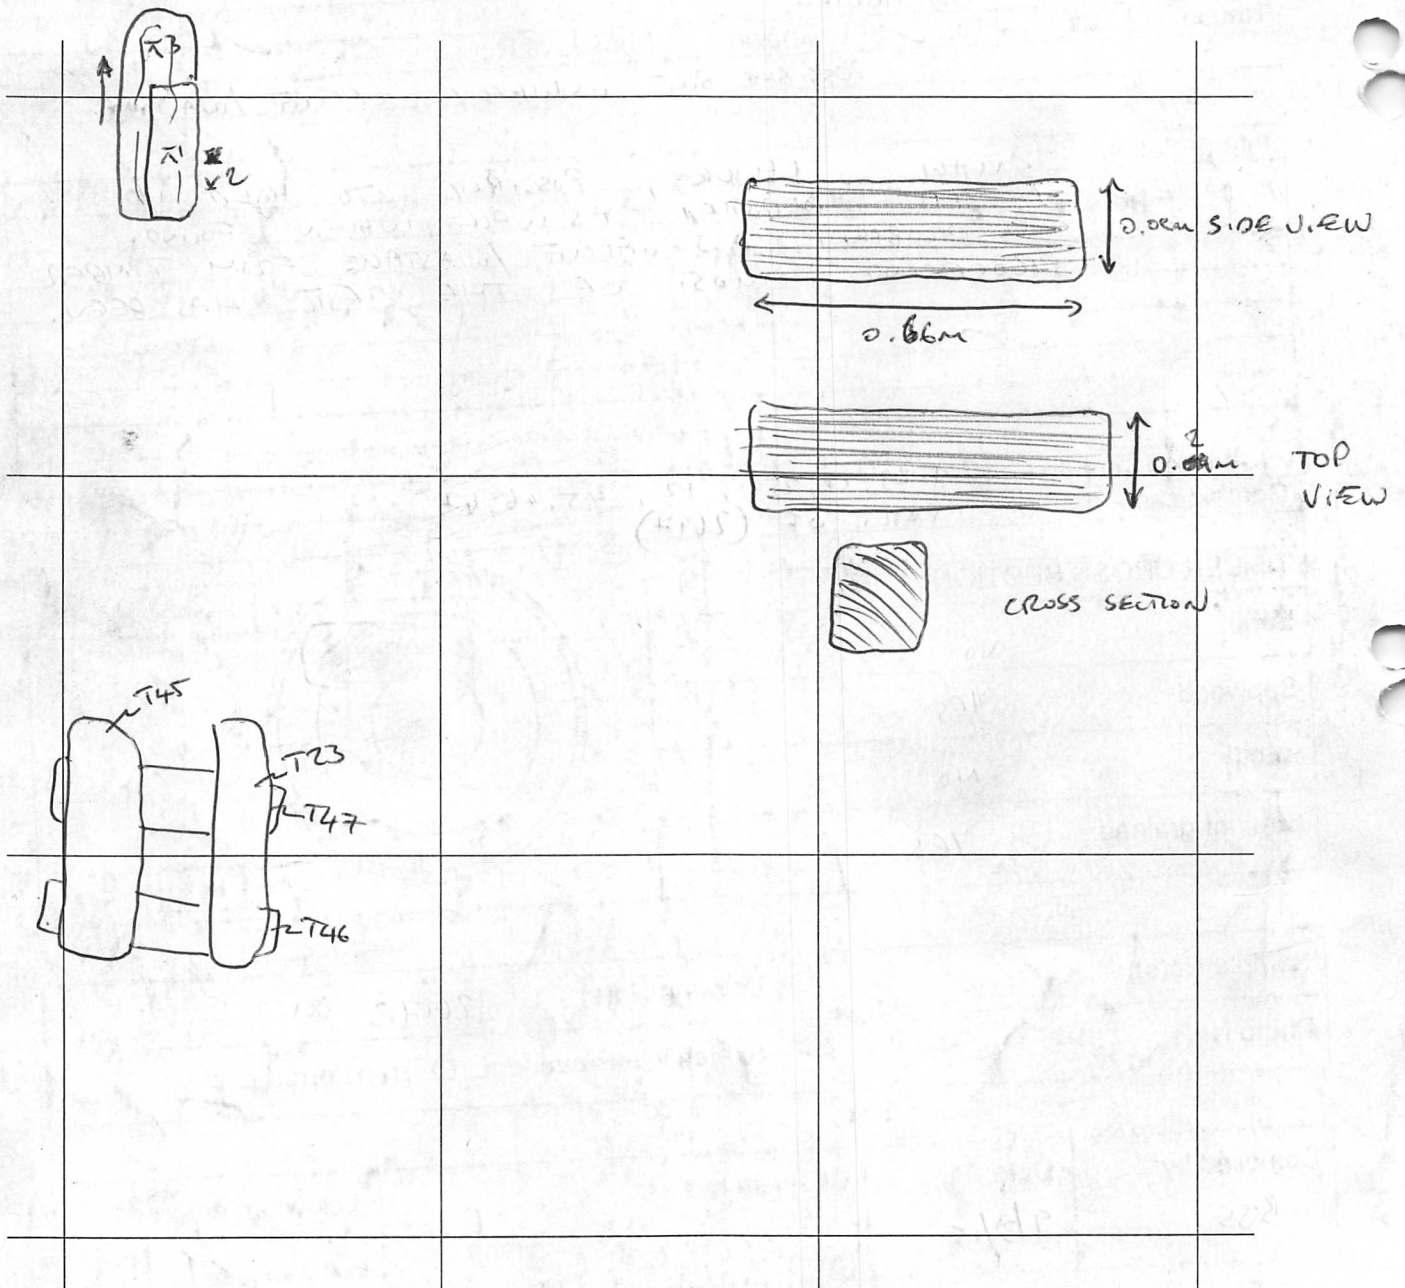
Interpretation: SMALL CHOCK, POSSIBLY TO HOLD UP N END OF TR - ROTTEN AS WERE WHEN FOUND. PROBABLY AN OFFCUT / WASTAGE FROM TIMBER PROCESSING. MOST OF THE REST HAS BEEN.

TIMBER CROSS SECTION		
Bark:		NO
Sapwood:		YES
Knotty:		NO
Straight-grained:		YES
