Site Code: MNO12	Grid Square: 115/21-	Context Type: TIMBER	Context Number: T29 2694
1 Type	(1) CHOCK		
2 Setting	(2) ON BED. ON TOP OF T30. IN SITU		
3 Orientation	(3) N/A		
4 Cross-Section	(4) RECTANGLE		
5 Condition	(5) DAMAGED. PROBABLY IN COMPLETE ROTTEN.		
6 Dimensions m/mm	(6) 0.17m x 0.03m x 0.1m		
7 Conversion	(7) BOX HALVES		
8 Tool Marks	(8) NONE OBVIOUS DUE TO ROTTING		
9 Joints & Fittings			
10 Intentional Marks			
11 Surface Treatment	(9) NONE OBVIOUS		
12 Other Comments	(10) NONE		
13 Method & Conditions	(11) NONE		
(12) UNKNOWN SPECIES - 10 SAMPLE TAKEN.			
(13)			
Reuse	Yes:	No:	Unknown: Phases of Reuse:

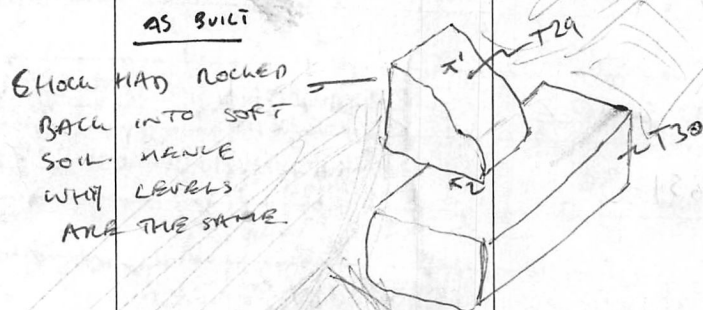
Interpretation:
 ONE OF PAIR OF CHOCKS WITH T30. ON TOP OF T30
 DAMAGED, PROBABLY IN SITU WITH N END SHAVED
 OFF. COULD HAVE BEEN DELIBERATE IN CONSTRUCTION -
 UNSURE. PART OF SERIES OF SMALL CHOCKS ALONG
 S EDGE OF DEEPER PART OF [2691]. STRUCTURAL
 TIMBERS FOR FLOORING?

SIDE VIEW

TOP VIEW
