Site Code: MNO12	Grid Square: 115/200	Context Type: TIMBER	Context Number: T87 2789
1 Type	① PLANK		
2 Setting	② FOUND IN TWO PIECES, ON END VERTICAL, INSITU		
3 Orientation	③ —		
4 Cross-Section	④ ELONGATED RECTANGLE		
5 Condition	⑤ IN TWO PIECES, INCOMPLETE, BROKEN AT TOP		
6 Dimensions m/mm	END (AS FOUND), BOTTOM END HAS SOME DAMAGE		
7 Conversion	ON CORNER		
8 Tool Marks			
9 Joints & Fittings	⑥ 0.36m x 100mm x 10mm		
10 Intentional Marks	⑦ <del>TANGENTIALLY FACED</del> RADIAL CUT		
11 Surface Treatment	⑧ —		
12 Other Comments	⑨ BOTTOM END HAS A LINEAR DEPRESSION APPROX. 30mm WIDE ACROSS BOTH PIECES - NOT CERTAIN IF THIS FOR FITTING TOGETHER WITH <del>ANOTHER</del> OTHER WOOD OR RAISED BY WEIGHT OF SOME KIND. THERE IS ALSO A SPLIT <del>IN</del> ALONG THE SMALLER PIECE WHICH APPEARS INTENTIONAL.		
13 Method & Conditions			
Reuse	Yes:	No:	Unknown: Phases of Reuse:
	LIKELY

Context Number:  
T87

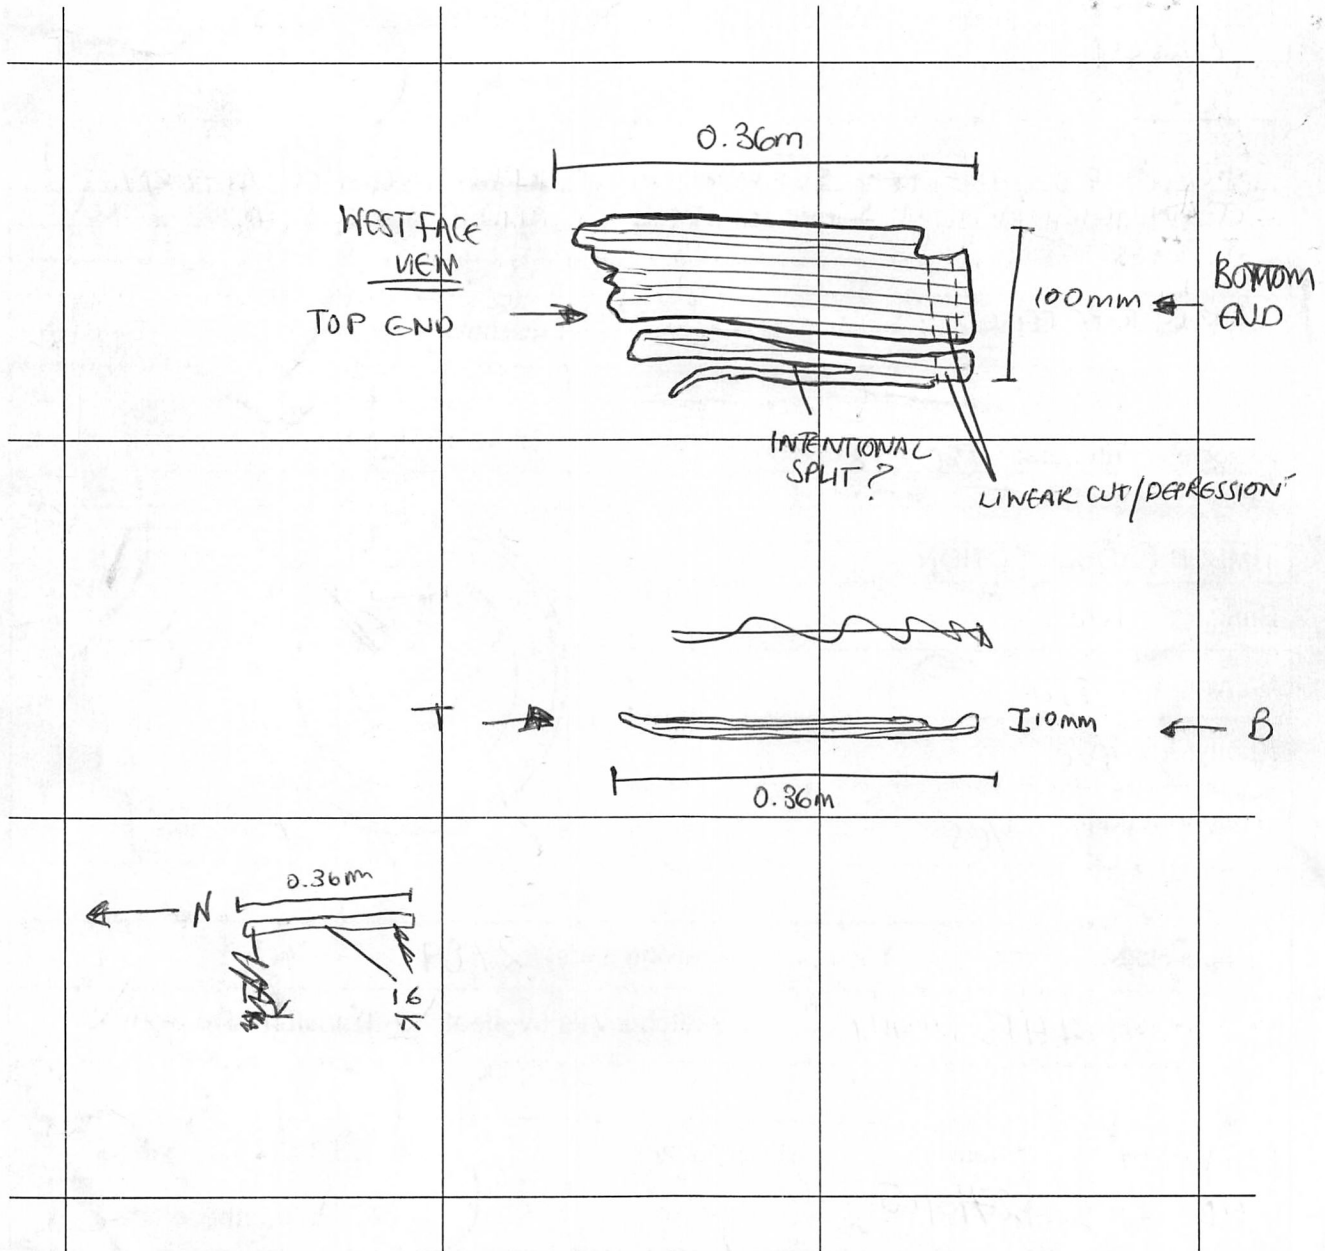
Interpretation:	
PLANK OF WOOD <del>SET</del> SET VERTICALLY SUPPORTING T86. AS PART OF AN ALIGNMENT OF <del>STAKES</del> TIMBERS AND POST HOLES <del>IT</del> = REMAINS OF A REINFORCEMENT?	
LIKELY TO BE REUSED	
	2778
	2789
	2802
Associated Timbers: T86 T89	
Context same as:	
TIMBER CROSS SECTION	
Bark: No	
Sapwood: No	
Knotty: No	
Straight-grained: Yes
