Site Code: MNO12	Location: AREA A.	Grid Sq: 150/250	Context Type: DEPOSIT	Context Number: (1301)
Deposit	① COMPACTED ② SILT CLAY DARK GREY BROWN ③ SILTY CLAY ④ FREQUENT CHARCOAL PATCHES $\leq 0.2m$ MODERATE BROKEN TILE $\geq 100mm$ MORTAR OCCASIONAL MORTAR FLECKS. ⑤ CRRA SHARP ⑥ L 1.04m, W 0.74m, D 0.03m Text			Cut
1. Compaction				1. Shape in Plan
2. Colour				2. Corners
3. Composition				3. Dimensions
4. Inclusions				4. Break of slope - Top
5. Interface				5. Sides
6. Dimensions				6. Break of slope - Base
7. Other Comments				7. Base
8. Method/Conditions				8. Orientation
⑨ NONE.				9. Inclination
⑩ HAND DUG, WET				10. Truncation
				11. Other comments
				Max Level: 9.98 m OD
				Min Level: 9.95 m OD

Context Number:
1301

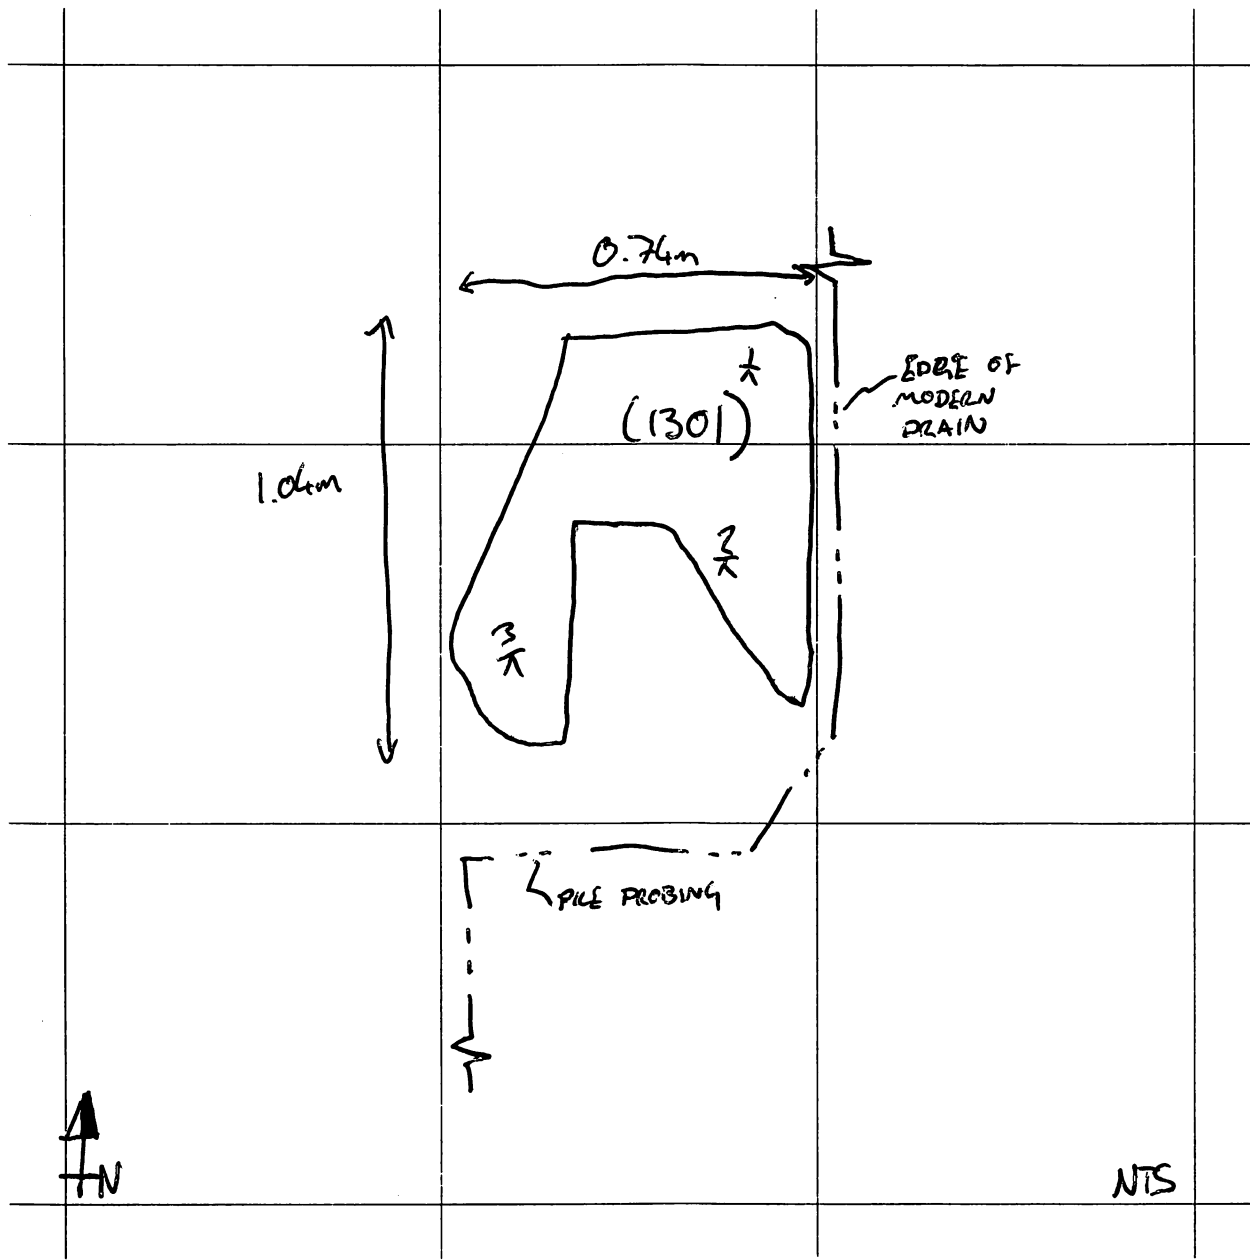
Interpretation:	Internal	External	Structural
DARK GREY BROWN SILTY CLAY DEPOSIT,			
HIGH FREQUENCY OF LARGE, $\leq 0.20m$, CHARCOAL PATCHES. ALSO A			
MODERATE AMOUNT OF CBM, MOSTLY BROKEN TILE. OCCASIONAL PATCHES			
OF MORTAR.			
LIKELY BH DEMOLITION/CONSTRUCTION WASTE.			
Context same as:
