Site Code: MNO 12	Gr. Sq. / TP / Tr: TP 2	Context Type: Cut	Context Number: 64
Deposit	Cut		
1. Compaction	1. LIME	1. Shape in Plan	
2. Colour	2. NONE	2. Corners	
3. Composition	3. 1.2m N-S x 0.20m EW.	3. Dimensions	
4. Inclusions	4. TRUNCATED	4. Break of slope - Top	
5. Dimensions	5. SPEEDY SLOPING	5. Sides	
6. Other Comments	6. SUMP	6. Break of slope - Base	
7. Method/Conditions	7. FRT	7. Base	
	8. N-S	8. Orientation	
	9. N/A	9. Inclination	
	10. VERTICALLY TRUNCATED BY CONSTRUCTION OF 1960s EXISTING STRUCTURE	10. Truncation	
	11. BRICK DRENCH TO SOUTH CUT LAYER (66)	11. Other comments	
		Min Level: 10.42	
		Max level: 10.96

CONSTRUCTION CUT FOR BRICK WALL [65]. SAME TRUNCATION EVENT AS [71] TO SUMP

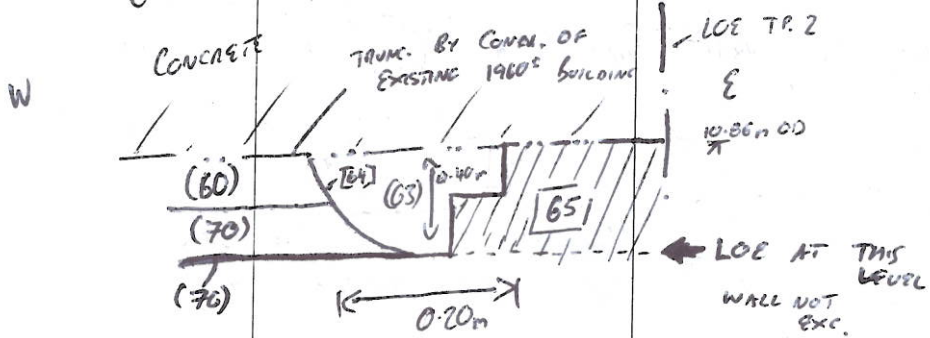
SKETCH PROFILE (NOT TO SCALE)

SEE SECTION OF SHEET 63
