Site Code: MNO12	Gr. Sq. / TP / Tr: 140 / 255	Context Type: MASONRY	Context Number: 1131
1. Materials	1. PURPLISH RED BRICK, SOME SHALLOW FROGGING. HARD		
2. Size of materials (brick: BTL in mm)	2. B = 70MM T = 100MM L = 250MM		
3. Finish of stones	3. SOME WHOLE AND SOME HALF BRICKS. WORN		
4. Coursing / bond	4. MOST ON EDGE IN ROWS. TWO BRICKS ON S END ARE ON BED		
5. Form	5. BRICK DRAIN		
6. Direction of face(s)	6. UP		
7. Bonding material (if brick: record height of 4 courses & 4 bed joints in m)	7. MID RED BROWN, SANDY LIME. LIME INCLUSIONS < 2MM, BRITTLE. 4 COURSES = 0.28M		
8. Dimensions of masonry as found	8. E-W = 0.4M N-S = 0.9M		
9. Other comments

Context Number:
1131

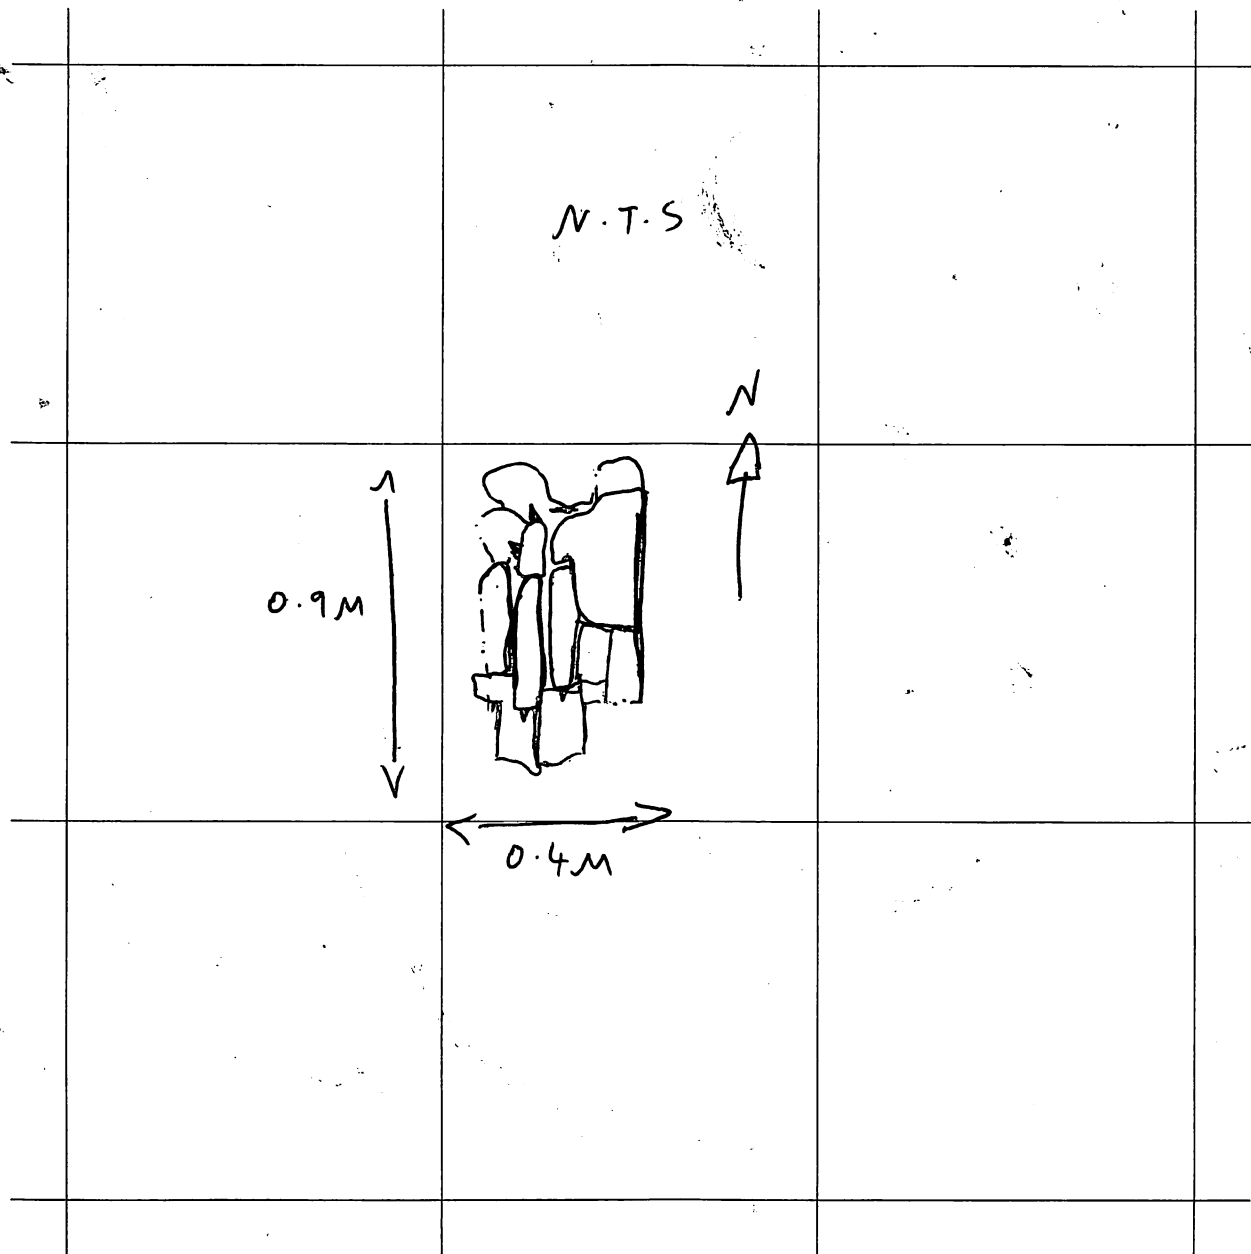
Interpretation:	internal	<u>external</u>
BRICK DRAIN, DRAWS FROM SOUTH TO NORTH. SOME OF THE BRICKWORK IS COVERED BY TANKING WHICH WOULD HAVE WATERPROOFED THE DRAIN. IT IS HEAVILY TRUNCATED BY MODERN PILE ON THE NORTH AND WEST, AND BY A MODERN DRAIN ON THE SOUTH. SOME BRICKS HAVE A LIGHT GREY MORTAR AS WELL INDICATING THAT THEY WERE RE-USED FROM OTHER STRUCTURES. SOME ARE SLIGHTLY WORN, PROBABLY FROM WATER EROSION, AND BEING RE-USED.		
DRAIN BUILT IN PURPOSE-MADE CUT-IN SLOT IN WALL [1235]		
Context same as:
