Site Code: MNO12	Gr. Sq. / TP / Tr: A	Context Type: MASONRY	Context Number: 271
1. Materials	1. BRICK.		
2. Size of materials (brick: BTL in mm)	2. B=100 T=75 L=225		
3. Finish of stones	3. BRICK		
4. Coursing / bond	4. UNCERTAIN		
5. Form	5. PAD ?		
6. Direction of face(s)	6. UNCERTAIN		
7. Bonding material (if brick: record height of 4 courses & 4 bed joints in m)	7. GREYISH LIME MORTAR		
8. Dimensions of masonry as found	8. 1.0m x 0.95m HEIGHT UNCERTAIN		
9. Other comments	9. BADLY TRUNCATED BOND DIFFICULT TO DISCERN.		
	DEPOSIT TO WEST LOOKS LIKE IN SITU ARCHAEOLOGY. NOT RUBBLE

Context Number:
271

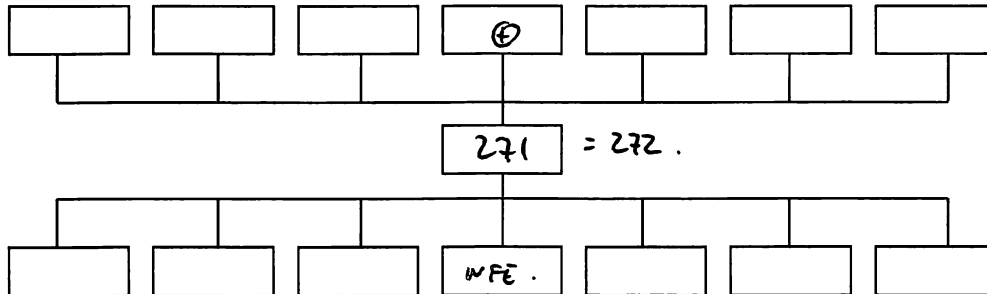
Stratigraphic Relationships:

NO CONTOURS
