Site Code: MNO12	Location: E.	Grid Sq:	Context Type: DEPOSIT	Context Number: 4443
Deposit	① FRIABLE WITH COMPACT SURFACE. ② LIGHT YELLOW BROWN. ③ SAND ④ MOD' ABRAIDED CBM FLECKS & FRAGS $\leq 20mm$ OCC; SMALL SUB-ROUNDED STONES. ⑤ GOOD, CLEAR ⑥ N-S 1.84m E-W 2.65m D $\leq 0.76m$ ⑦ EXTENDS BEYOND L.O.E. N-S & E-W ⑧ HAND DUG IN SHAFT, DRY.			Cut 1. Shape in Plan 2. Corners 3. Dimensions 4. Break of slope - Top 5. Sides 6. Break of slope - Base 7. Base 8. Orientation 9. Inclination 10. Truncation 11. Other comments
				Max Level: 8.76 m OD
				Min Level: 7.86 m OD

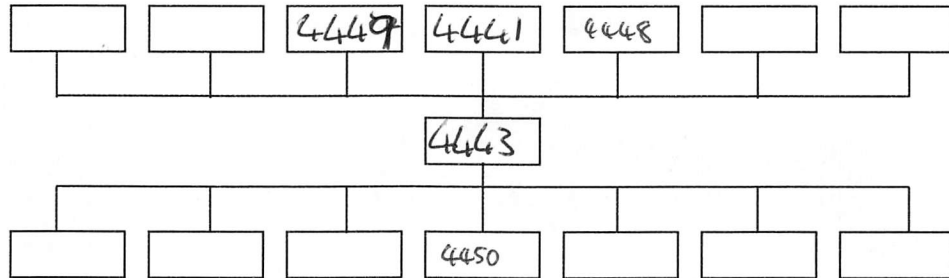
Interpretation:	Internal	External <input checked="" type="checkbox"/>	Structural
SLOPING SAND DEPOSIT - SLOPES TOWARDS WEST			
MODERATE ABRAIDED CBM FRAGMENTS & FLECKS - WATER LAIN?			
GOOD CONTACT WITH ABOVE DITCH FILL LAYERS			
LENS' OF GREY PLASTIC SILT.			
Context same as:
