Site Code: MNO12	Gr. Sq. / TP / Tr: 140/ 245 140/ 250	Context Type: MASONRY	Context Number: 1163
1. Materials	1 Full long red bricks; blackened on top		
2. Size of materials (brick: BTL in mm)	2. 100mm x 240mm x @ 80mm		
3. Finish of stones	3. Top blackened		
4. Coursing / bond	4. Dark brownish grey with white + reddish inclusions		
5. Form	5 Brick floor		
6. Direction of face(s)	6 Upwards / towards ceiling / sky		
7. Bonding material (if brick: record height of 4 courses & 4 bed joints in m)	7. One course @ 0.08m OD		
	8 NS - 0.62m EV - @ 1.0m OD		
	Thickness - 0.08m OD		
8. Dimensions of masonry as found	9. Mark of floor missing (only 3 bricks present) could have relation to brick floor [1164] truncated / separated by (+) drain pipe running North East to South West could also be related to brick floor + to East		
9. Other comments

Context Number:
1163

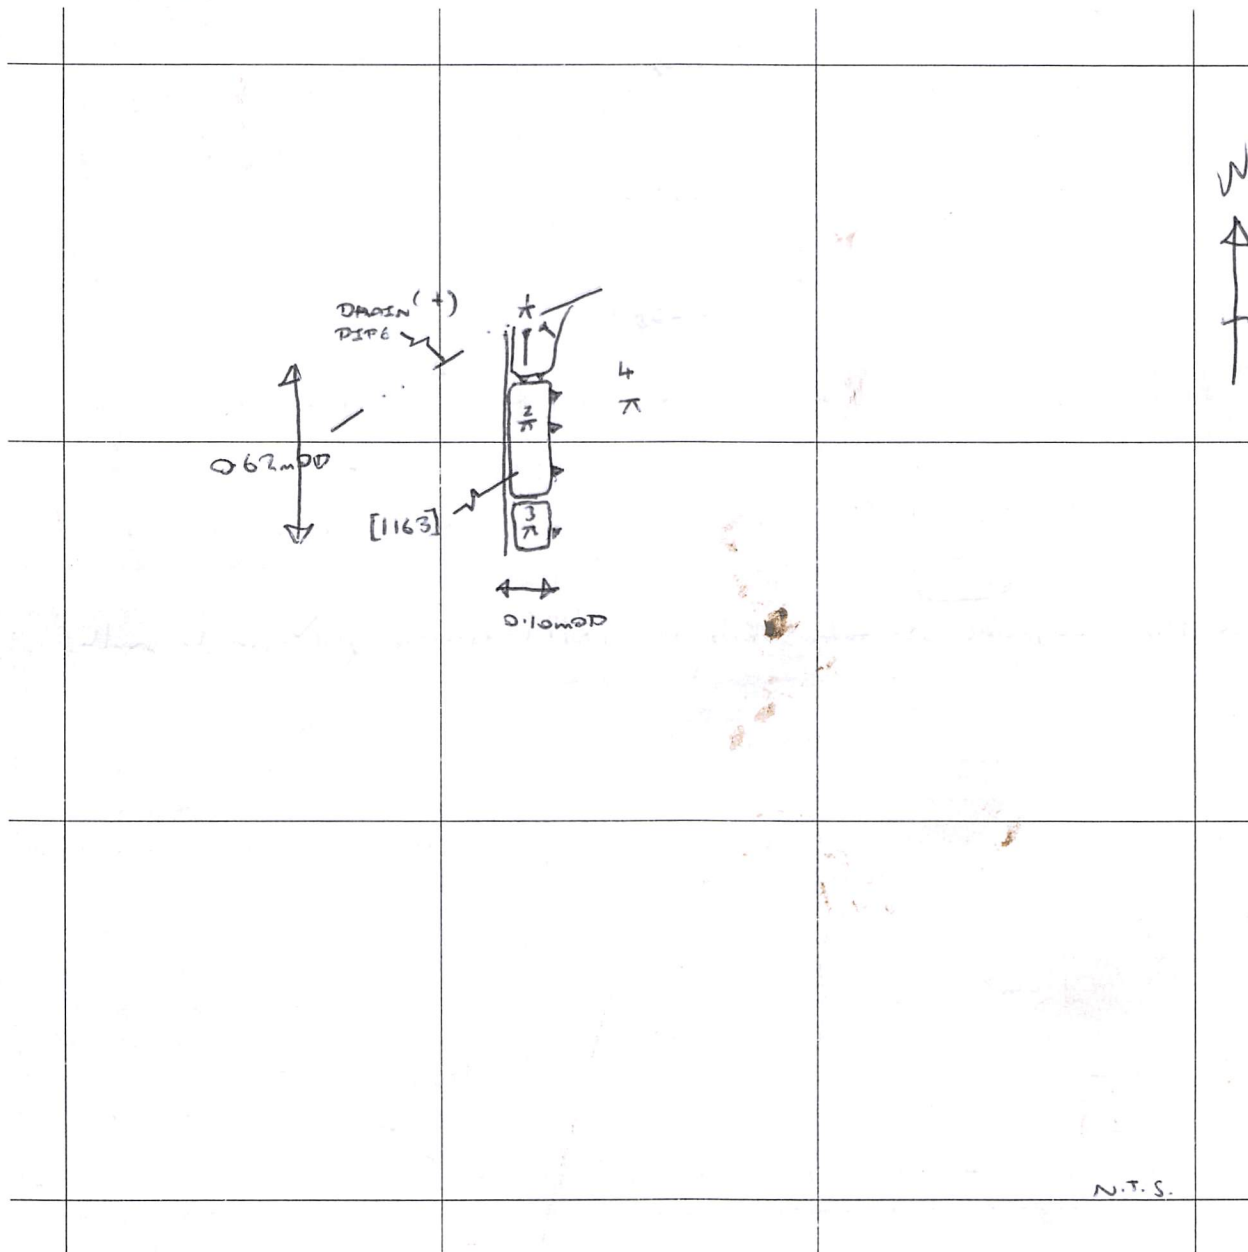
Interpretation:	<u>internal</u>	external
Brick floor adjacent to red brick wall [1152]; running North to South		
TRW - CONT'D TO CASE -		
Context same as: 1164(?)

No.	F/S	R/L (m OD)	No.	F/S	R/L (m OD)	No.	F/S	R/L (m OD)	No.	F/S	R/L (m OD)
1	2.13	9.98									
2	2.04	10.07									
3	2.14	9.97									
4	2.20	9.91
