Site Code: MNO12	Gr. Sq. / TP / Tr: 145/290	Context Type: CUT	Context Number: 1095
Deposit	① TRUNCATED LINEAR		Cut
1. Compaction	② N/A		1. Shape in Plan
2. Colour	③ 0.5m x 0.3m x 0.12m		2. Corners
3. Composition	④ SHARP		3. Dimensions
4. Inclusions	⑤ STEEP.		4. Break of slope - Top
5. Dimensions	⑥ SHARP		5. Sides
6. Other Comments	⑦ FLAT		6. Break of slope - Base
7. Method/Conditions	⑧ N-S		7. Base
	⑨ N/A		8. Orientation
	⑩ YES BY PILE TO S		9. Inclination
			10. Truncation
			11. Other comments
			Max Level:
			Min Level: 10.33m

Context Number:
1095

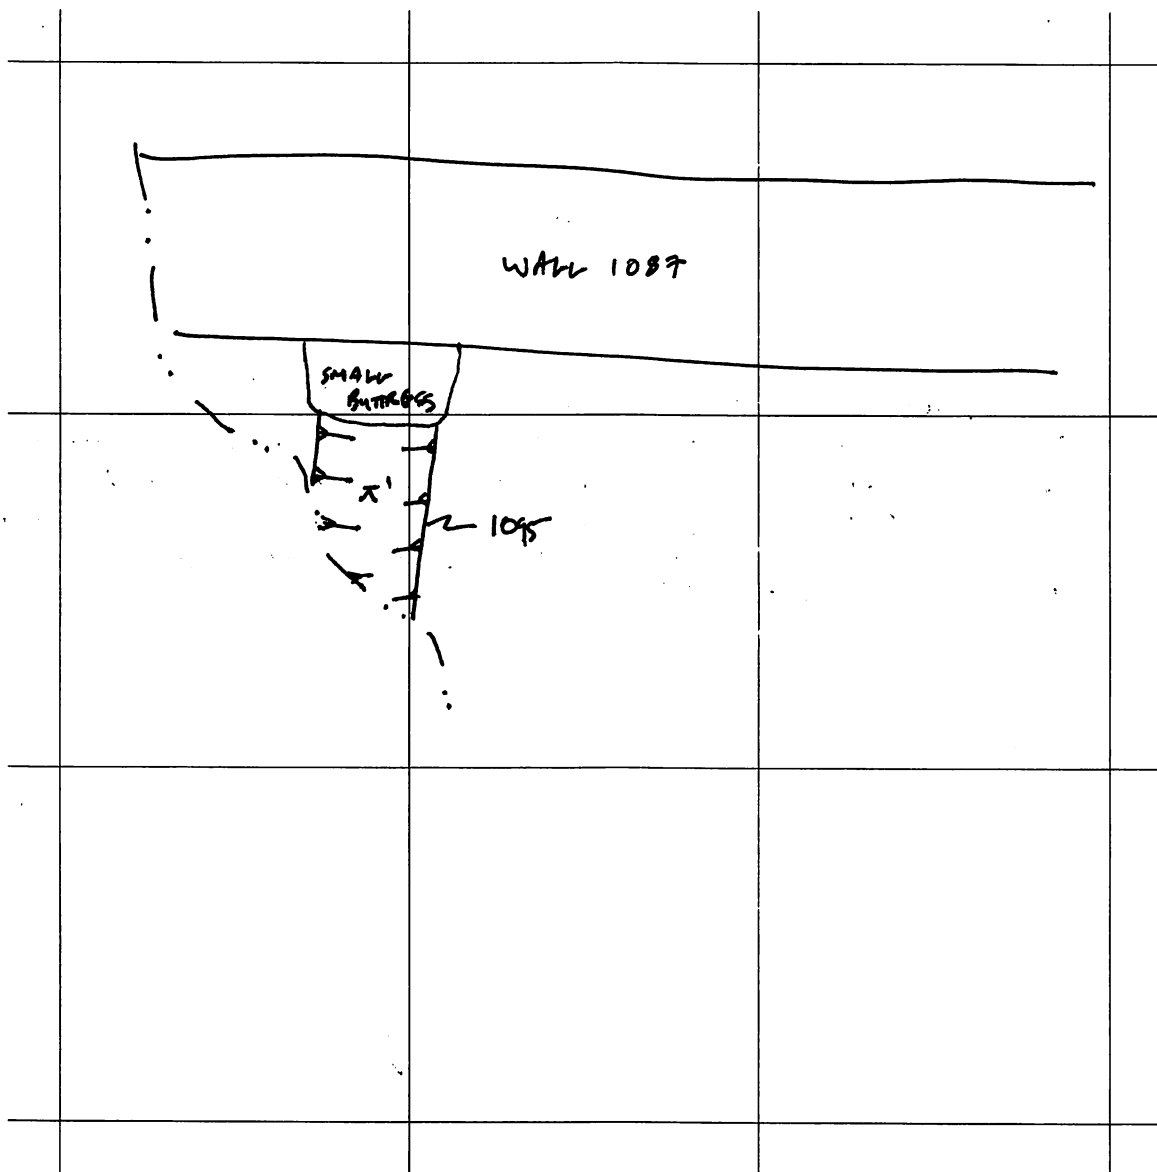
Sketch Plan & Notes

Interpretation: SHORT N-S LINEAR CUT TO S OF WALL
 1087. UNCLEAR FUNCTION. FILL (1089) CONTAINED MORTAR
 + BRICK FRAGS - CONSTRUCTION OR DEMO DEBRIS?
 VERY TRUNCATED BY MURDER. MAY WELL BE PART
 OF CONSTRUCTION CUT FOR SOME WALL/BEAM NOW
 COMPLETELY DESTROYED.
