Site Code: <b>MNO12</b>	Gr. Sq. / TP / Tr: <b>B</b>	Context Type: <b>MASONRY</b>	Context Number: <b>315</b>
1. Materials 2. Size of materials (brick: BTL in mm) 3. Finish of stones 4. Coursing / bond 5. Form 6. Direction of face(s) 7. Bonding material (if brick: record height of 4 courses & 4 bed joints in m) 8. Dimensions of masonry as found 9. Other comments	1. <b>reddish purple v. slight frosted (depression only) BRICKS</b>		
	2. <b>97 x 60 x 220 mm</b>		
	3. <b>BRICKS.</b>		
	4.		
	5. <b>STRUCTURAL WALL</b>		
	6. <b>SOUTH.</b>		
	7. <b>SOFT mud clay mortar, moderate lime &amp; charcoal pieces</b>		
	8. <b>0.69 m wide x 2.72 m E-W.</b>		
	9.

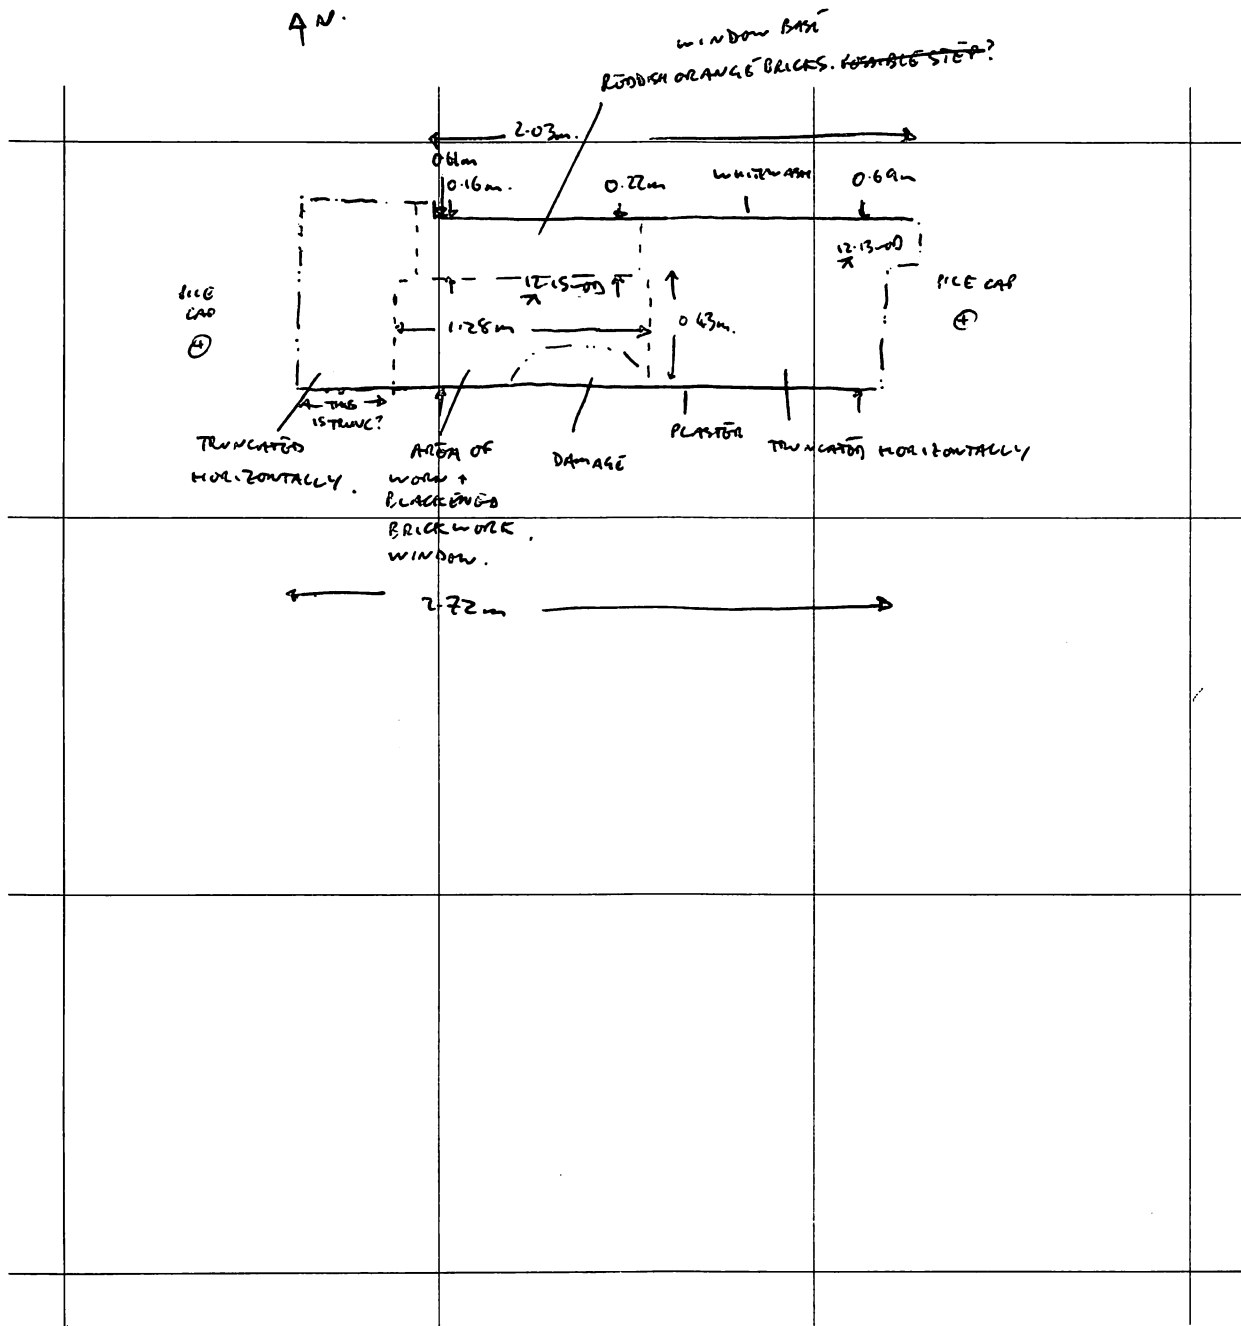
Interpretation:	internal + external
<b>N. wall of No 1 THE CRESCENT - PLASTERED ON INTERNAL FACE,</b> <b>POSSIBLE REBUILD ON INTERNAL FACE - DARKENED BRICKS. *</b> <b>WHITE WASH ON N. FACE.</b> <b>NOTICE BRICK LAYING TO NORTH INDICATES FURTHER CELLAR/LIGHTWELL TO NORTH.</b> <b>* THIS AREA IS BASE OF WINDOW INTO AREA TO NORTH.</b>	
Context same as:
