Site Code: MNO12	Location: <i>C w/B</i>	Grid Sq: <i>T35/220</i>	Context Type: MASONRY	Context Number: 334
1. Materials	1. <i>IRREGULAR - RED V.S. SLIGHTLY FLECKED BRICKS</i>			
2. Size of materials (brick: BTL in mm)	2. <i>BTL 105 x 62 x 225 mm.</i>			
3. Finish of stones	3. <i>BRICKS</i>			
4. Coursing / bond	4. <i>ENGLISH.</i>			
5. Form	5. <i>WALL WITH INTERNAL ARCH OF BARREL VAULT.</i>			
6. Direction of face(s)	6. <i>EAST</i>			
7. Surface treatment	7. <i>LIMEWASH.</i>			
8. Bonding material (if brick: record height of 4 courses & 4 bed joints in m)	8. <i>LIGHT GREY LIME MORTAR WITH FINE LIME FLOCKS</i>			
9. Dimensions of masonry as found	9. <i>2.65 - N-S x ? 0.6 - THICK x 3.0 - HIGH.</i>			
10. Other comments	10. <i>OBSERVED IN W/BRIEF</i>			
			Max Level: <i>13.23 m OD</i>	
			Min Level: <i>10.23 m OD</i>

Context Number:
334

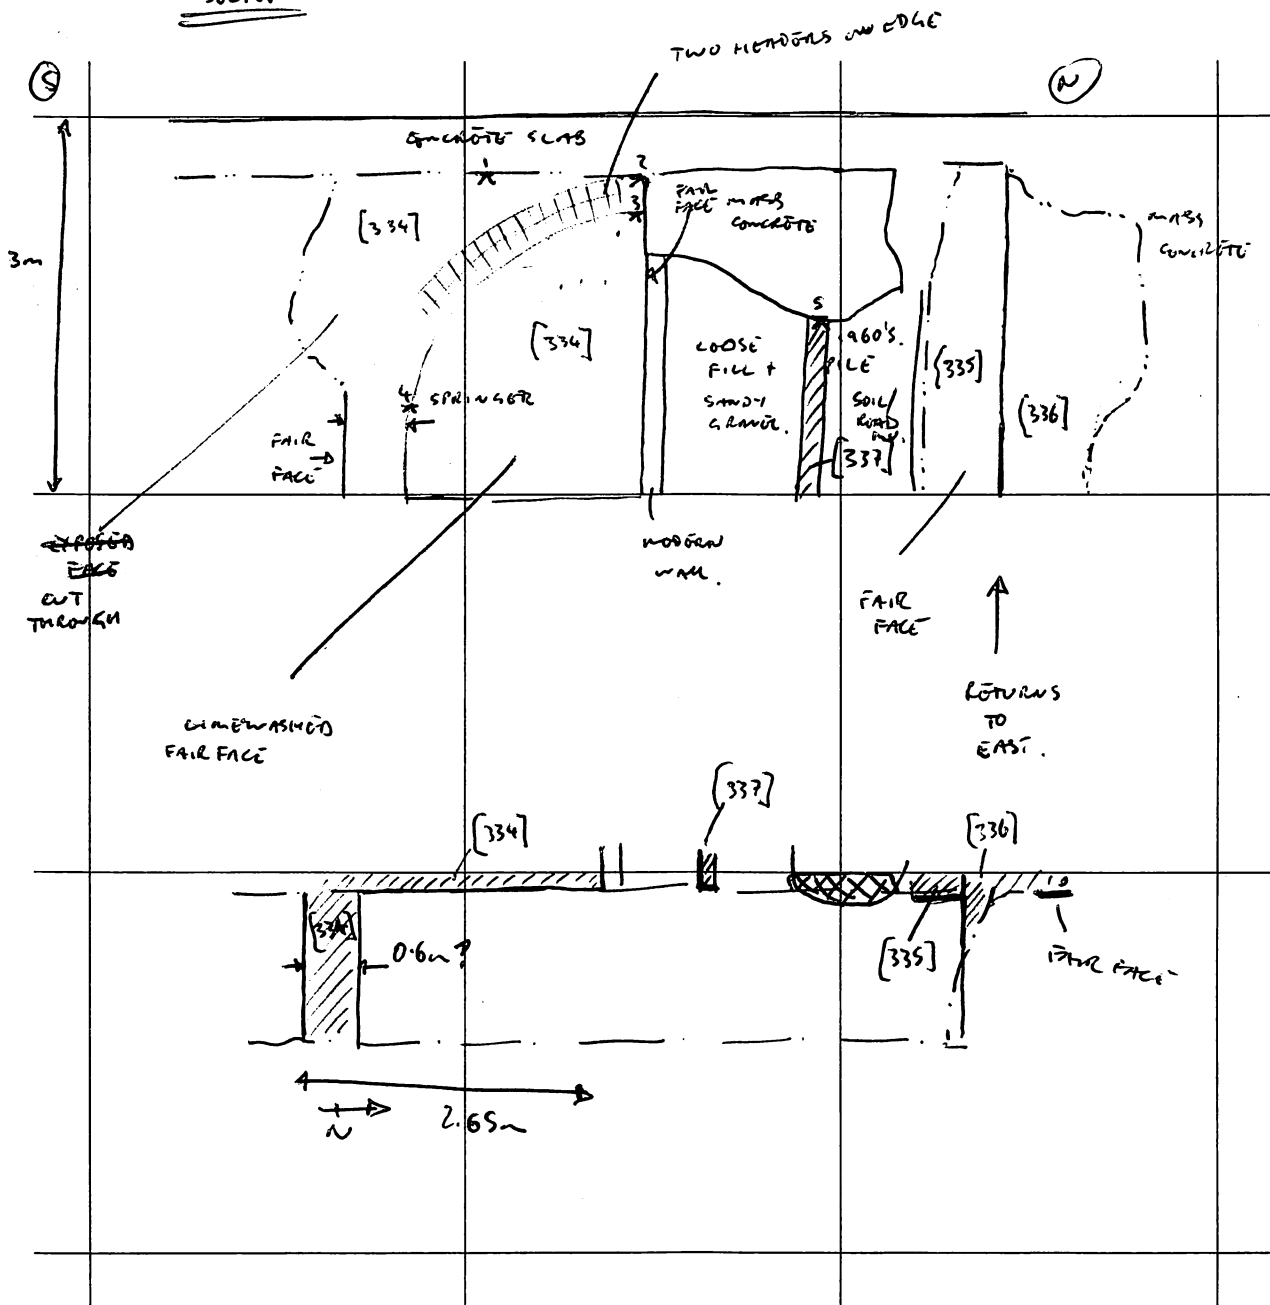
EAST FACING SECTION
SECTION

Interpretation:	<input checked="" type="checkbox"/> internal	<input type="checkbox"/> external
<i>WESTERN OF VINE STREET - STREET FROM THIS WALL, EXPOSED.</i>		
<i>INTERNAL FACE OF WALL DURING WATCHING BRIEF ON PILE PROBING.</i>		
<i>SURVEYED BY ISJ.</i>		
<i>BARREL VAULT IS ON EAST SIDE OF WALL - SNAPPED OFF BUT CONTINUES UNDER CONCRETE TO EAST.</i>		
Context same as:
