Site Code: MNO12	Location: ARCAB	Grid Sq: 125/200 130/200	Context Type: Fill	Context Number: 2478
Deposit 1. Compaction	1. Firm			Cut 1. Shape in Plan 2. Corners 3. Dimensions 4. Break of slope – Top 5. Sides 6. Break of slope – Base 7. Base 8. Orientation 9. Inclination 10. Truncation 11. Other comments
2. Colour	2. Dark grayish brown			
3. Composition	3. Sandy silt			
4. Inclusions	4. Frag. pot, bone, occ. charcoal, bones, glass, C.T.P. & Oyster			
5. Interface	5. None Under			
6. Dimensions	6. NS - 3.24mod EV - 6.18mod			
7. Other Comments	Depth 1.54mod 0.05 - 0.3m wide			
8. Method/Conditions	Text 7			
8. Hand dug; maltack, shovel, wet/snow				
10.46			Max Level: 10.76 m OD	
10.41 [Ⓚ]			Min Level: 10.71 m OD

Context Number:
2478

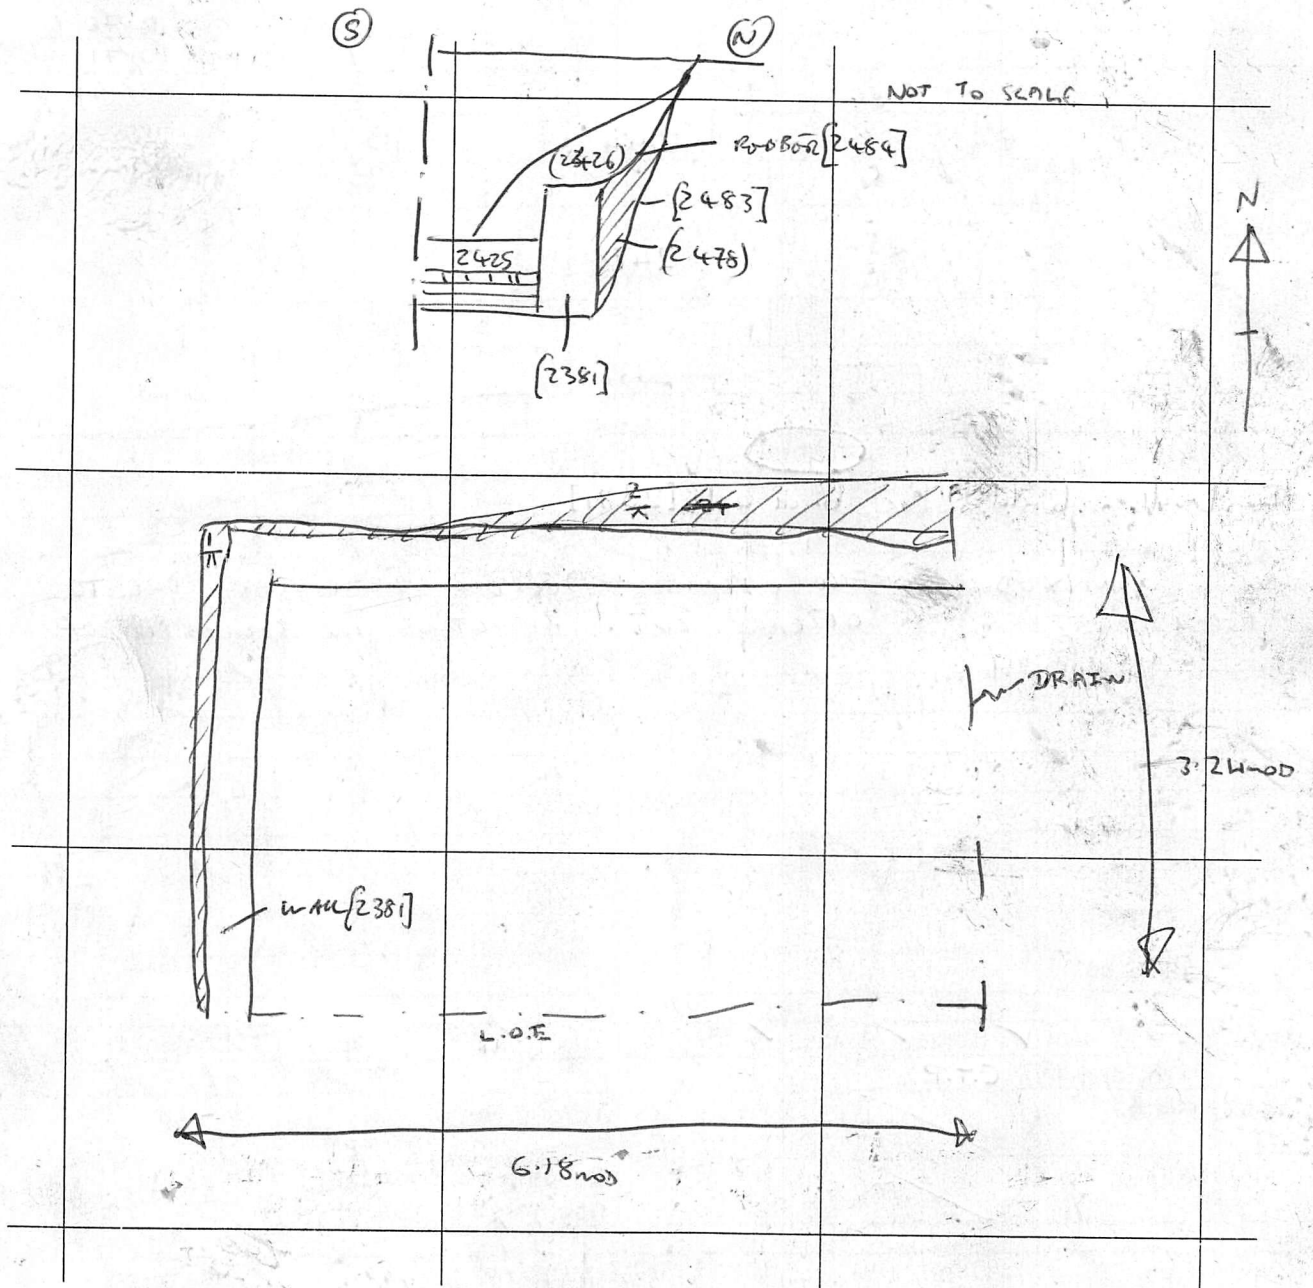
Interpretation:	<input checked="" type="checkbox"/> Internal	<input type="checkbox"/> External	<input type="checkbox"/> Structural
Construction backfill for brick wall [2381]			
MADE OF BACKFILL, QUITE WIDE ON NORTH SIDE DUE TO POOR CUTTING OF CURAR CUT. RESULTING IN COLLAPSE OF WALL [2381]			
Context same as:			
Finds: None <input type="checkbox"/> Pot <input checked="" type="checkbox"/> Bone <input type="checkbox"/> Glass <input checked="" type="checkbox"/> Metal <input type="checkbox"/> CBM <input checked="" type="checkbox"/> Flint <input type="checkbox"/> Wood <input type="checkbox"/> Leather <input type="checkbox"/>			
Other (specify): C.T.P.			
Sample No(s):		Drawing No(s): (x -)	
Photo No(s):		Sketch/levels overleaf: <input type="checkbox"/>	
		Transferred to plan: <input type="checkbox"/>

No.	F/S	R/L (m OD)	No.	F/S	R/L (m OD)	No.	F/S	R/L (m OD)	No.	F/S	R/L (m OD)
1	2.22	10.76	10.46								
2	2.27	10.71	10.41 (2)
