Site Code: MNO12	Location: B	Grid Sq: 120/210 115/210	Context Type: MASONRY	Context Number: 2222
1. Materials	① RED BRICK			
2. Size of materials (brick: BTL in mm)	②			
3. Finish of stones	③ MOULDED UNWORN			
4. Coursing / bond	④ UNCLEAR VERY FRAGMENTED.			
5. Form	⑤ WALL? FLOOR?			
6. Direction of face(s)	⑥ —			
7. Surface treatment	⑦ NONE			
8. Bonding material (if brick: record height of 4 courses & 4 bed joints in m)	⑧ MORTAR			
9. Dimensions of masonry as found	⑨			
10. Other comments	⑩			Max Level: 10.81 m OD Min Level: 10.70 m OD

Interpretation:	<u>internal</u>	external
POSSIBLE WALL FOOTING BUT VERY TRUNCATED AT POTENTIALLY THE BASE OF THE STAIRCASE TO BASEMENT. MAY RELATE TO THAT? NEXT TO BRICK JOINT BASE [2252]		
Context same as:

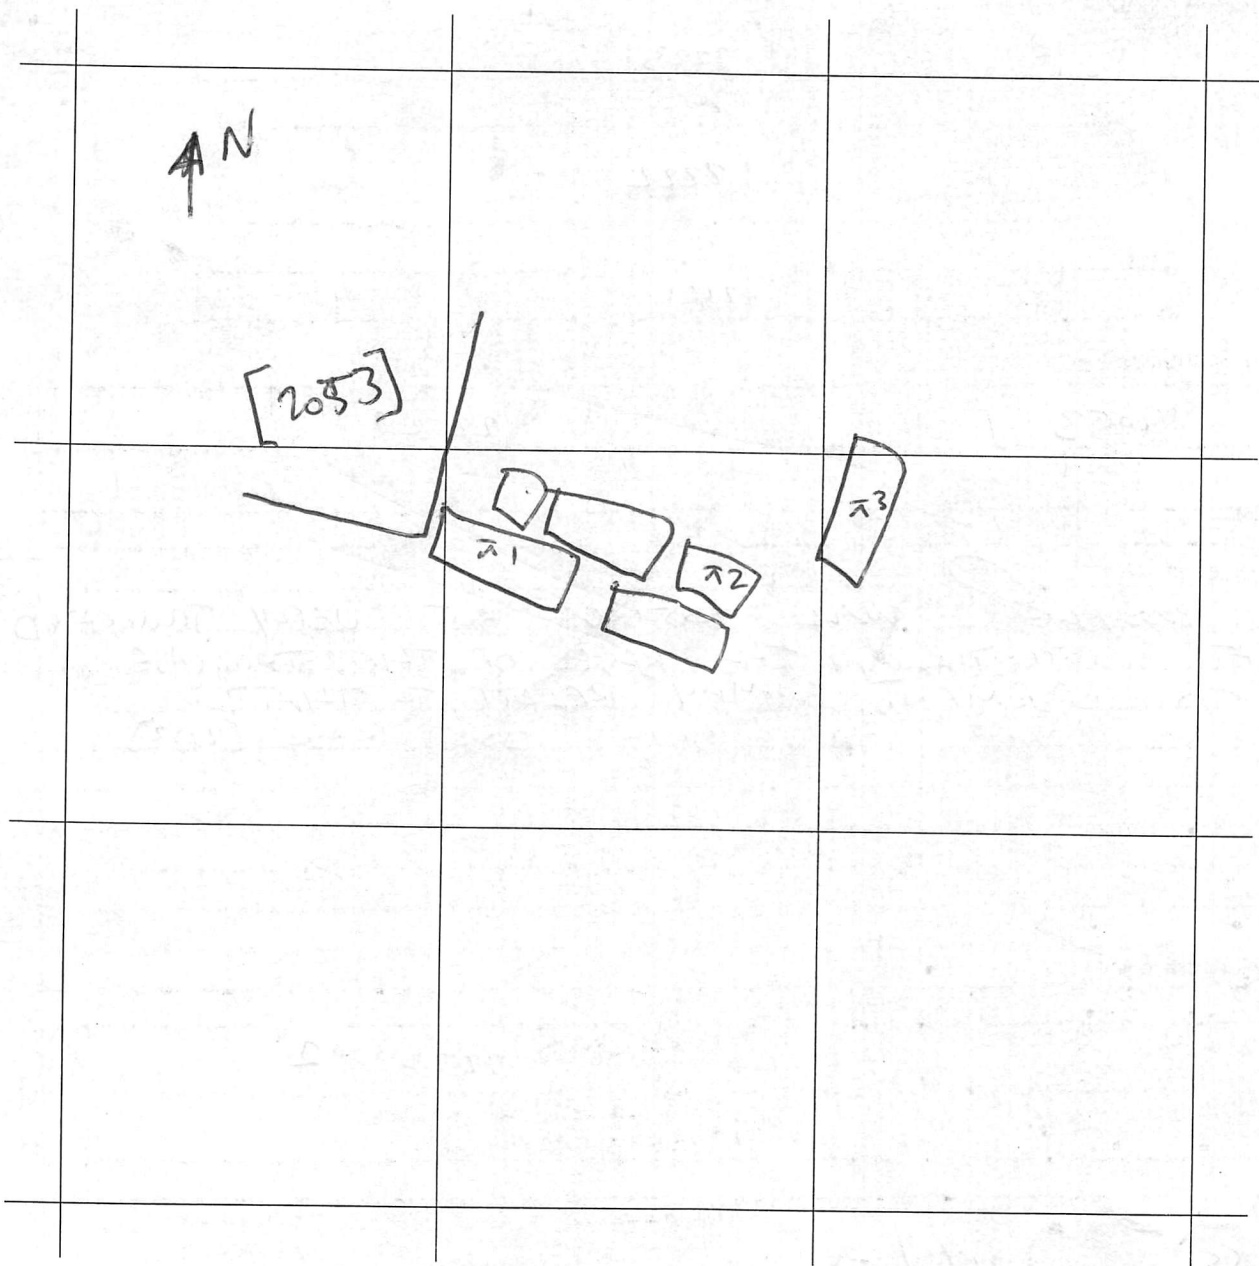
Context Number:
2222

No.	F/S	R/L (m OD)	No.	F/S	R/L (m OD)	No.	F/S	R/L (m OD)	No.	F/S	R/L (m OD)
1	1.63	10.81									
2	1.69	10.75									
3	1.74	10.70
