Site Code: <b>MNO12</b>	Location: AREA B30	Grid Sq: 110/10 115/210	Context Type: <b>MASONRY</b>	Context Number: 2179
1. Materials	1. HARD YELLOW AND RED BRICKS WITH FROGGING			
2. Size of materials (brick: BTL in mm)	2. 100MM x 65MM x 220MM			
3. Finish of stones	3. MOULDED BRICKS			
4. Coursing / bond	4. 9 COURSES OF HEADERS ON BED			
5. Form	5. BRICK CHAMBER			
6. Direction of face(s)	6. N, S, E, W, UP			
7. Surface treatment	7. TANKING ON BASE?			
8. Bonding material (if brick: record height of 4 courses & 4 bed joints in m)	8. HARD MORTAR, PINKISH GREY 4 COURSES = 0.34m			
9. Dimensions of masonry as found	9. W = 0.88 x L = 1.15 x DEPTH = 0.67			
10. Other comments	10. SECTION NO 50			
				Max Level: 11.01 m OD
				Min Level: 10.31 m OD

Context Number:  
2179

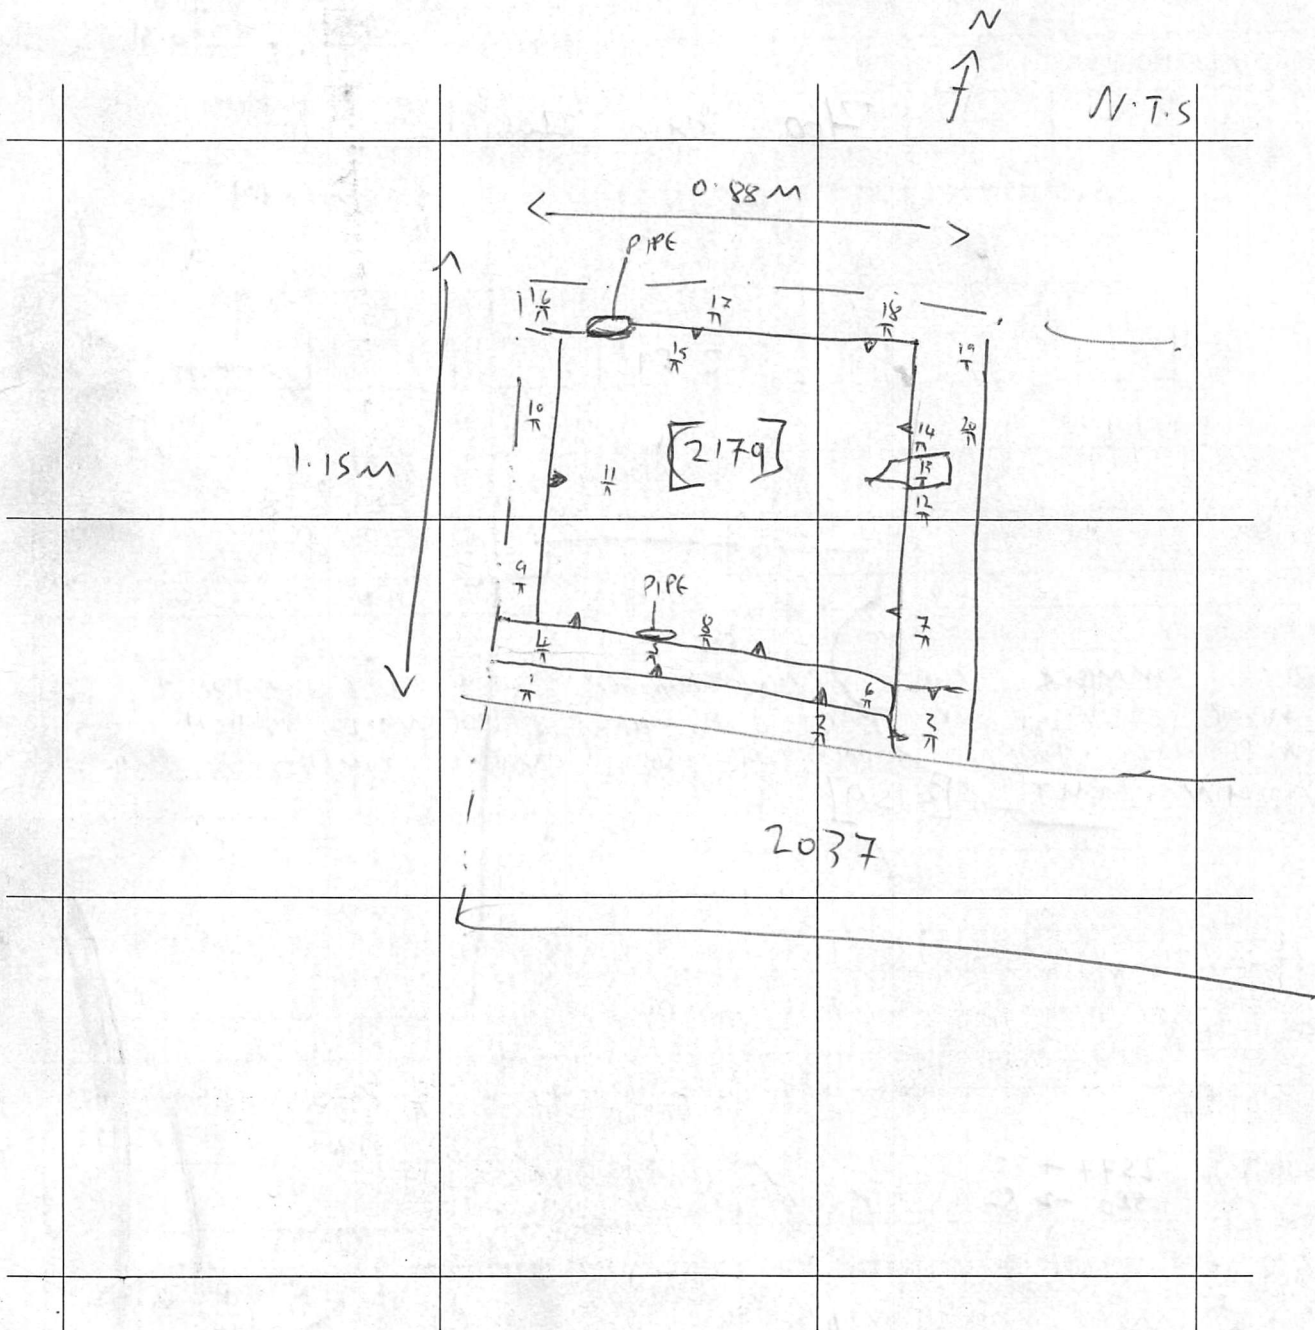
Interpretation:	<input checked="" type="checkbox"/> internal/structure <input type="checkbox"/> external
BRICK CHAMBER FOR PIPING/DRAINAGE. POSSIBLY AN INSPECTION CHAMBER, LIKELY LATER THAN ORIGINAL FLOORING WHICH WOULD HAVE BEEN RIPPED UP SO CHAMBER WOULD BE BUILT WITHIN CUT [2159]	
Context same as:

Level No.s	Level No.s	Level No.s	Level No.s
TBM 11.68	TBM	TBM	TBM
B/S 0.73	B/S	B/S	B/S
IH 12.41	IH	IH	IH

No.	F/S	R/L (m OD)	No.	F/S	R/L (m OD)	No.	F/S	R/L (m OD)	No.	F/S	R/L (m OD)
1	1.42	10.99	6	1.49	10.92	11	2.09	10.32	16	1.81	10.60
2	1.42	10.99	7	1.49	10.92	12	1.56	10.85	17	1.67	10.74
3	1.55	10.86	8	2.10	10.31	13	1.40	11.01	18	1.49	10.92
4	1.65	10.76	9	1.75	10.66	14	1.51	10.9	19	1.51	10.90
5	1.57	10.84	10	1.82	10.59	15	2.09	10.32	20	1.52	10.89
