Site Code: <b>MNO12</b>	Location: <b>B</b>	Grid Sq: <b>125-30 / 205-15</b>	Context Type: <b>MASONRY</b>	Context Number: <b>2035</b>
1. Materials	① <b>RED MOULDED BRICK</b>			
2. Size of materials (brick: BTL in mm)	②			
3. Finish of stones	③ <b>MOULDED. NOT VERY WEATHERED.</b>			
4. Coursing / bond	④			
5. Form	⑤ <b>WALL</b>			
6. Direction of face(s)	⑥ <b>E + W FACING</b>			
7. Surface treatment	⑦ <b>RED BR POINTED ON EXTERIOR.</b>			
8. Bonding material (if brick: record height of 4 courses & 4 bed joints in m)	⑧ <b>MID GREY HARD MORTAR WITH WHITE LIME FLECKS</b>			
9. Dimensions of masonry as found	⑨ <b>0.72m THICK</b>			
10. Other comments	⑩		Max Level:	m OD
			Min Level:	m OD

Context Number:  
2035

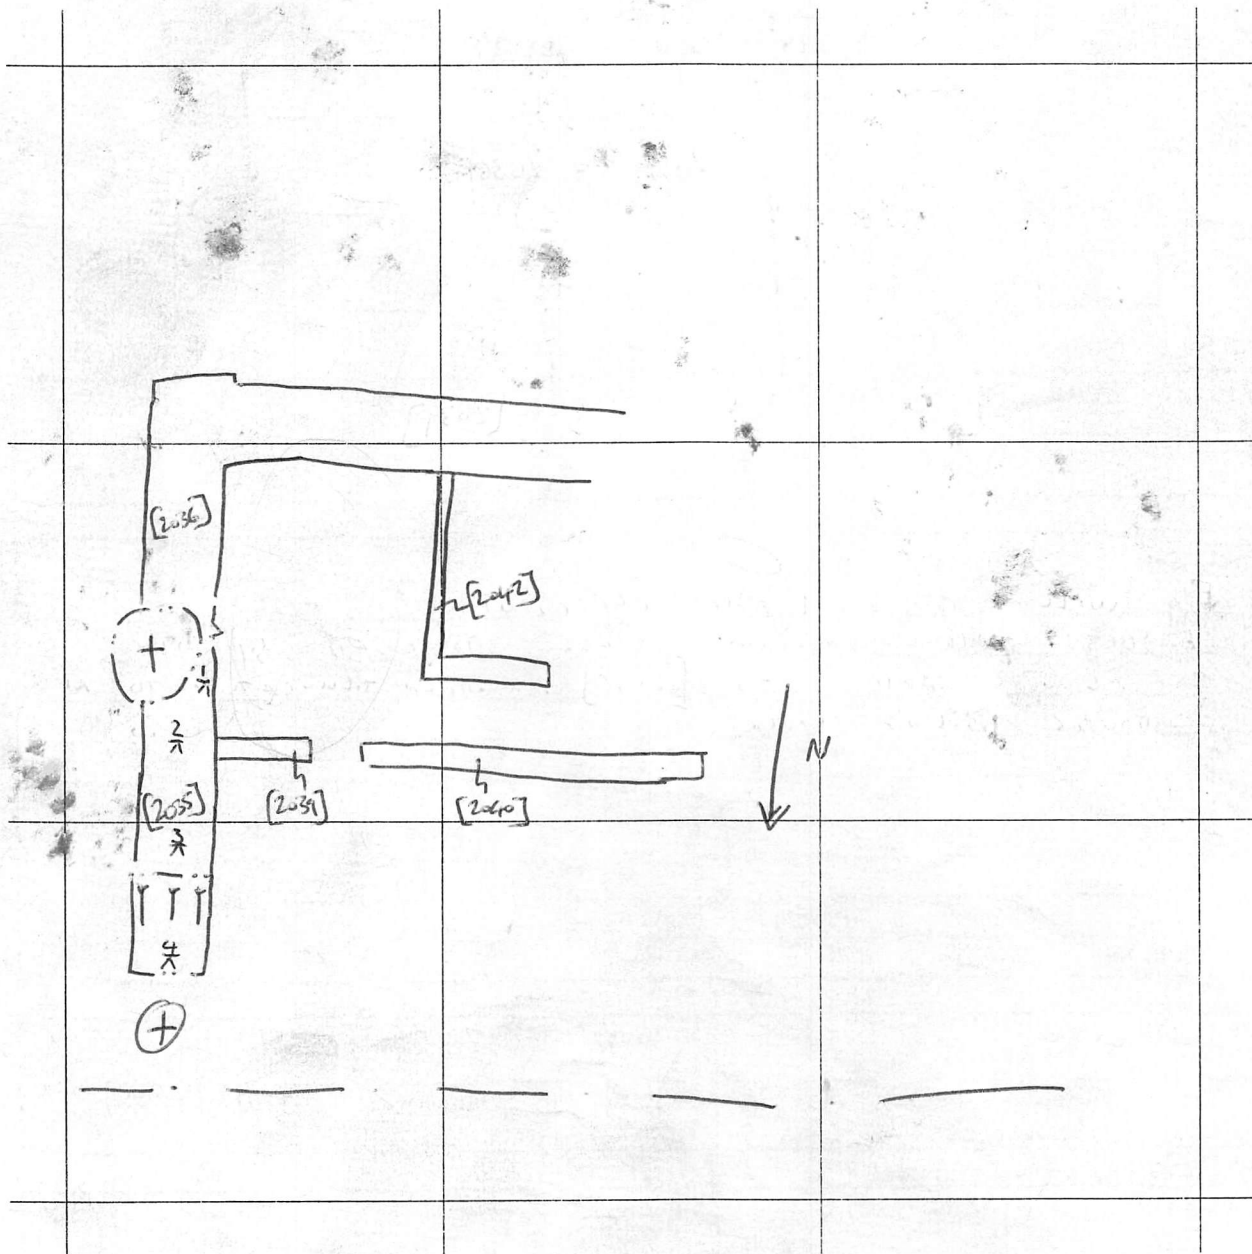
Interpretation:	internal	external
<b>E WALL OF 1 THE CRESCENT.</b>		
<b>LARGE + THICK EXTERIOR WALL. DAMAGED BY PILE</b>		
<b>TO S. SAME AS [2036]. MODERN TRUNCATION TO A</b>		
<b>DOUBLE STRING COURSE</b>		
Context same as:

No.	F/S	R/L (m OD)	No.	F/S	R/L (m OD)	No.	F/S	R/L (m OD)	No.	F/S	R/L (m OD)
1	0.98	11.46									
2	0.25	12.19									
3	0.84	11.95									
4	1.28	11.16
