| Site Code:<br><b>MNO12</b> | Location:<br><b>B</b> | Grid Sq:<br><b>130/200-215</b> | Context Type:<br><b>MASONRY</b> | Context Number:<br><b>2383</b> |
| 10. Other comments | 10. Vine Street bridge sewer running North to South alignment not fully excavated (09/03/15) | | | |

| VINE STREET SEWER N-S ALIGNMENT. | | |

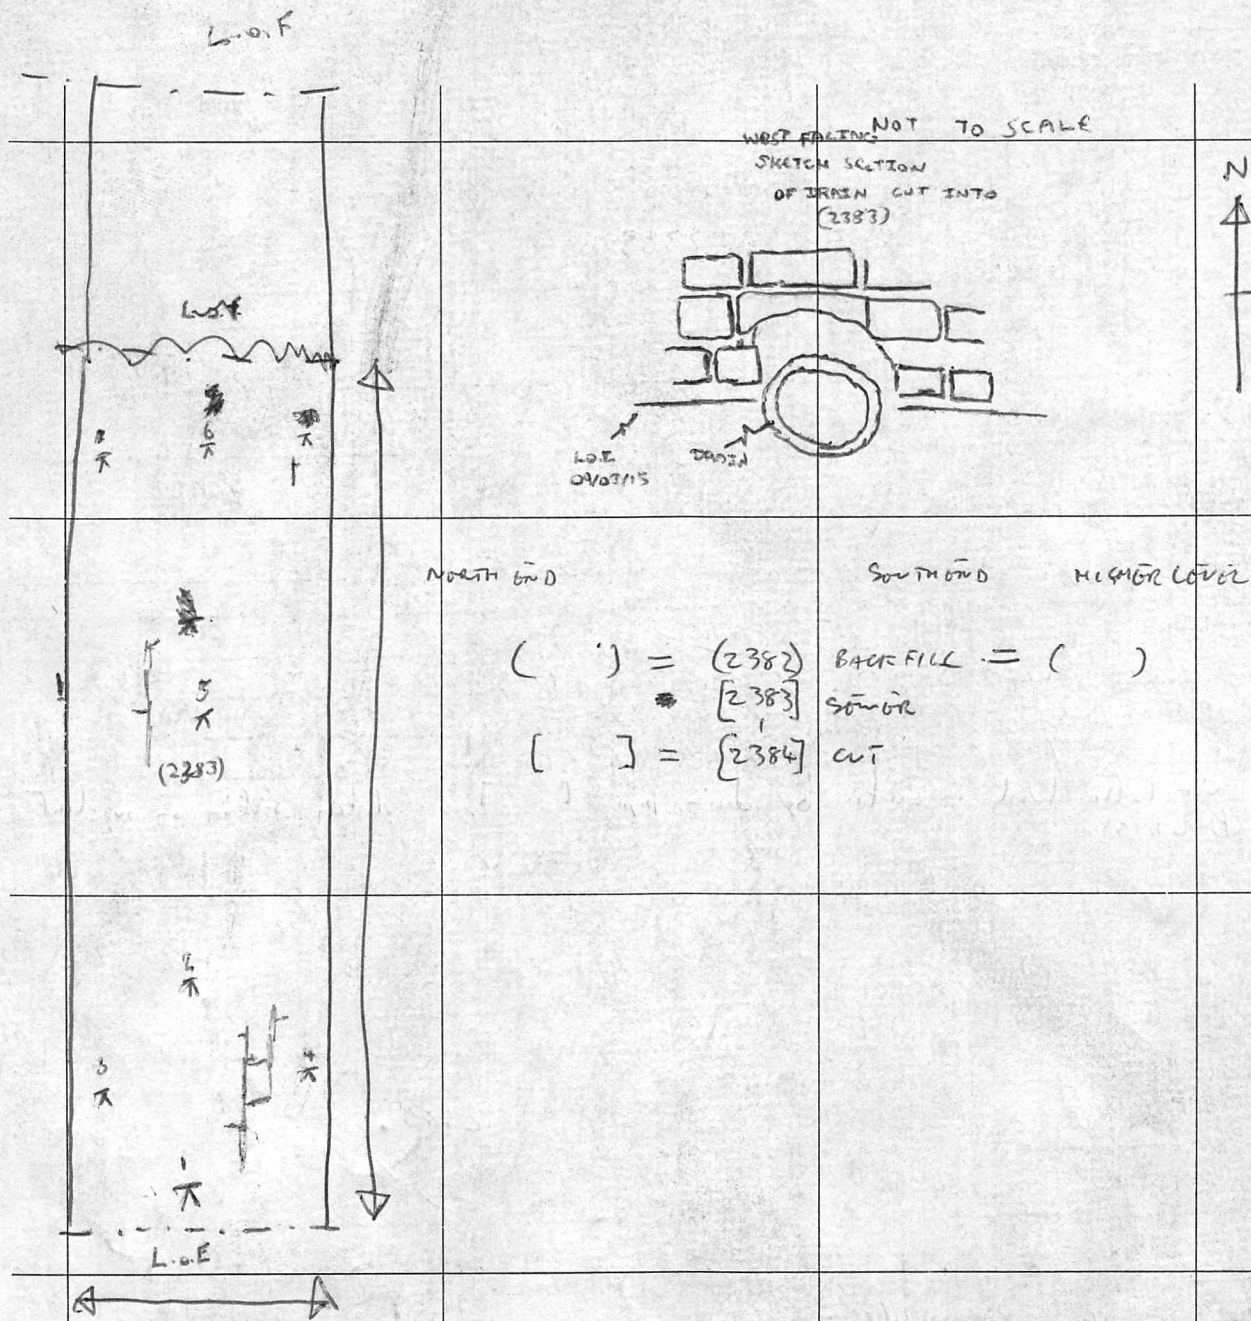
2383

| ROUND TOP - CIRCULAR OR OVAL X-SECTION? | | |
| MASONRY MADE OF 'RINGS' OF BRICK STRUTTED ON EDGE | | |
| Cut by the Work in center by drain pipe [ ]; see sketch section on over-leaf (09/03/15) | | |
