Site Code: <b>MNO12</b>	Location: AC14 B	Grid Sq: 120/205	Context Type: DEPOSIT	Context Number: (2147)
Deposit	① COMPACTED ② MID GREY BROWN ③ SILTY SAND ④ FREQUENT ROUNDED STONES $\leq 50mm$ OCCASIONAL LIME FLECKS. ⑤ DIFFUSE. ⑥ L 0.43m, W 0.9m, D 0.3m ⑦ NONE. Text			Cut
1. Compaction				1. Shape in Plan
2. Colour				2. Corners
3. Composition				3. Dimensions
4. Inclusions				4. Break of slope - Top
5. Interface				5. Sides
6. Dimensions				6. Break of slope - Base
7. Other Comments				7. Base
8. Method/Conditions				8. Orientation
				9. Inclination
				10. Truncation
				11. Other comments
				Max Level: 11.62 m OD
				Min Level: 11.53 m OD

Context Number:  
2147

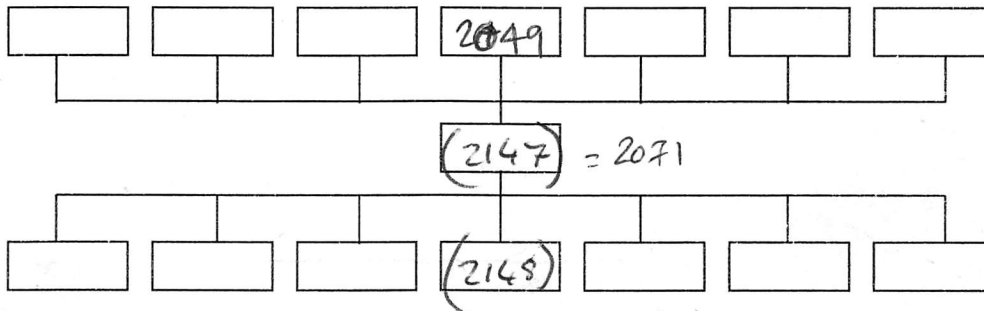
Interpretation:	Internal	External	Structural
SILTY SAND BACKFILL DUMP, CONTAINING SOME WASTE BUILDING MATERIAL - NAMELY LIME FLECKS.			
BACKFILL LP AGAINST EXTERIOR WALL [2049].			
LIKELY FORMED FOR BUILDING LP OF GROUND FLOOR WALL.			
Context same as:

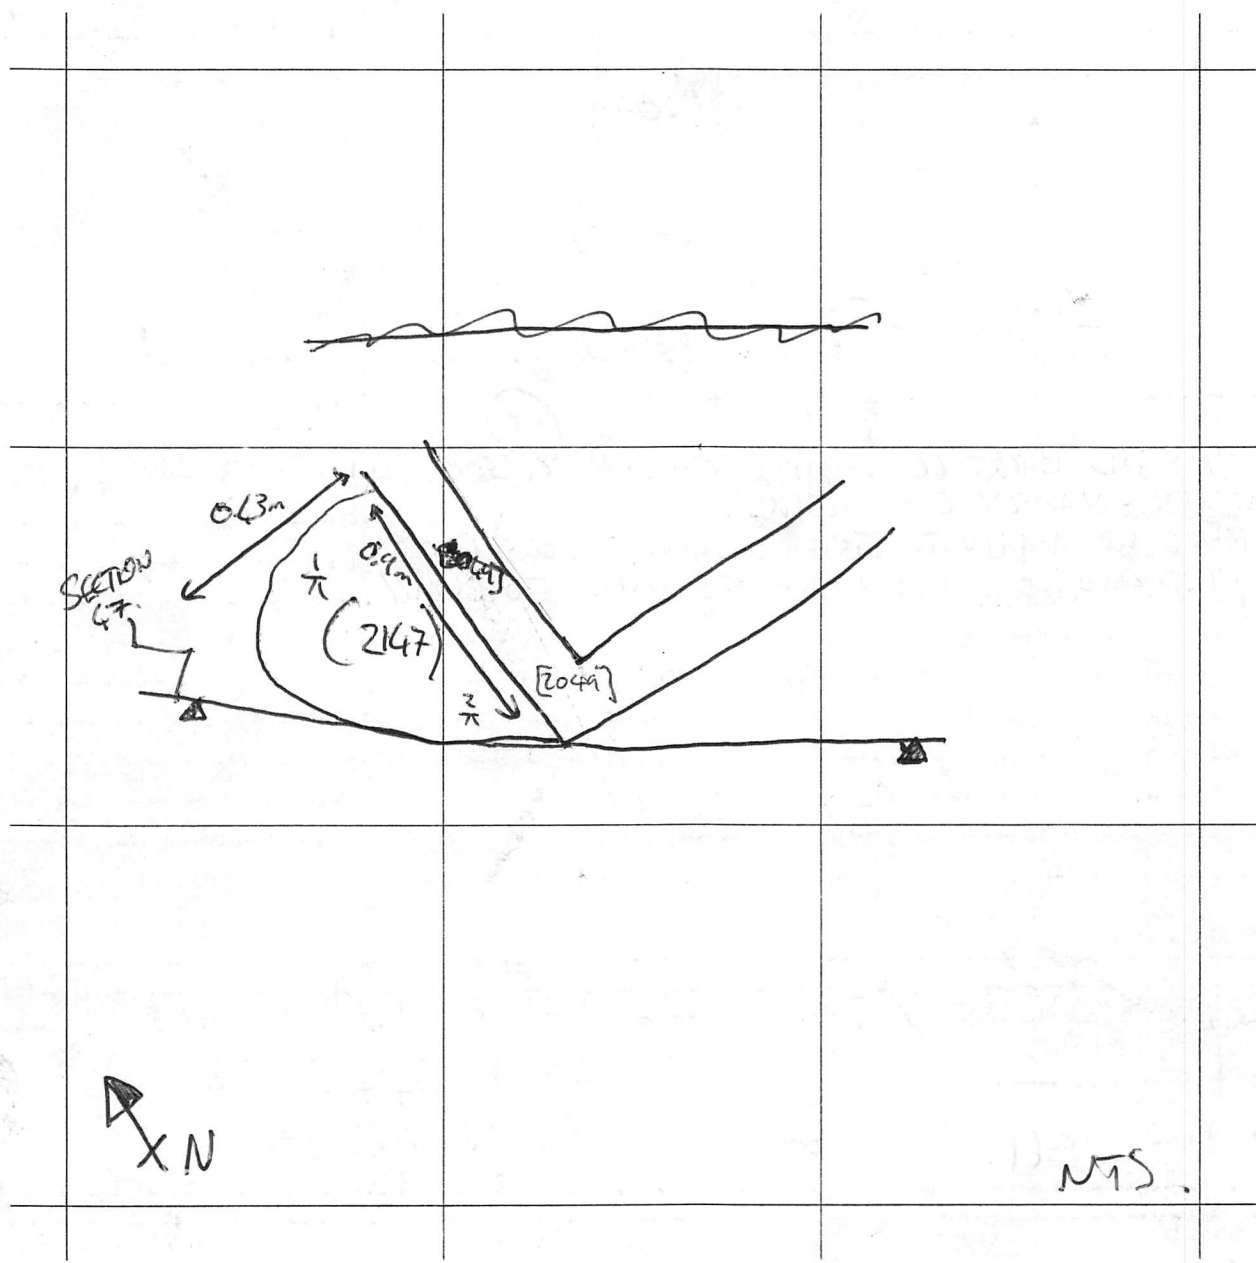
Level No.s  
 TBM 11.68  
 B/S 0.53  
 IH 12.25

No.	F/S	R/L (m OD)	No.	F/S	R/L (m OD)	No.	F/S	R/L (m OD)	No.	F/S	R/L (m OD)
1	0.61	11.62									
2	0.70	11.53
