Site Code: MNO12	Location: B	Grid Sq: 120/210	Context Type: MASONRY	Context Number: 222 2221
1. Materials	① RED BRICK			
2. Size of materials (brick: BTL in mm)	② 220mm x 110mm x @ 50mm			
3. Finish of stones	③ ROUGHLY SMOOTHED - WORN?			
4. Coursing / bond	④ 1 COURSE - FLORR. NO OBVIOUS BOND			
5. Form	⑤ FLOOR			
6. Direction of face(s)	⑥ UP			
7. Surface treatment				
8. Bonding material (if brick: record height of 4 courses & 4 bed joints in m)	⑦ NONE			
	⑧ MORTAR BEDDING BELOW.			
9. Dimensions of masonry as found	⑨ 0.5M x 0.5M			
10. Other comments	⑩			Max Level: 11.00 m OD
				Min Level: 10.86 m OD

Context Number:
2221

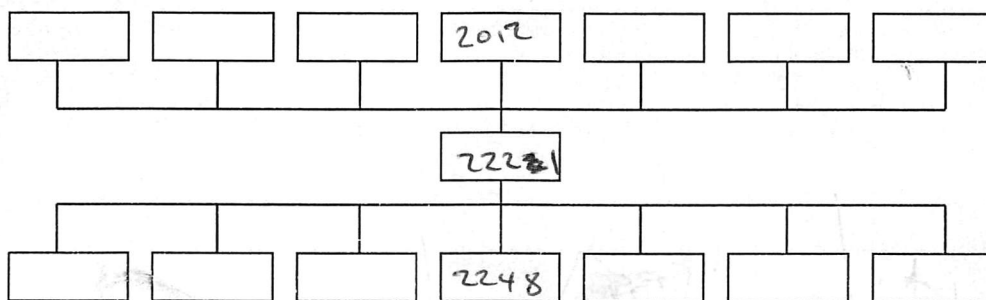
Stratigraphic Relationships:

Abuts: 2053	Abutted by:
Cut by:

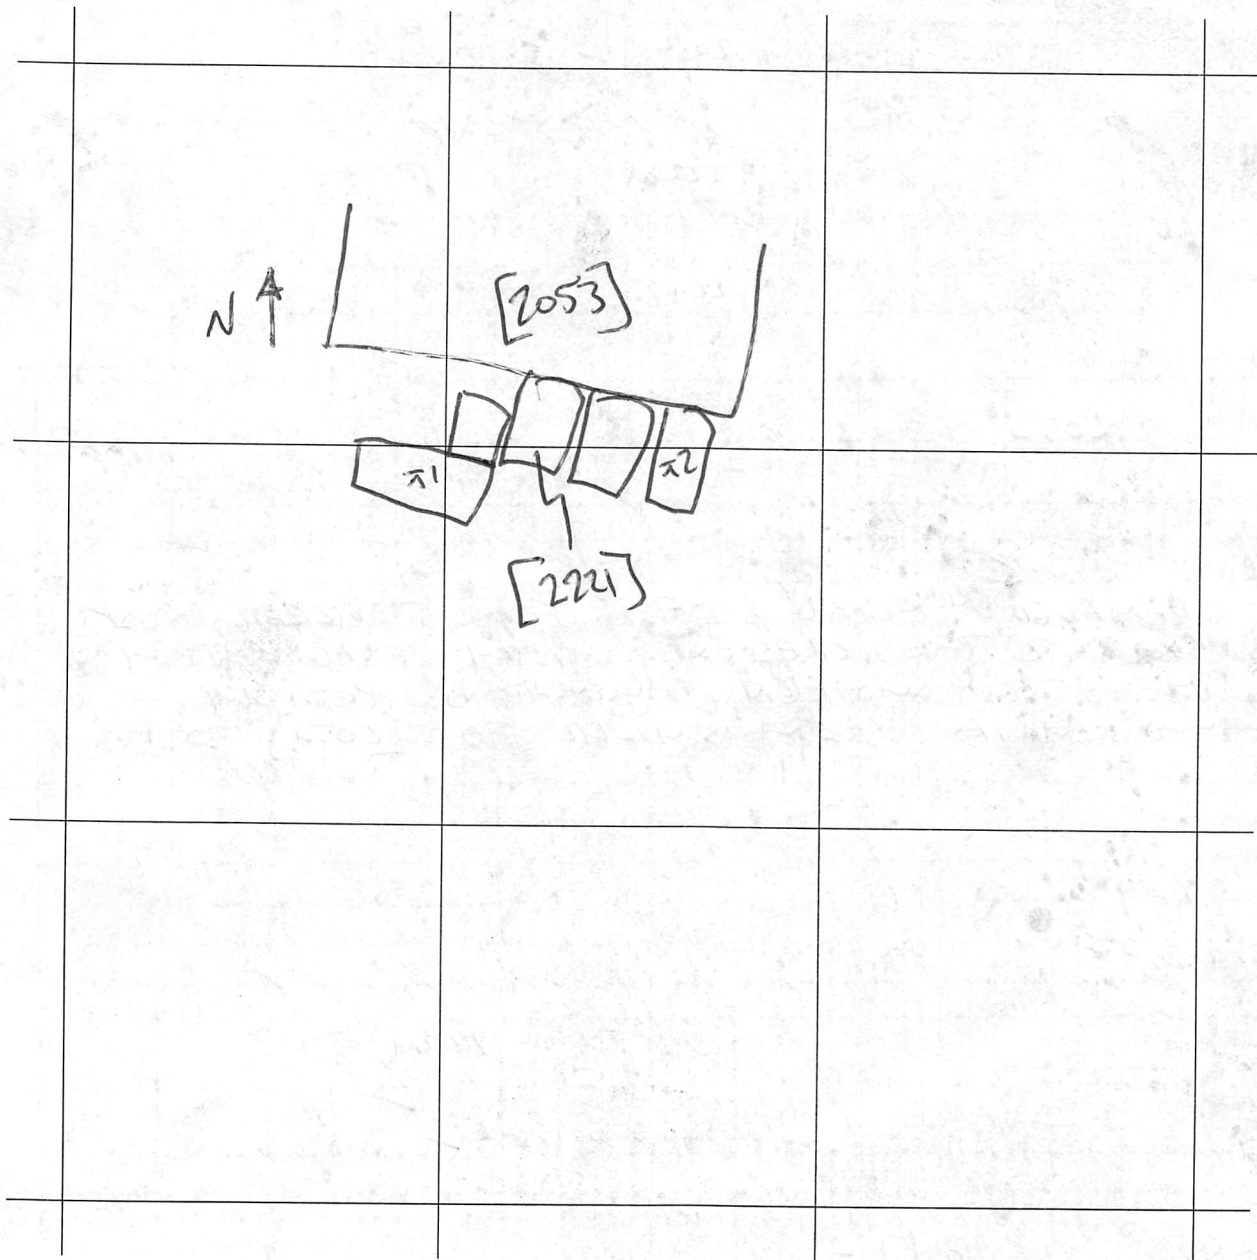
Interpretation:	<input checked="" type="checkbox"/> internal	<input type="checkbox"/> external
DAMAGED BRICK FLOOR OF E MOST REAR ROOM IN NO 2 THE CRESENT. VERY FRAGMENTARY DUE TO MODERN TRUNCATIONS POSSIBLY WOULD HAVE BEEN SIMILAR TO [2054] TO E.		
Context same as:

No.	F/S	R/L (m OD)	No.	F/S	R/L (m OD)	No.	F/S	R/L (m OD)	No.	F/S	R/L (m OD)
	11.71		2	1.58	10.86						
	1.7										
	1.68										
	11.65										
1	1.44	11.00
