Site Code: <b>MNO12</b>	Location: <b>C</b>	Grid Sq: <b>145-150/210</b>	Context Type: <b>MASONRY</b>	Context Number: <b>3581 1/2</b>
1. Materials	1. <del>RED</del> SLIGHTLY FROCKED BRICKS, PURPLE RED SLIGHTLY FROCKED BRICKS

2. Size of materials (brick: BTL in mm)	1. <del>110</del> 110 x 70 x 220			
3. Finish of stones	3. -			
4. Coursing / bond	4. ROUGHLY ENGLISH			
5. Form	5. BRICK-LINED SILT TRAP - SOME RE-USED BRICKS?

Context Number:  
3581.

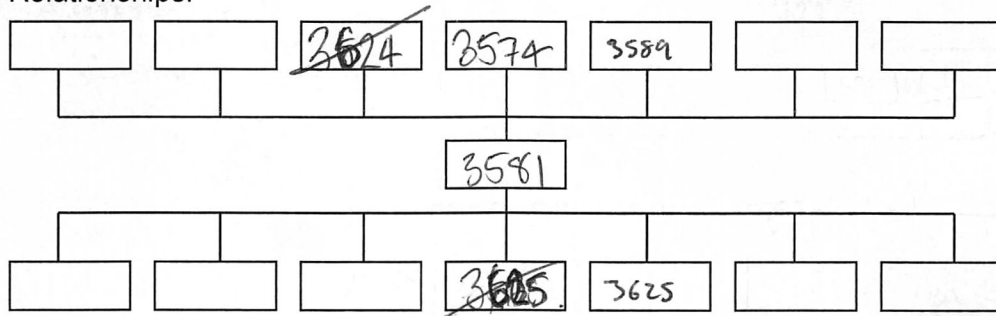
Stratigraphic Relationships:

Abuts: [3443] AND [3455]	Abutted by:
Cut by:

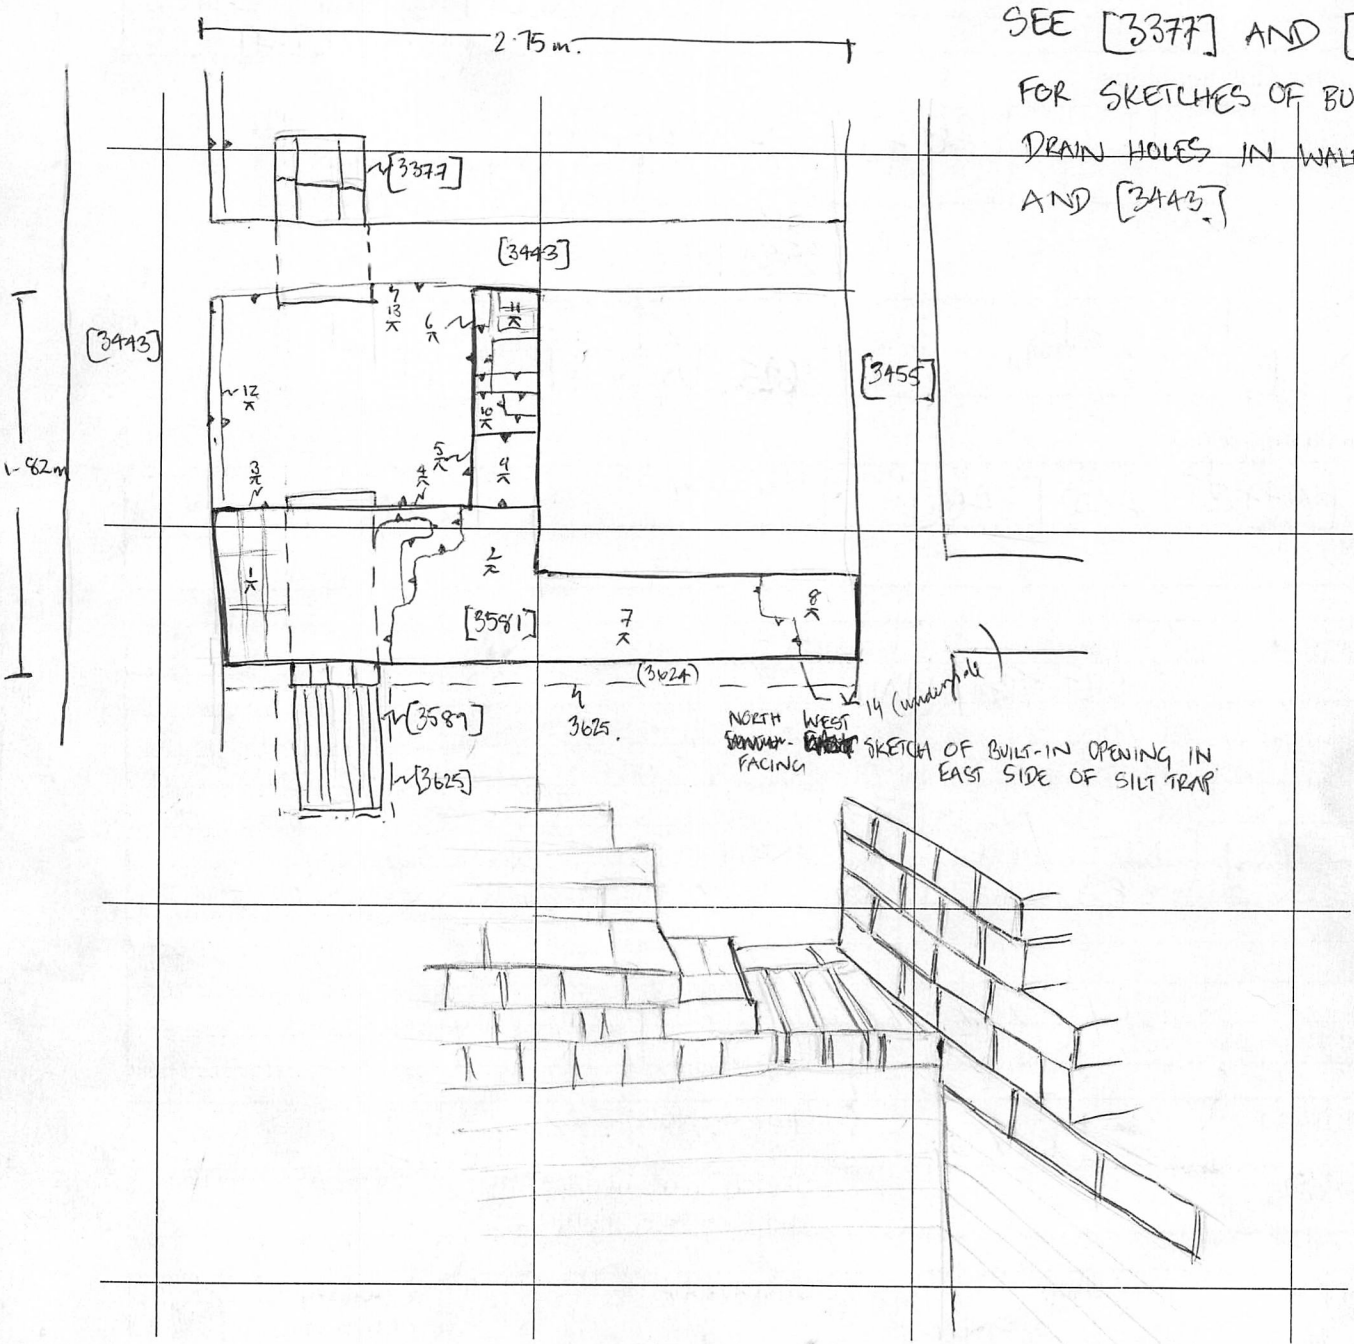
SEE [3377] AND [3589]  
FOR SKETCHES OF BUILT IN  
DRAIN HOLES IN WALLS [3581]  
AND [3443]

14 (underplate)  
NORTH WEST  
SKETCH OF BUILT-IN OPENING IN  
EAST SIDE OF SILT TRAP

Interpretation:	internal	external
SILT TRAP WALL		
WALL HAS BEEN INSERTED BETWEEN STRUCTURAL WALLS [3443] AND [3455], AND BUILT WITH DRAIN OPENING IN SOUTHERN ELEVATION TO CONNECT WITH BRICK LINED DRAIN [3589] WITH WHICH [3581] SHARES A CONSTRUCTION CUT [3605] [3625]. THERE IS ALSO ANOTHER INBUILT NARROW OPENING IN SOUTHERN END OF EASTERN ELEVATION, PERHAPS FOR OTHER DRAINAGE IN OR OUT OF SILT TRAP.		
Context same as:

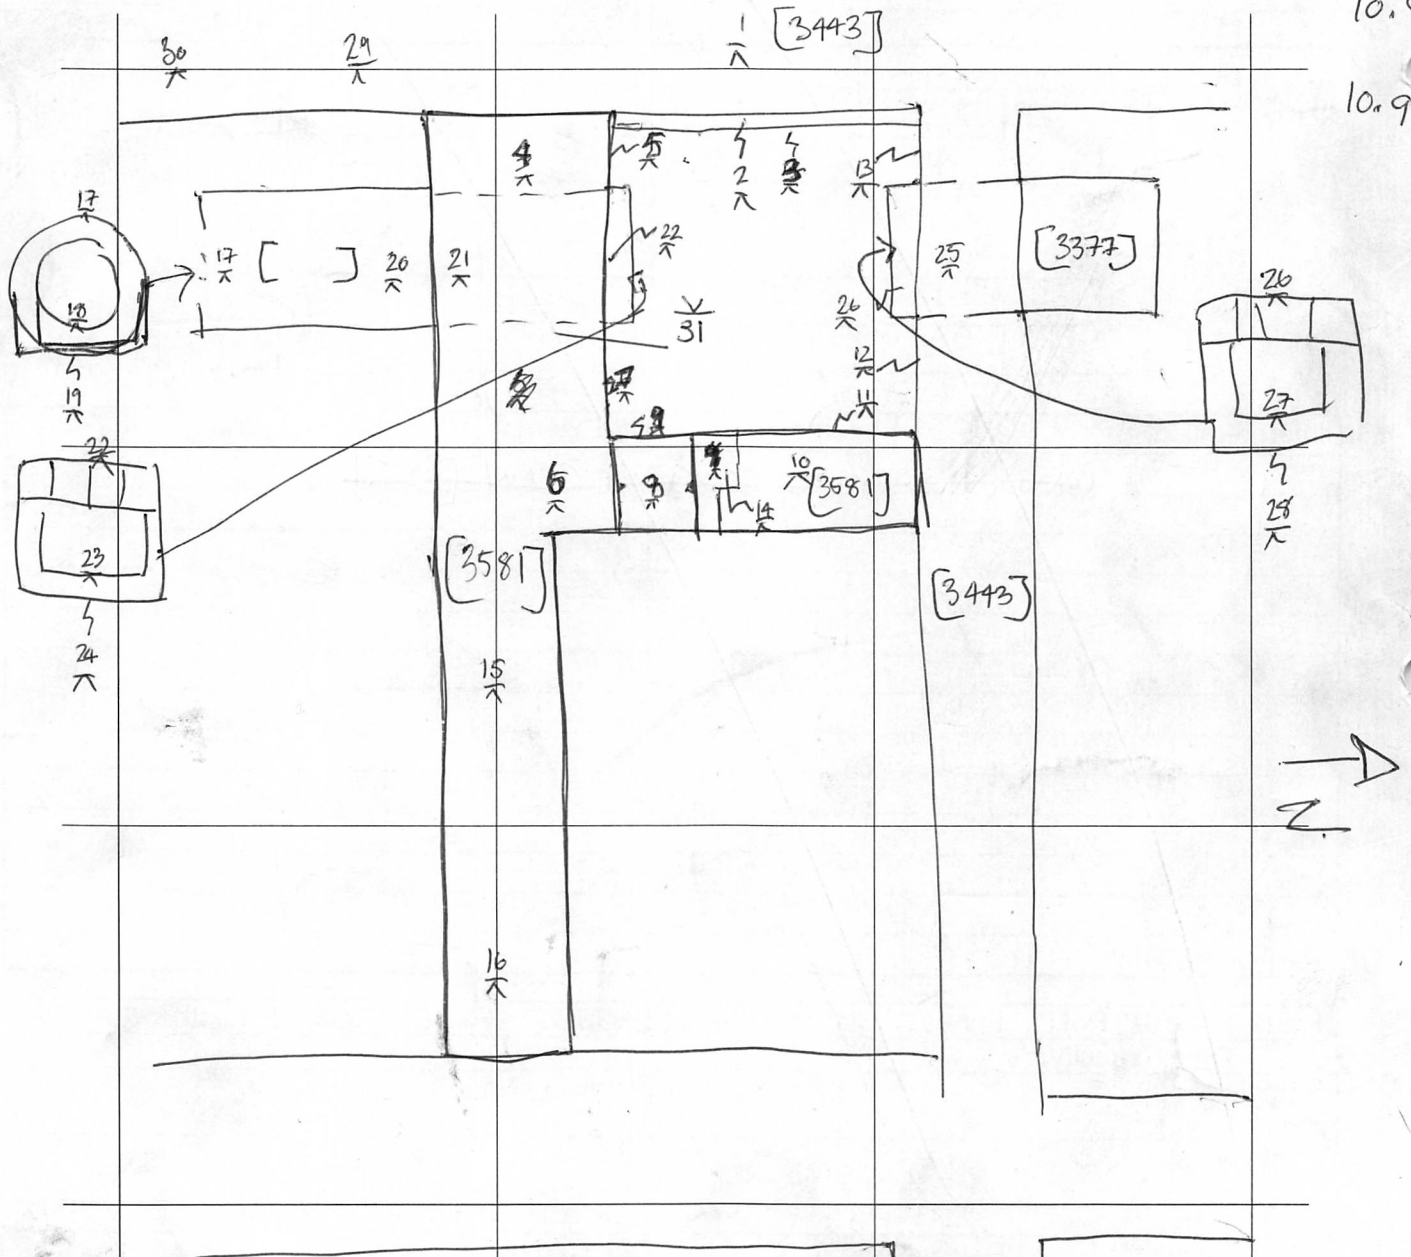
Sketch Plan & Notes

BASE OF WALL  
31 2.72 9.43

21 1.45 10.80  
22 1.59 10.66  
23 1.99 10.26  
24 2.06 10.19  
25 1.47 10.78  
26 1.54 10.71  
27 2.02 10.16  
28 2.16 10.09  
29 1.32  
30 1.26  
10.93  
10.99
