Site Code: <b>MNO12</b>	Gr. Sq. / TP / Tr: <b>B</b>	Context Type: <b>MASONRY</b>	Context Number: <b>324</b>
1. Materials	1. <b>RED BRICK.</b>		
2. Size of materials (brick: BTL in mm)	2. <b>100 x 70 x 225 - -</b>		
3. Finish of stones	3. <b>BRICKS.</b>		
4. Coursing / bond	4. <b>ENGLISH.</b>		
5. Form	5. <b>WALL.</b>		
6. Direction of face(s)	6. <b>NORTH.</b>		
7. Bonding material (if brick: record height of 4 courses & 4 bed joints in m)	7. <b>WALL SIFT <del>AND</del> LIGHT CLAY - GRT LIME MORTAR.</b>		
	<b>ORGA CHARCOAL FIBRES, MOD. LIME FIBRES</b>		
	8. <b>7:2 - HIGH UNKNOWN WIDTH.</b>		
8. Dimensions of masonry as found	a. <b>TRUNC TO E+W BY PILECAPS + ABOVE BY (D).</b>		
9. Other comments

Context Number:  
324.

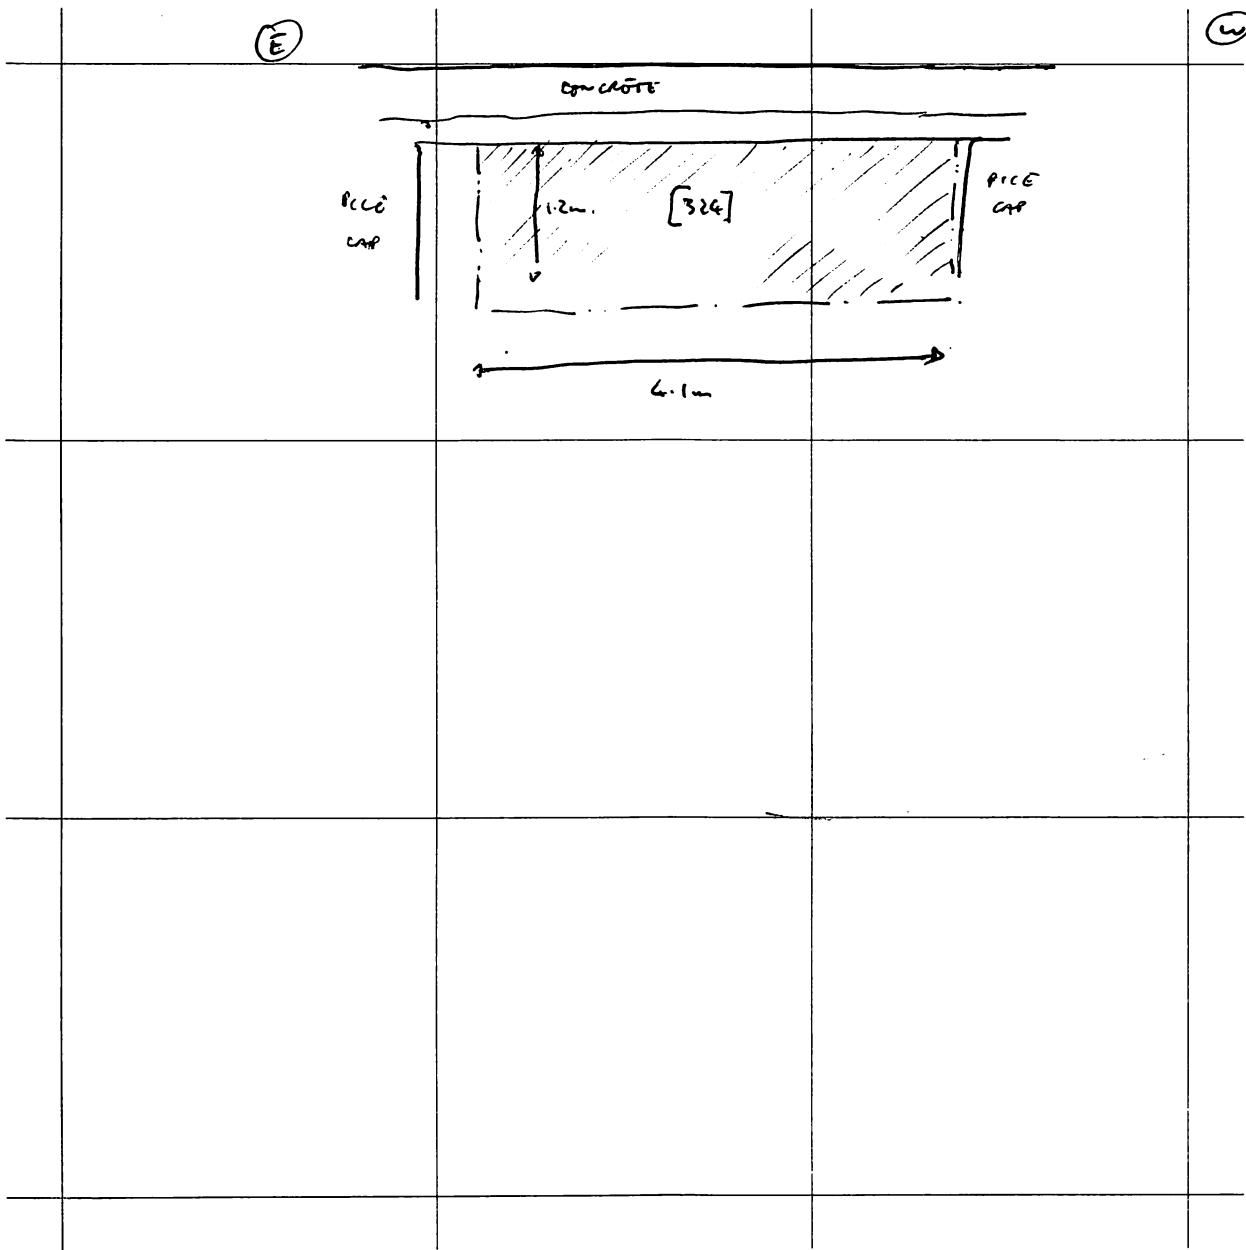
Interpretation:	internal	external ?
<b>RED BRICK WALL EXPOSED ON SOUTH SIDE OF AREA B. TRUNC BY PILE CAPS TO E+W. GOOD FACE ON NORTH SIDE</b> <b>POST 1760 WALL?</b>		
<b>NO LEVELS DUE TO NATURE OF W.B</b>		
Context same as:
