Site Code: MNO12	Location: B	Grid Sq: 120/210	Context Type: MASONRY	Context Number: 2105
1. Materials	1. TWO STONE SLABS LIMESTONE OR MARBLE?			
2. Size of materials (brick: BTL in mm)	2. 0.33m x 0.15m AND 0.41m x 0.13m			
3. Finish of stones	3. SMOOTH, EVEN SURFACES			
4. Coursing / bond	4. TWO STONE SLABS ORIENTATED E-W ALONG THEIR LONGEST AXIS AXIS.			
5. Form				
6. Direction of face(s)	5. FOOTING FOR A DOORWAY			
7. Surface treatment				
8. Bonding material (if brick: record height of 4 courses & 4 bed joints in m)	9. 0.74m x 0.13-0.15m (EW) (NS)			
9. Dimensions of masonry as found	10. STONE TO EAST BROKEN IN TWO, STONE TO WEST BROKEN IN 3 AND HAS A SLANTED EDGE			
10. Other comments				Max Level: 11.20 m OD
				Min Level: 11.22 m OD

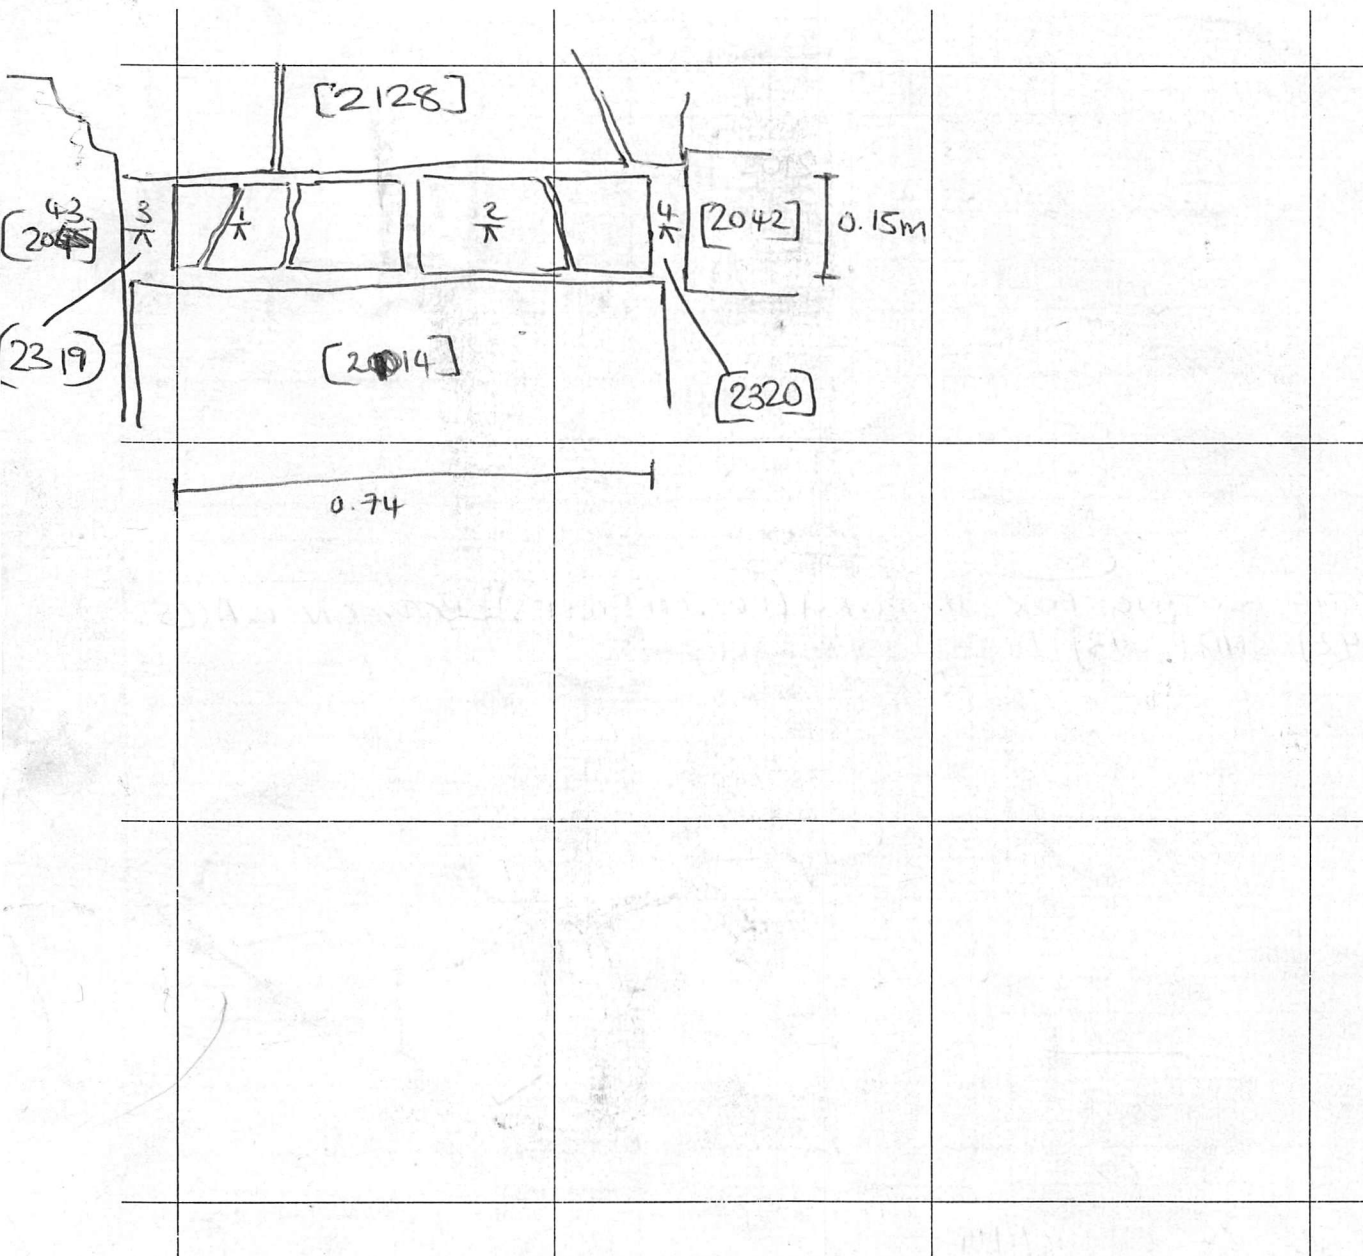
2105

Interpretation:	<input checked="" type="radio"/> internal	<input type="radio"/> external
STONE FOOTING FOR DOORWAY (BROKEN STONES), BETWEEN WALLS ([2042] AND [2043]) AND FLOORS [2114] + [2128]		
Context same as:
