Site Code: MNO12	Location: AREA C	Grid Sq: 155/200	Context Type: MASONRY	Context Number: 3254
1. Materials	① MID ORANGEY RED UNFROGLED BRICK.			
2. Size of materials (brick: BTL in mm)	② 100mm x 76mm x 220mm.			
3. Finish of stones	③ N/A			
4. Coursing / bond	④ STRECHERS ON BED.			
5. Form	⑤ SMALL INTERNAL DIVIDING WALL			
6. Direction of face(s)	⑥ VERTICAL LPS E & W			
7. Surface treatment	⑦ NONE.			
8. Bonding material (if brick: record height of 4 courses & 4 bed joints in m)	⑧ RELIABLE SANDY LIME MORTAR - PALE WHITE GREY MODERATE LIME LUMPS $\leq 10\text{mm}$ OCCASIONAL CHALK LUMPS $\leq 10\text{mm}$ MODERATE SMALL SUB-ANGULAR STONES $\leq 10\text{mm}$			
9. Dimensions of masonry as found	ONLY x2 COURSES HIGH - HEIGHT = 150mm			
10. Other comments	⑨ N-S 0.47m, E-W 0.24m, D 0.15m			Max Level: 10.62 m OD
				Min Level: 10.47 m OD

Context Number:
3254

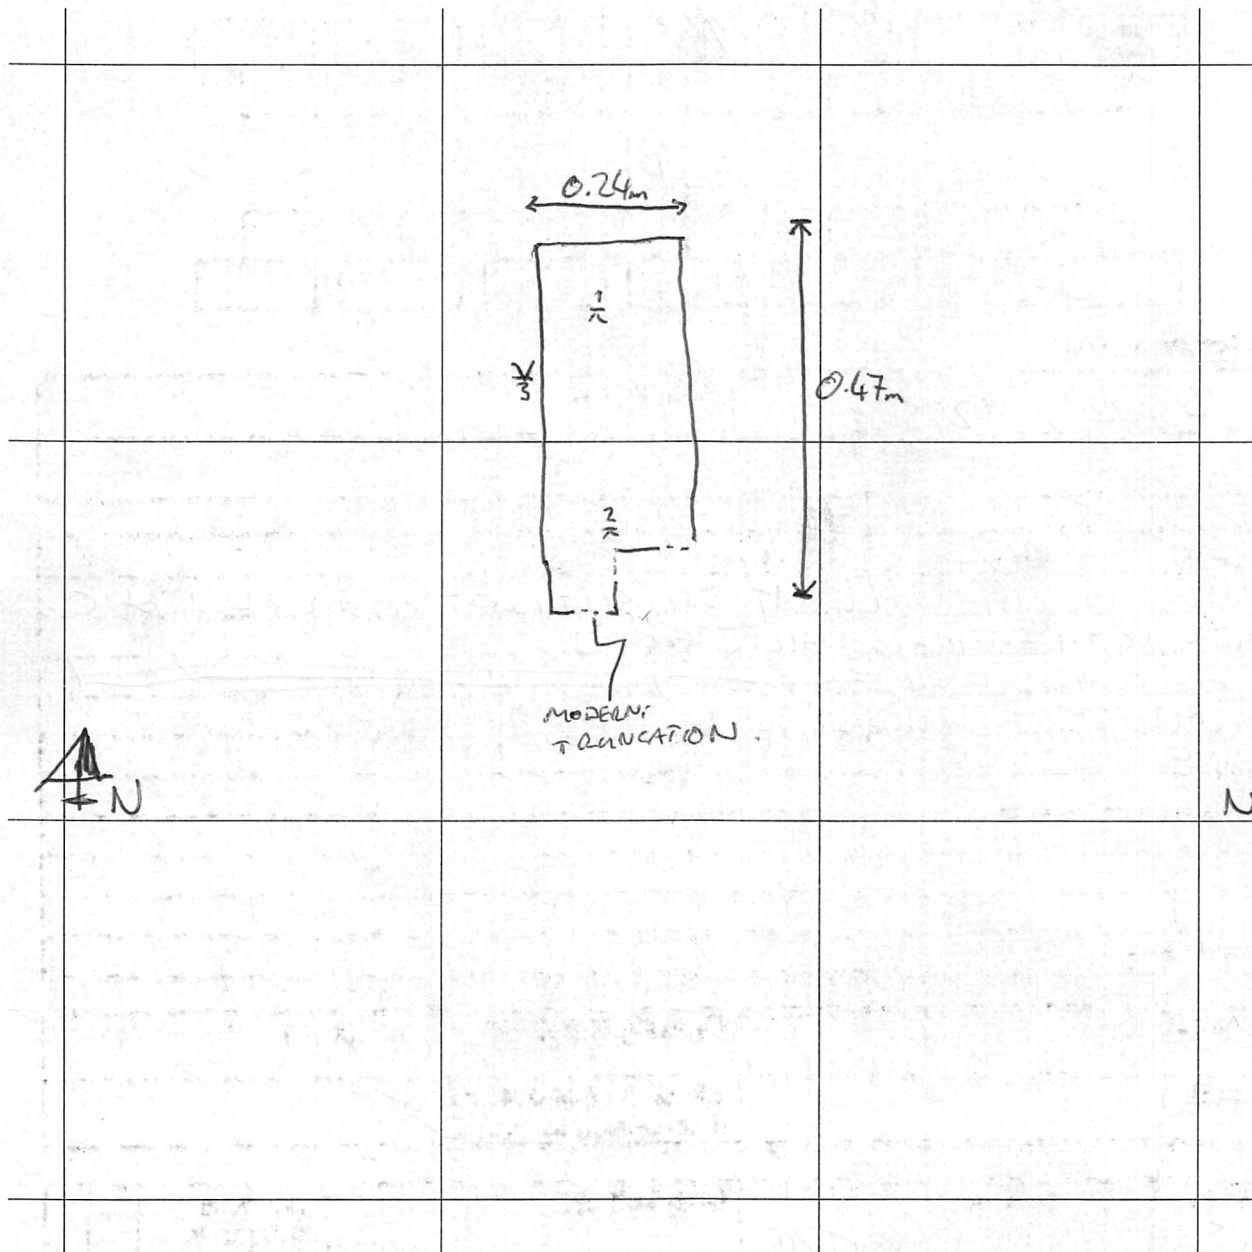
Interpretation:	<input checked="" type="checkbox"/> internal	<input type="checkbox"/> external
INTERNAL DIVIDING WALL AT FAR SOUTH WEST CORNER OF AREA C. IT ABUTS NORTH EXTERNAL WALL [3290].		
ONLY x2 COURSES HIGH, SO EXPECTED TO HAVE BEEN TOO SUBSTANTIAL. MORTAR ON TOP OF BRICKS SURVIVING SHOWS TRUNCATION BY MODERN DISTURBANCE.		
Context same as:

No.	F/S	R/L (m OD)	No.	F/S	R/L (m OD)	No.	F/S	R/L (m OD)	No.	F/S	R/L (m OD)
1	0.53	10.62									
2	0.54	10.61									
3	0.68	10.47
