Site Code: MNO12	Location: AREA 2	Grid Sq: 140/205	Context Type: MASONRY	Context Number: 3193
1. Materials	1. Full length reddish brick			
2. Size of materials (brick: BTL in mm)	2. 110 mm x 70 mm x 230 mm			
3. Finish of stones	3. N/A			
4. Coursing / bond	4. English bond;			
5. Form	5. Brick rebuild of wall			
6. Direction of face(s)	6. North + South + East West at Eastern end			
7. Surface treatment	7. N/A			
8. Bonding material (if brick: record height of 4 courses & 4 bed joints in m)	8. Height = 1.03 m; 14 courses			
9. Dimensions of masonry as found	9. NS = 0.74 m EW = 2.31 m			
10. Other comments	Thickness = 1.03 m			
	10. Truncated at the East end to the South by drain pipe running on an East West alignment; also truncated to the West by [3196]			
			Max Level:	m OD
			Min Level:	m OD

Context Number:

3193

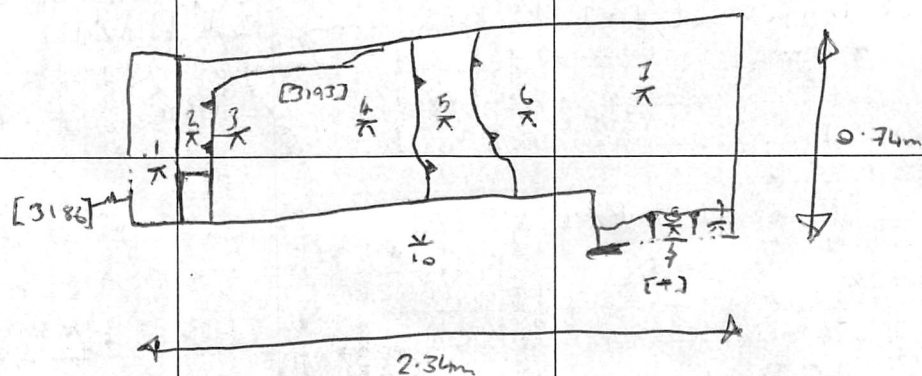
NOT TO SCALE

Interpretation:	<u>internal</u>	external
Brick rebuild of earlier brick wall [3186]; running on an East West alignment; turning 90° South to form North South alignment at Eastern end. Truncated at this point by [3196] drain pipe running East to West.		
Wooden planks (remains) found at the bottom of the wall - used for the construction of the wall.		
Context same as:
