Site Code: <b>MNO12</b>	Location: <b>AREA C</b>	Grid Sq: <b>150 / 205</b>	Context Type: <b>MASONRY</b>	Context Number: <b>3477</b>
1. Materials	① <b>YELLOW STOCK BRICK - SLIGHTLY FROGGED.</b>			
2. Size of materials (brick: BTL in mm)	② <b>100mm x 70mm x 230mm</b>			
3. Finish of stones	③ <b>N/A</b>			
4. Coursing / bond	④ <b>STRETCHES ON BED WITH OFFSETS.</b>			
5. Form	⑤ <b>YELLOW STOCK FOOTING.</b>			
6. Direction of face(s)	⑥ <b>VERTICAL, UP &amp; N, S, &amp; W</b>			
7. Surface treatment	⑦ <b>NONE.</b>			
8. Bonding material (if brick: record height of 4 courses & 4 bed joints in m)	⑧ <b>LIGHT WHITE GREY CONCRETE. HEIGHT ONLY x 3 COURSES = 0.28m</b>			
9. Dimensions of masonry as found	⑨ <b>N-S 0.75m E-W 0.64m D 0.28m</b>			
10. Other comments	⑩ <b>NONE.</b>			
				Max Level: <b>10.86</b> m OD
				Min Level: <b>10.55</b> m OD

Interpretation:	<input checked="" type="checkbox"/> internal	<input type="checkbox"/> external
<b>YELLOW STOCK FOOTINGS WITH x2 OFFSETS.</b>		
<b>POSSIBLY FOR SUPPORTING SINK DUE TO DOWN PIPE.</b>		
<b>FOOTINGS SIT WITHIN CUT FOR MODERN DRAINAGE [3875].</b>		
Context same as:

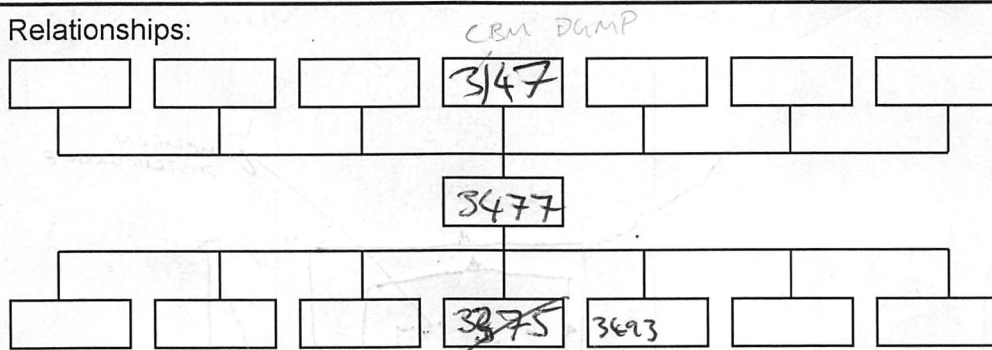
Stratigraphic Relationships:

Abuts: <b>3142</b>	Abutted by: <b>3493</b>
Cut by:

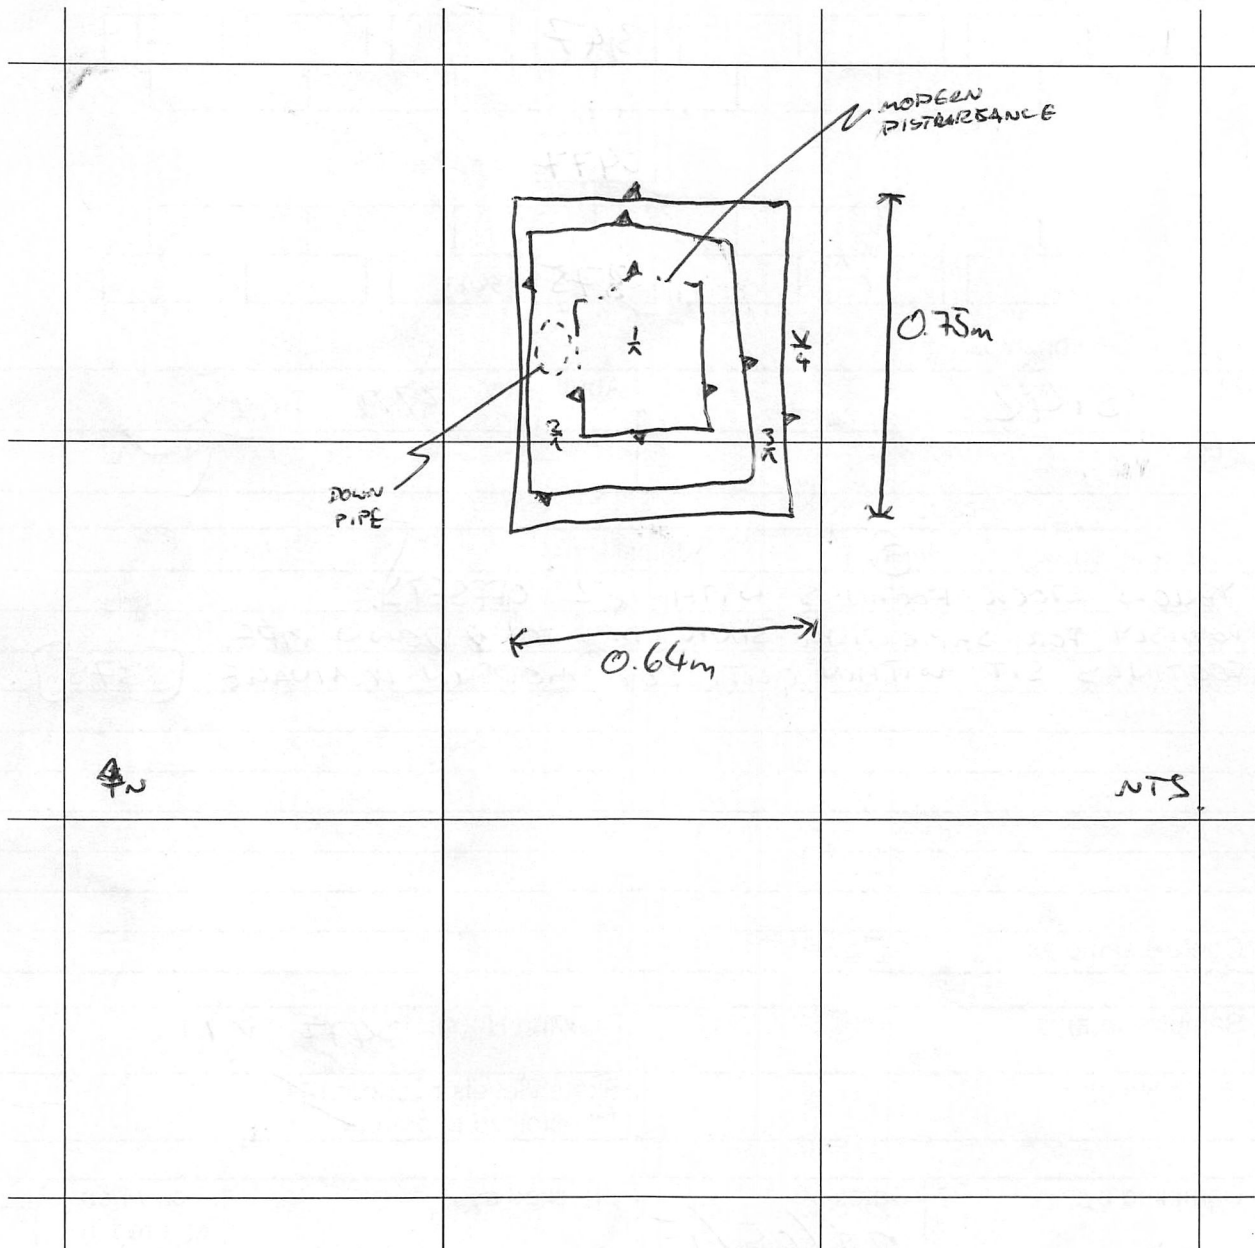
Context Number:  
3477

No.	F/S	R/L (m OD)	No.	F/S	R/L (m OD)	No.	F/S	R/L (m OD)	No.	F/S	R/L (m OD)
1	1.71	10.86									
2	1.84	10.73									
3	1.90	10.67									
4	2.02	10.55
