Site Code: MNO12	Location: AREA C	Grid Sq: 150/205 150/200	Context Type: MASONRY	Context Number: 3410
1. Materials	1. Full length Reddish + yellow bricks + Reddish brick tile			
2. Size of materials (brick: BTL in mm)	2. 100x65x230 - Brick 130x40x300 - Tile			
3. Finish of stones	3. N/A			
4. Coursing / bond	4. Irregular / none			
5. Form	5. Roof repair for brick drain [3153]			
6. Direction of face(s)	6. Coding / sky			
7. Surface treatment	7. N/A			
8. Bonding material (if brick: record height of 4 courses & 4 bed joints in m)	8. courses; Height - 0.06m; On bricks its side, one flat/regular + tile flat/regular			
9. Dimensions of masonry as found	9. NS - 0.30m EW - 0.32m Thickness - 0.06m			
10. Other comments	10. NONE			
				Max Level: 10.72 m OD
				Min Level: 10.65 m OD

Interpretation:	<u>internal</u> external 3153 Subterranean
Roof repair for brick drain running East to West * [3153]	
Context same as:

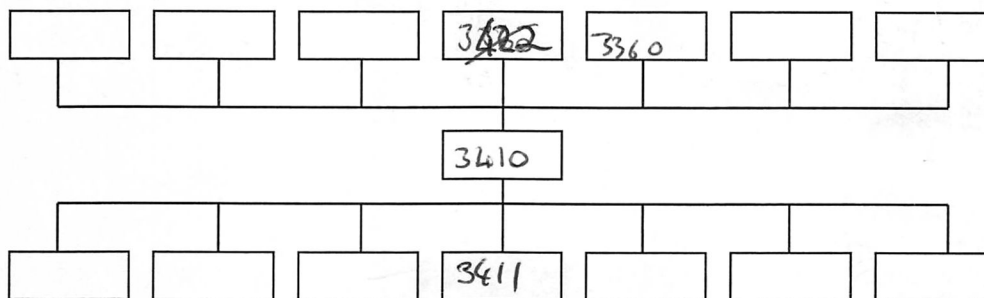
Stratigraphic Relationships:

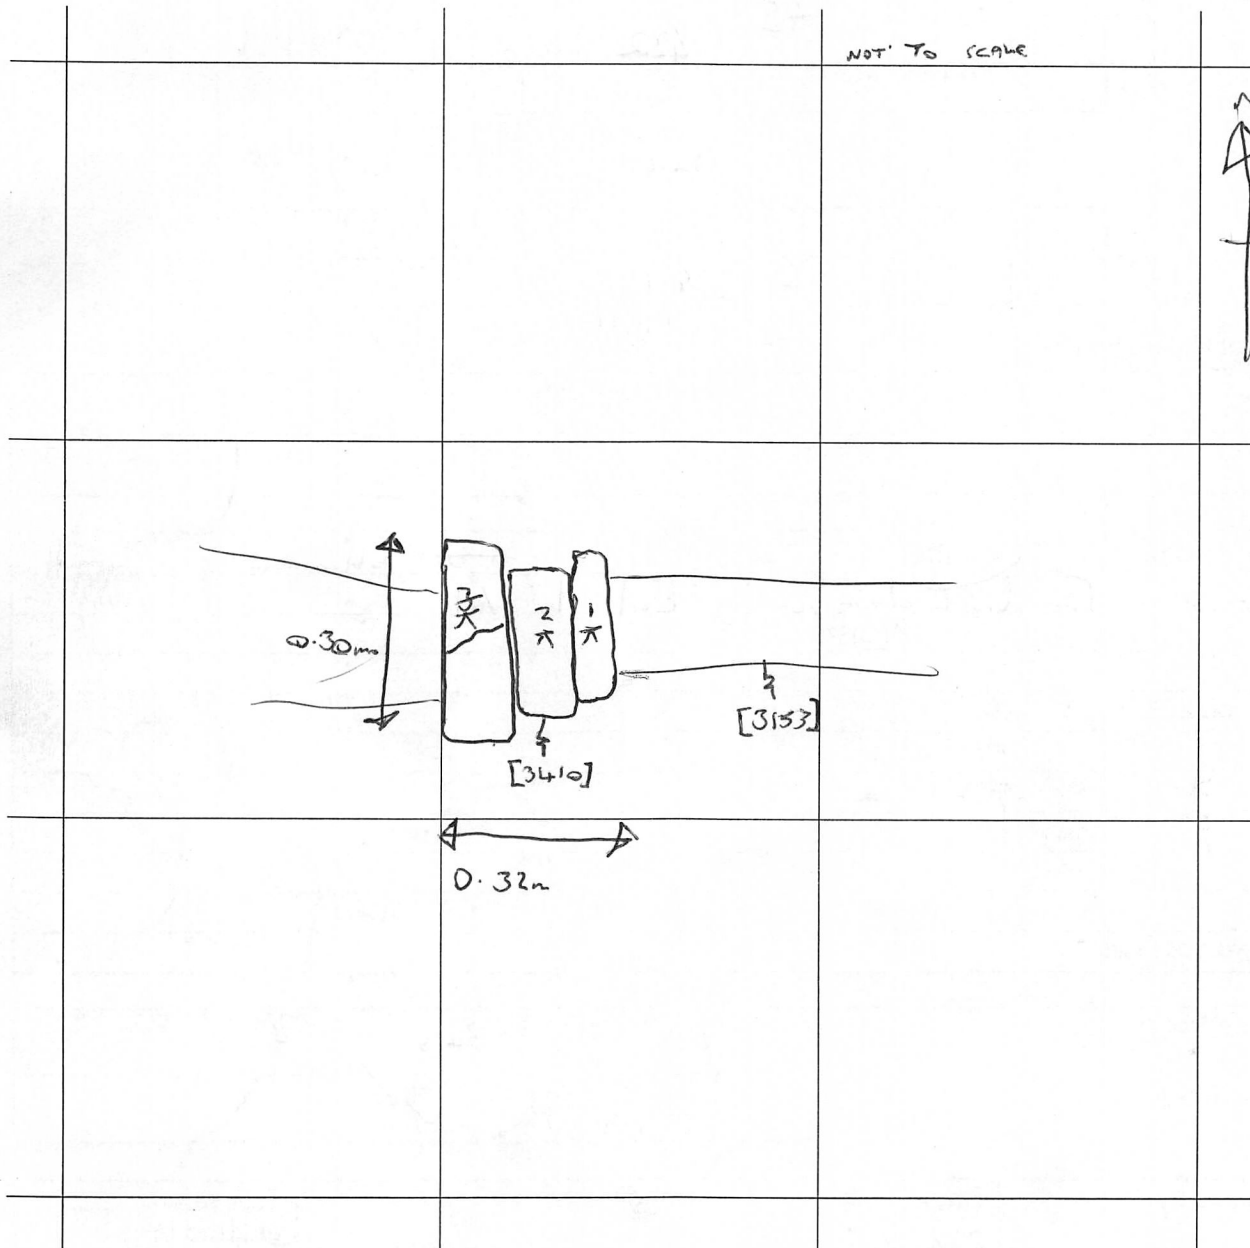
Context Number:
3410

Level No.s 1-3
TBM 11.60
B/S 1.08
IH 12.48

No.	F/S	R/L (m OD)	No.	F/S	R/L (m OD)	No.	F/S	R/L (m OD)	No.	F/S	R/L (m OD)
1	1.76	10.72									
2	1.79	10.69									
3	1.83	10.65
