Site Code: MNO12	Location: AREAL	Grid Sq: 150/205	Context Type: MASONRY	Context Number: 3422
1. Materials	1. Yorkshire Slabs			
2. Size of materials (brick: BTL in mm)	2. 330 x 430 x 470mm

Interpretation:	<u>internal</u>	external
Easternmost yorkshire slabs used as ceiling/roof for brick drain [3153] running East to West at South of Area C; Slightly smooth, roughly hewn		
Context same as:

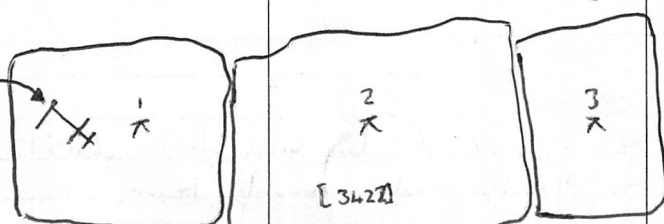
SECTION OF
EASTERN SLAB

10. Other comments	10. Mason marks on Western most slab; Fetched on West end, rob on East; Furthest to the East is curved			Max Level: 10.67 m OD
on underside				Min Level: 10.62 m OD

MASONRY
MARK

1.07m

0.35m
