Site Code: MNO12	Location: AREAC	Grid Sq: 155 215	Context Type: MASONRY	Context Number: [3396]
1. Materials	1. orange, red and yellow brick + orange tile (HARD)			
2. Size of materials (brick: BTL in mm)	2. Varying in size, they are not half bricks; no whole bricks (100mm x 60mm x 130mm in average)			
3. Finish of stones				
4. Coursing / bond	3. /			
5. Form	4. irregular			
6. Direction of face(s)	5. brick floor			
7. Surface treatment	6. /			
8. Bonding material (if brick: record height of 4 courses & 4 bed joints in m)	7. /			
9. Dimensions of masonry as found	8. Bonding material (if there was one) was washed out, only found silty sand between bricks			
10. Other comments	9. 0.50m (E-W); 0.45m (N-S); 0.2m 0.07m thick			
				Max Level: 10.72 m OD
				Min Level: 10.70 m OD

Context Number:
3396

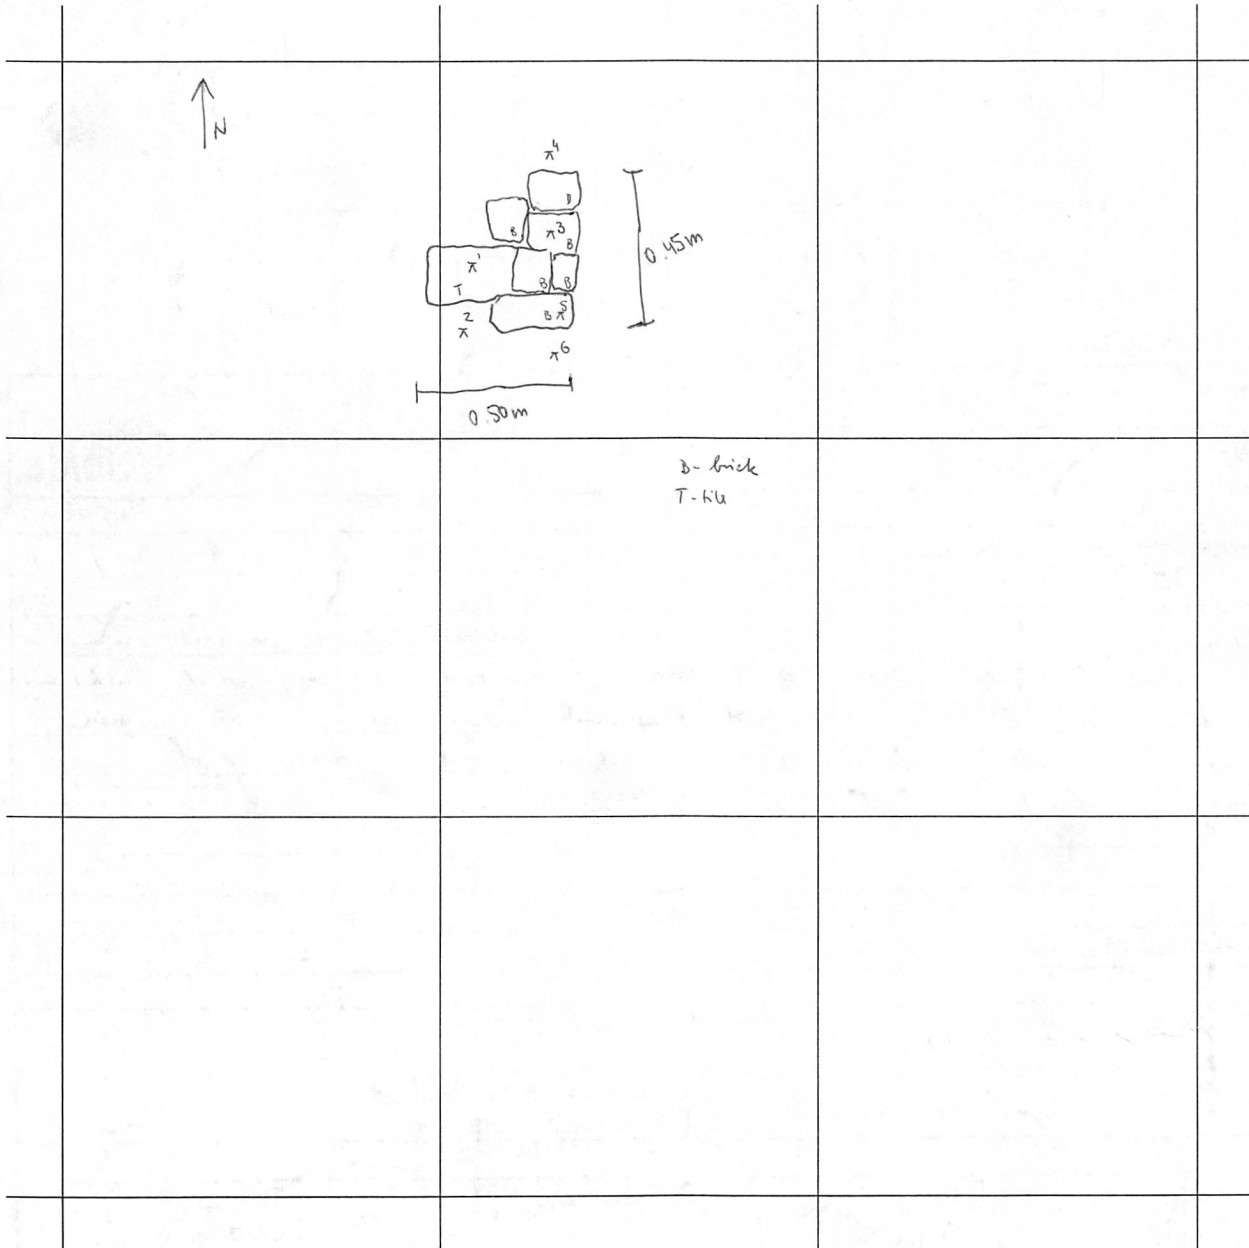
Interpretation:	internal	<u>external</u>
Brick floor in central Georgian the room.		
Only a small fragment of the floor was preserved, it was composed of bricks and Vane tile. Bricks were both fragmented fragmented, not one whole brick was recorded. A Bricks varied in size and colour (yellow, orange and red) and were very hard.		
Context same as:

No.	F/S	R/L (m OD)	No.	F/S	R/L (m OD)	No.	F/S	R/L (m OD)	No.	F/S	R/L (m OD)
1	1.81	10.70	6	1.84	10.67						
2	1.85	10.66									
3	1.79	10.72									
4	1.84	10.67									
5	1.81	10.70
