Site Code: MND12	Gr. Sq. / TP / Tr: 150/205 155/205	Context Type: Fill	Context Number: 3374
Deposit	1. Layer	Cut 1. Shape in Plan 2. Corners 3. Dimensions 4. Break of slope - Top 5. Sides 6. Break of slope - Base 7. Base 8. Orientation 9. Inclination 10. Truncation 11. Other comments	
1. Compaction	2. Dark greyish brown		
2. Colour	3. Sandy silt		
3. Composition	4. Frag. brick / C.B.M + mortar, concrete,		
4. Inclusions	occ. pot, bone, glass, C.T.P., Fe shavings,		
5. Dimensions	Frag. small sub-angular bones, oyster		
6. Other Comments	5. NS- 2.40m EW- 5.60m D 0.50m		
7. Method/Conditions	Depth		
6. Not fully excavated (20/05/15)			
7. Wet, windy

Modern Fill of drain cut [3375] running on an East to West alignment splitting into a North Western direction up the Western most side

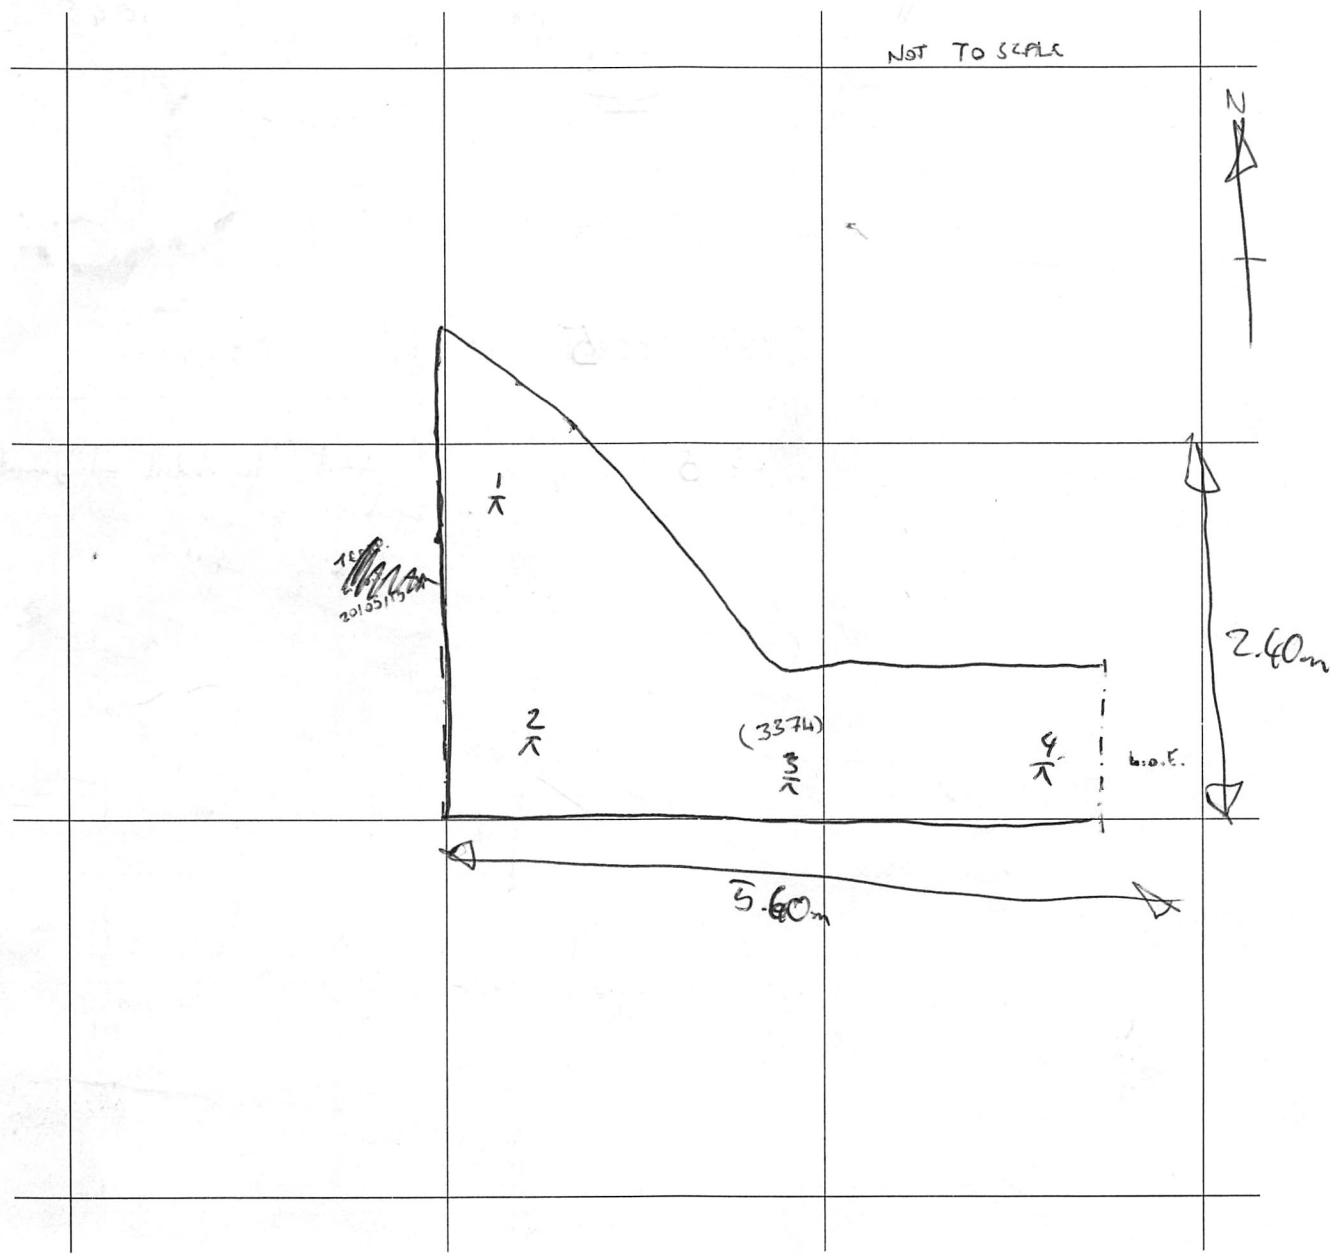
Context Number:
3374

No.	F/S	R/L (m OD)	No.	F/S	R/L (m OD)	No.	F/S	R/L (m OD)	No.	F/S	R/L (m OD)
1	1.74	10.78									
2	1.76	10.76									
3	2.04	10.48									
4	1.95	10.57
