Site Code: <b>MNO12</b>	Location: AREA C	Grid Sq: 145/215	Context Type: MASONRY	Context Number: 3355
1. Materials	① HALF/BROKEN BRICKS (MID PINKISH RED/DARK REDDY ORANGE, HARD, UNFROGGET)			
2. Size of materials (brick: BTL in mm)	②			
3. Finish of stones	③ MOULDED BRICK			
4. Coursing / bond	④ STRETCHERS ON BED, ON EDGE ADJACENT TO THE WALL [ ] - ONE COURSE THICK			
5. Form	⑤ BRICK FLOOR			
6. Direction of face(s)	⑥ UP			
7. Surface treatment	⑦ -			
8. Bonding material (if brick: record height of 4 courses & 4 bed joints in m)	⑧ MORTAR (MID-BROWN/YELLOW, SANDY, SOFT)			
9. Dimensions of masonry as found	⑨ N-S 0.37m, E-W 0.26m			
10. Other comments	⑩ HEAVILY TRUNCATED			
				Max Level: 10.90 m OD
				Min Level: 10.75 m OD

Interpretation:	<u>internal</u>	external
PART OF A BRICK FLOOR IN THE REAR ROOM OF A BUILDING ON THE MINORIES STREET FRONT		
Context same as: 3356

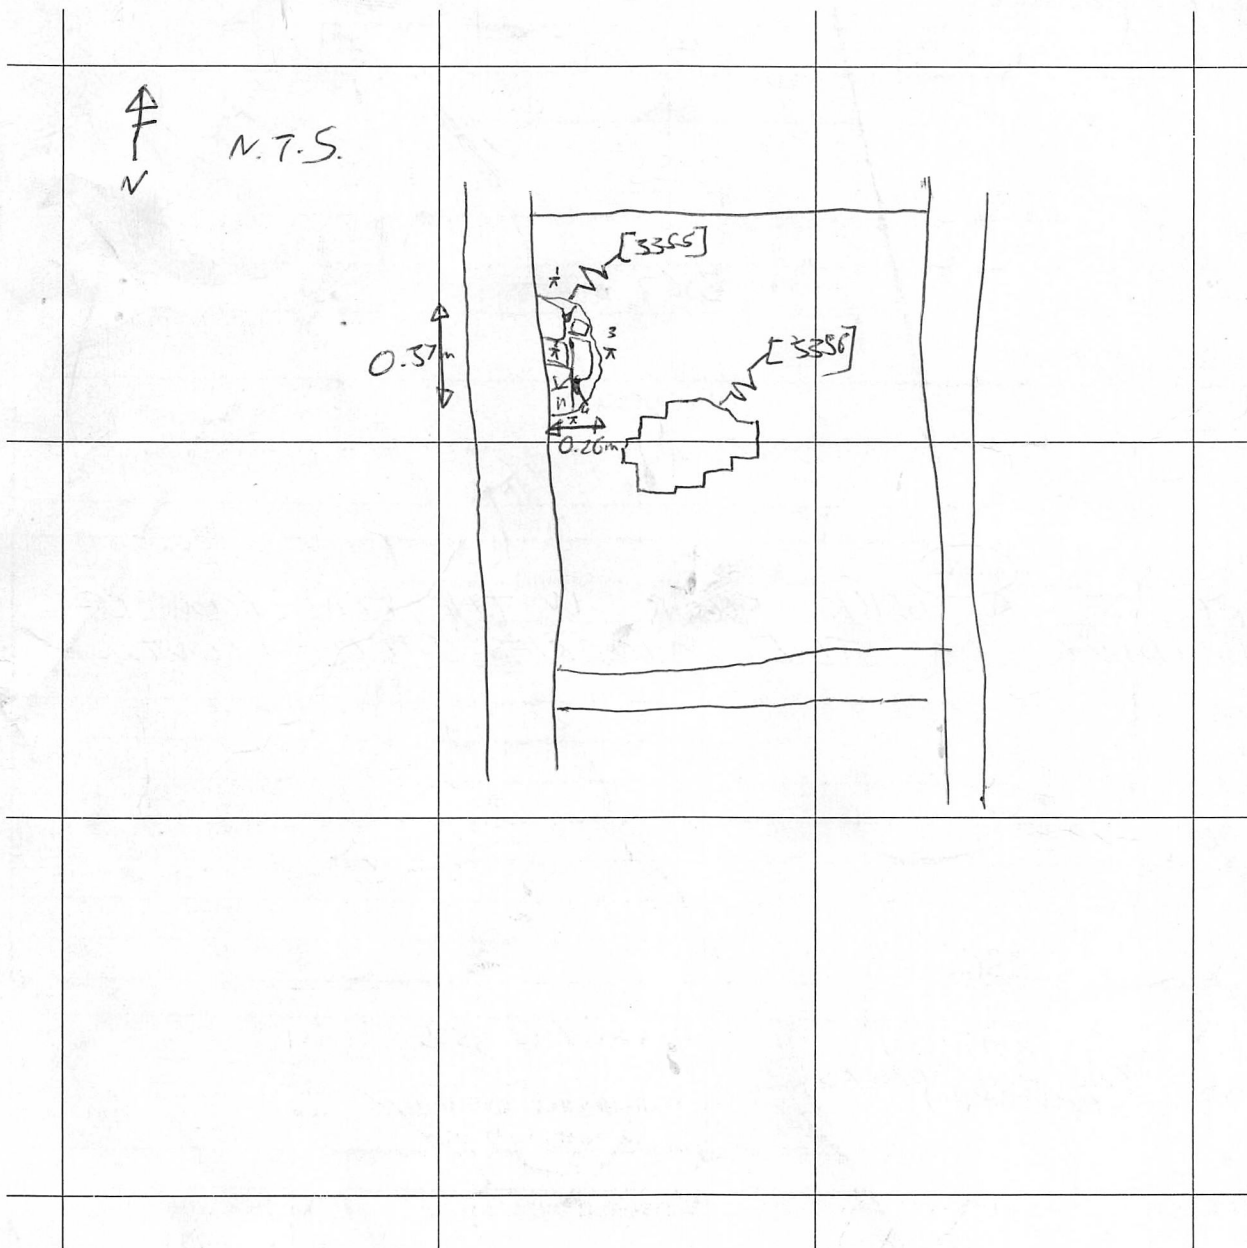
Context Number:  
3355

No.	F/S	R/L (m OD)	No.	F/S	R/L (m OD)	No.	F/S	R/L (m OD)	No.	F/S	R/L (m OD)
1	1.41	10.84									
2	1.35	10.90									
3	1.43	10.82									
4	1.41	10.84									
B	1.50	10.75
